NCC BCA Compliance & Building Condition Audit Report

Project:	Port Hedland Retirement Village
Site Address:	Stevens Street, Port Hedland
Client:	Town of Port Hedland
Our Ref:	P180104
Date:	27 th April 2018
Revision:	1

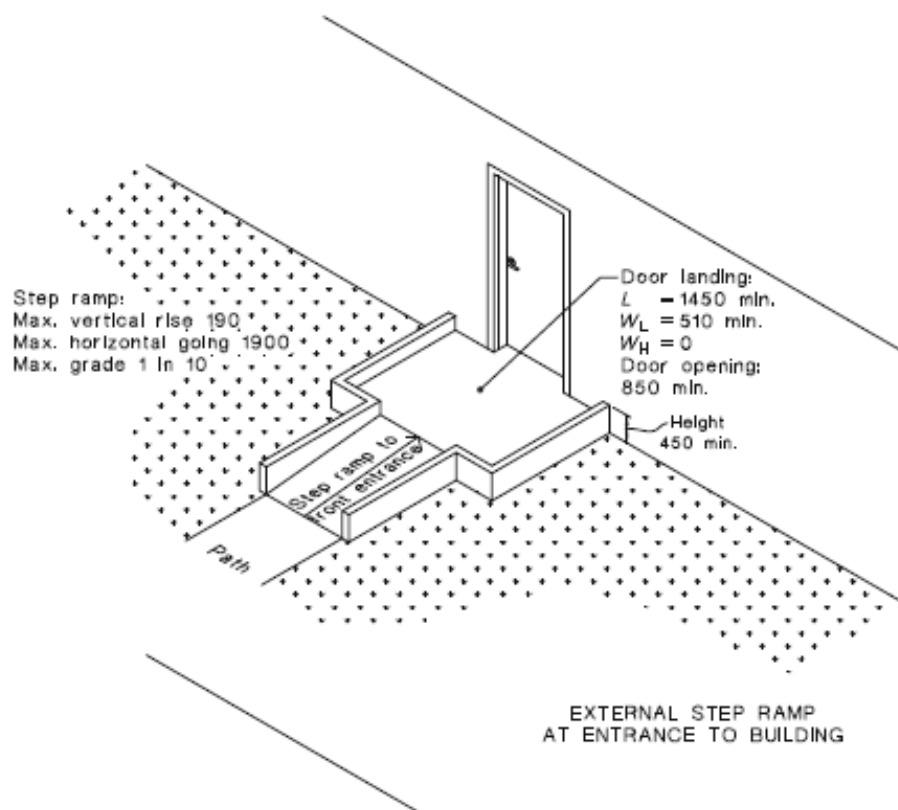
Figure 2 – Step ramp and landing details for external doorways

The external doorways all incorporate a step at the threshold of approximately 120 mm down to external paving level. This is a trip hazard and each doorway should be provided with a step ramp as detailed below.

Access would be required to and within the building with step free thresholds to entrance doors. This is not achieved and the ramps provided to entrance doors are too steep and do not provide a level landing or incorporate edge protection. Refer to Figure 1 in this report for details of an adequate step ramp and landing.

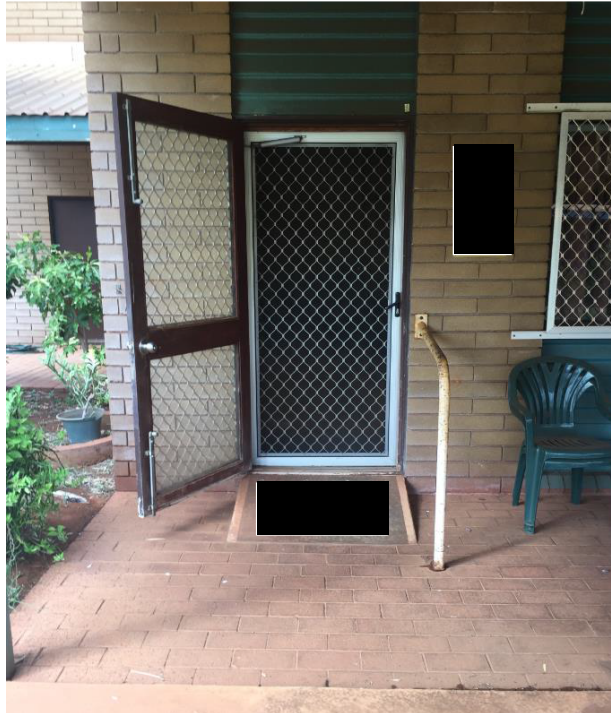
Photo 1 – Doorway to Communal Building

Access and egress from the building are compromised by the screen doors that incorporate latches that can be locked by a key from the inside. These screen doors also swing inwards and both these factors could impede emergency egress. These screen doors should therefore be removed from doors that are identified as emergency exits by the illuminated exit signs.

The main doors have locks with knob type latch handles. These latch handles should be replaced with lever type handles so that the doors can be opened by a simple downward action on the latch.

This photograph shows the steep access ramp as well as non-compliant latch to the door and the screen door that may impede emergency egress.

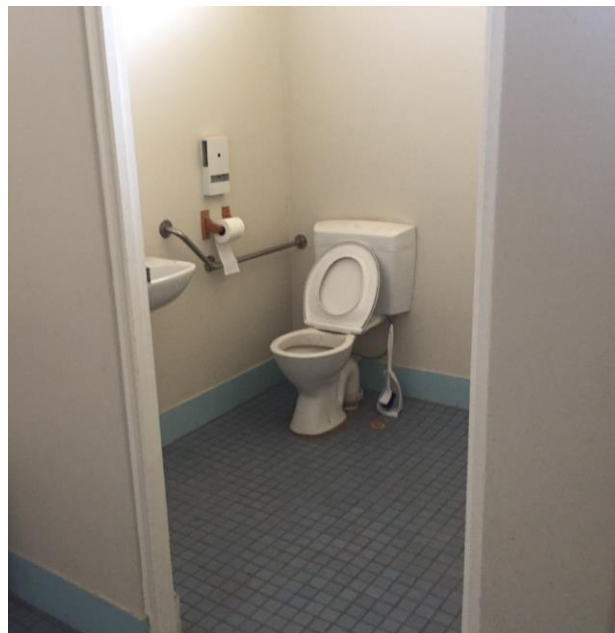
Photo 2 – Communal Building Accessible Sanitary Facility

One cubicle in each of the male and female toilets has been constructed for use by people with mobility disabilities. These cubicles do not conform with the current requirements and are accessed via doorways that do not provide adequate clear width for wheelchair users. The only way of addressing these non-compliances with current standards would be to construct a new unisex accessible sanitary facility separate to the existing toilets.

The accessible sanitary facilities within the Communal Building do not comply with current standards.

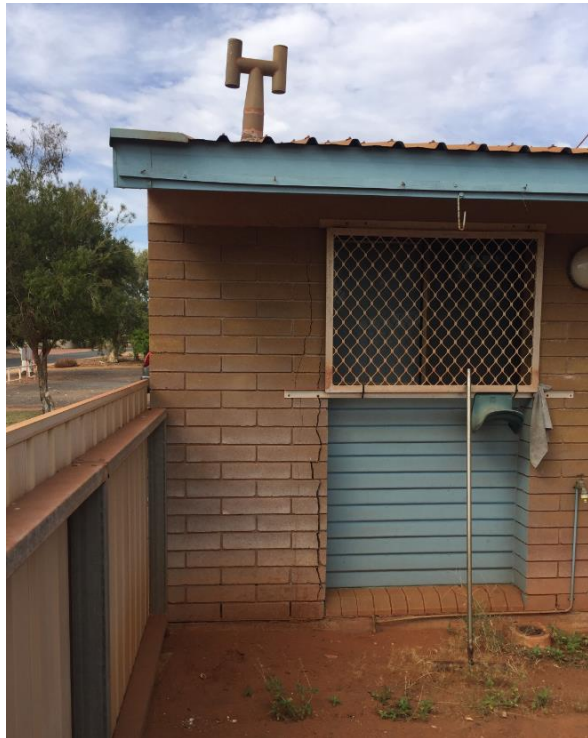
Photo 3 – External Walls Vertical Cracks

Several buildings have cracking to external walls similar to the above. The cause of these cracks is not clear, and should be investigated by a structural engineer.

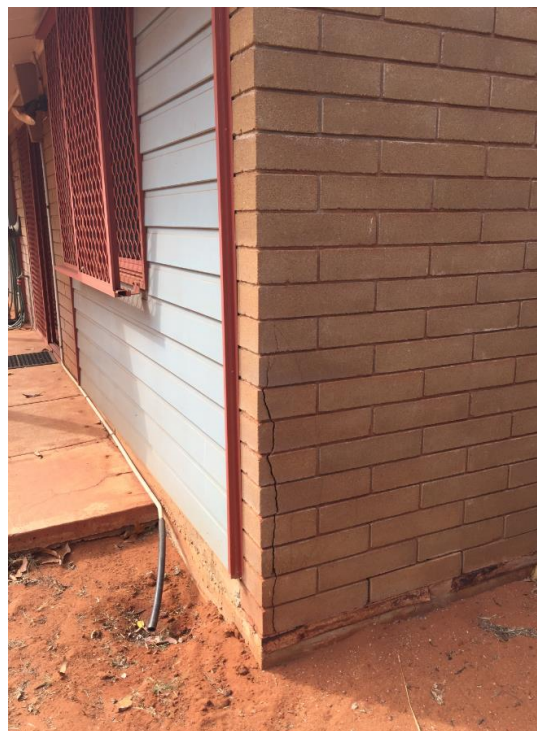
Photo 4 – External Walls Vertical Cracks

Several buildings have cracking to external walls similar to the above. The cause of these cracks is not clear, and should be investigated by a structural engineer.

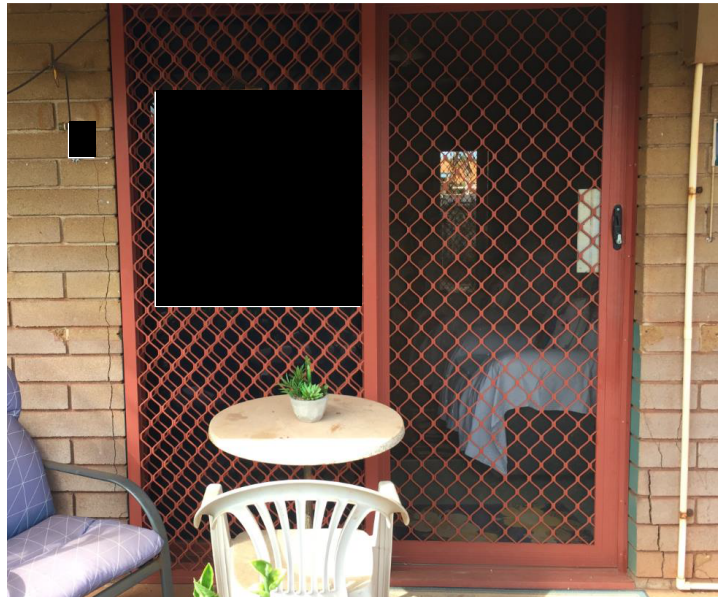
Photo 5 – External Walls Vertical Cracks

Several buildings have cracking to external walls similar to the above. The cause of these cracks is not clear, and should be investigated by a structural engineer.

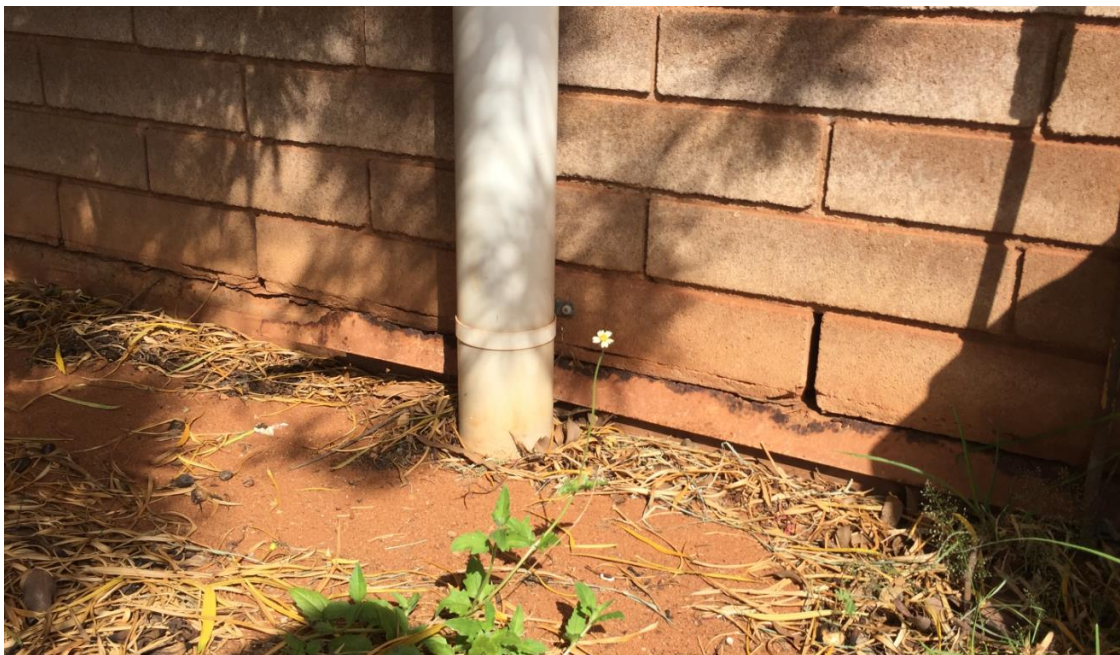
Photo 6 – External Walls Corroded Flashing

The cavity flashing and damp proof membrane to all residential blocks and the communal building has corroded and is no longer fit for purpose. Removal and replacement of these components should be investigated before further deterioration occurs.

All residential blocks and the Communal Building have corroded cavity flashing / damp proof membrane.

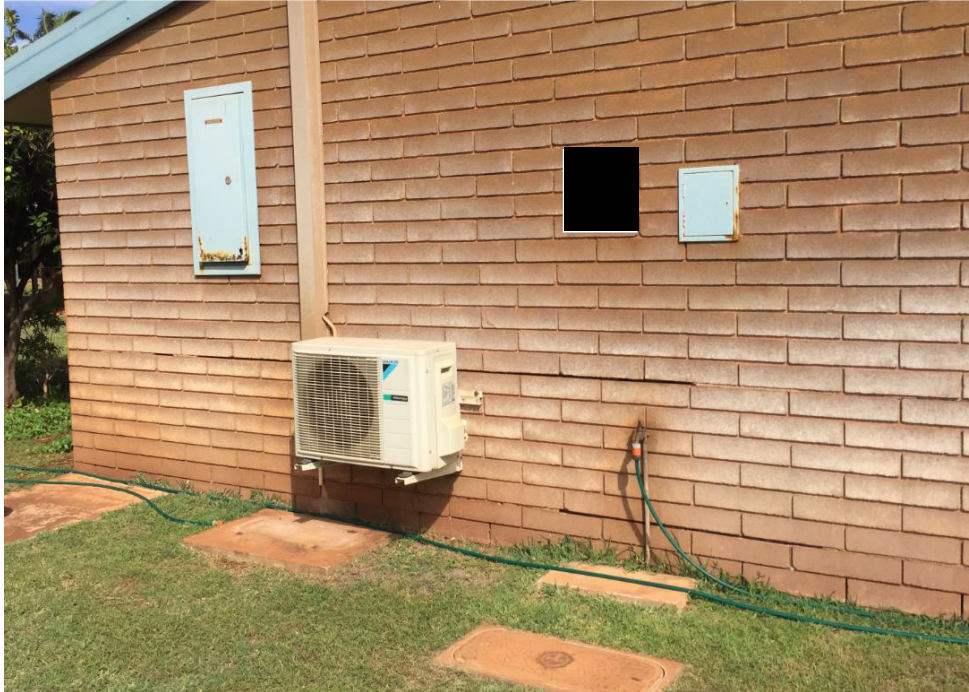
Photo 7 – External Walls Fretting Mortar

Mortar joints have fretted to the eastern external wall of the building. This may be due to spalling reinforcing within the mortar bed joint and this should be investigated further to determine the cause and possible remediation.

The eastern wall to residential units Block [REDACTED] has damage to mortar joints.

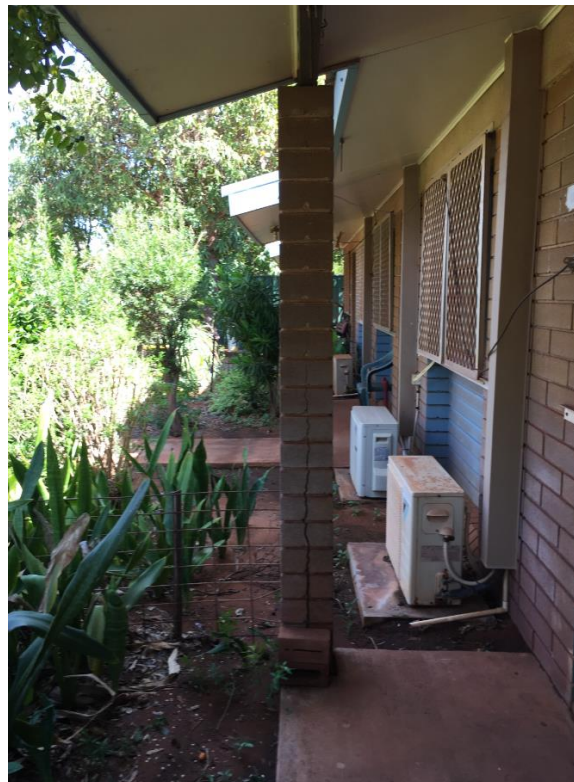
Photo 8 – Masonry Piers Vertical Cracking

There is evidence of vertical cracking to concrete blockwork piers. This may be the result of corroding steel members within the blockwork and should be investigated as matter of urgency due to structural stability being compromised.

Masonry piers to residential blocks and the communal building have vertical cracks that may be caused by corroding and expanding hold down rods within the piers.
