Town of Port Hedland

Structural Review of Observation Tower, Wedge Street, Port Hedland

RSA 15-0440-150727-R TOPH 139515 July 2015

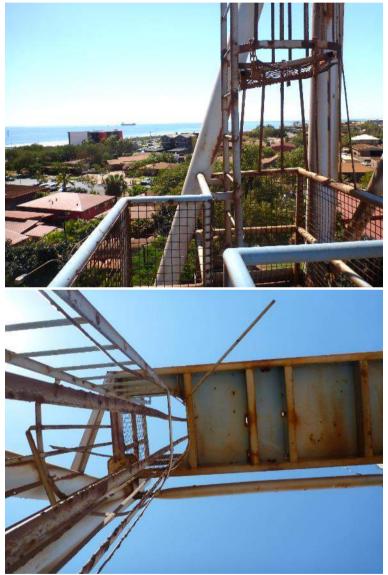
Figure 1: Photos showing the access ladder between Level 5 and 6

This ladder is in an unsafe condition with the steps being severely corroded. For this reason Level 6 was not accessed for the site inspection. The ladder is to be removed and replaced if required.

The existing access ladder (Level 5 to Level 6) is to be removed. Refer section 3.1 of this report.

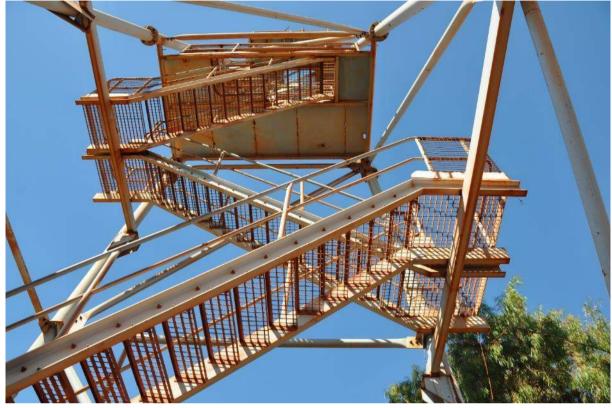
Figure 2: Photo showing lower level stairways

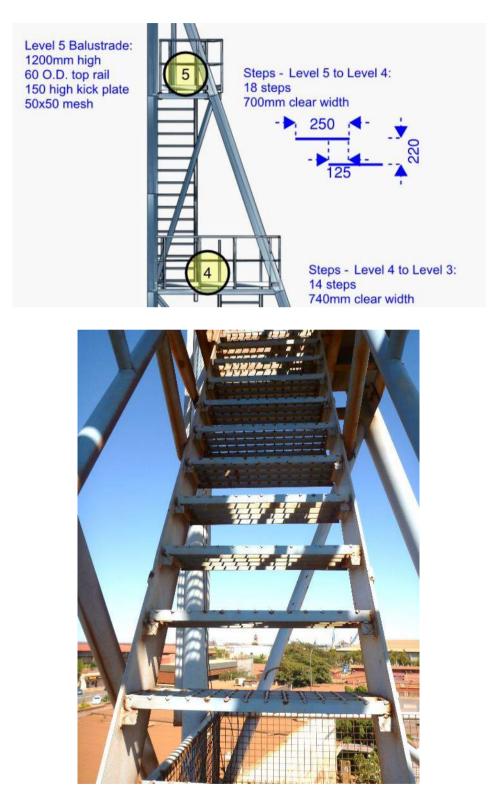
3.2.4 Level 4 to 5

Number	$2 \le N_{steps} = 18 \le 18$	ОК
Riser	$130mm \le R = 220mm \le 225mm$	OK

Going
 $G = 125mm \le 215mm$ NG

Combination
 $540mm \le (2R+G) = 565mm \le 700mm$ OK

The stairway steps do not comply with the requirements of AS 1657 for a stairway. They do, however, comply with the requirements of AS 1657 for a step-type ladder.

Provide floor plate or abrasive nosing to the existing treads on the stairway between Level 4 and 5. AS 1657 requires that the nosing of the tread is clearly visible against the background. Refer section 3.2.4 of this report.

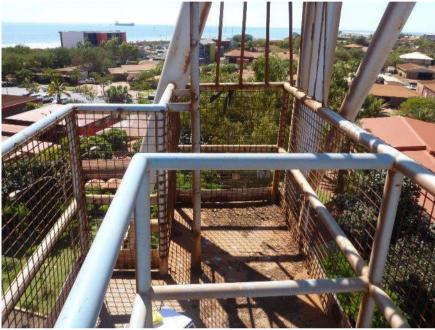
Figure 3: Photo showing Level 5 platform

The existing floor plate to Levels 4, 5, and 6 is rusting with significant corrosion and holes in some locations. The floor plate on these levels is to be replaced or repaired as appropriate.

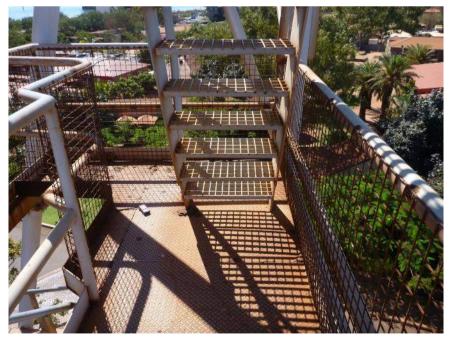
Figure 4: Photo showing Level 4 platform

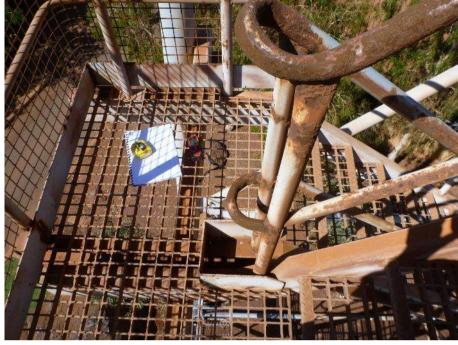
Figure 5: Photo showing Level 3 platform

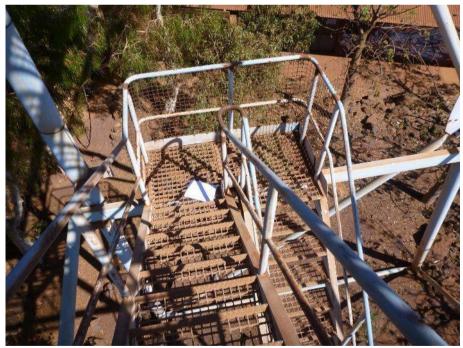
Figure 6: Photo showing Level 2 platform

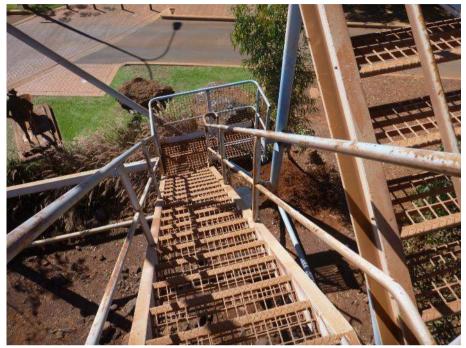
Figure 7: Photo showing Level 1 platform

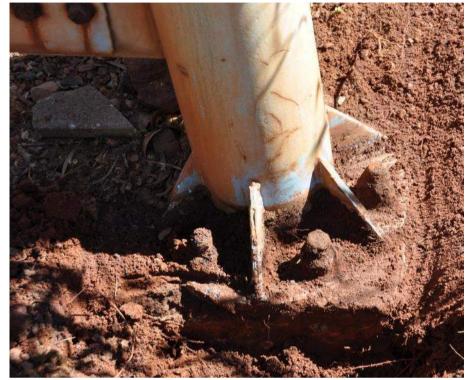
Figure 8: Column base connection to foundation

A more durable protective coating is specified for column bases. Site inspection suggests that this zone is more prone to corrosion, as evidenced by greater corrosion in this area.

At column bases provide additional thickness of the mid coating, extending up to the top of the lower strut and brace connection as illustrated and outlined below:

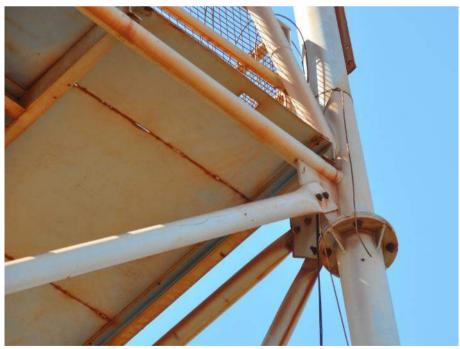
Figure 9: Column splice and strut and brace connections

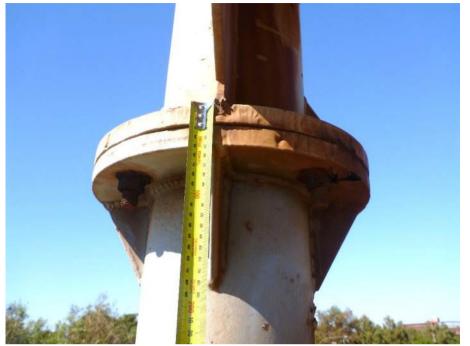
Figure 10: Closer view of column splice connection

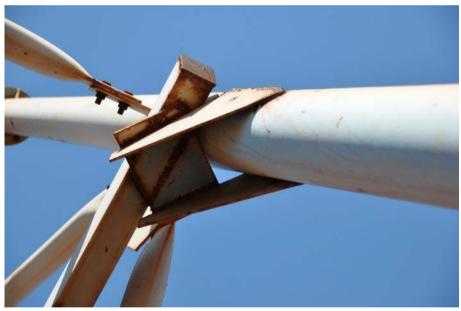
Figure 11: Underside of connection between beam B1 and column

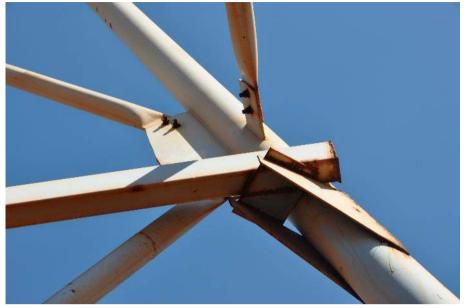
Figure 12: Side of connection between beam B1 and column

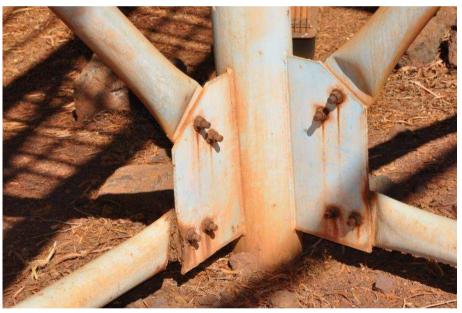
Figure 13: Connection between struts and braces at base of column
