Town of Port Hedland Observation Tower

Tower Condition Assessment Report

Prepared for the Town of Port Hedland
19 February 2026

Document Number	25-0564-02-001_0
------------------------	------------------

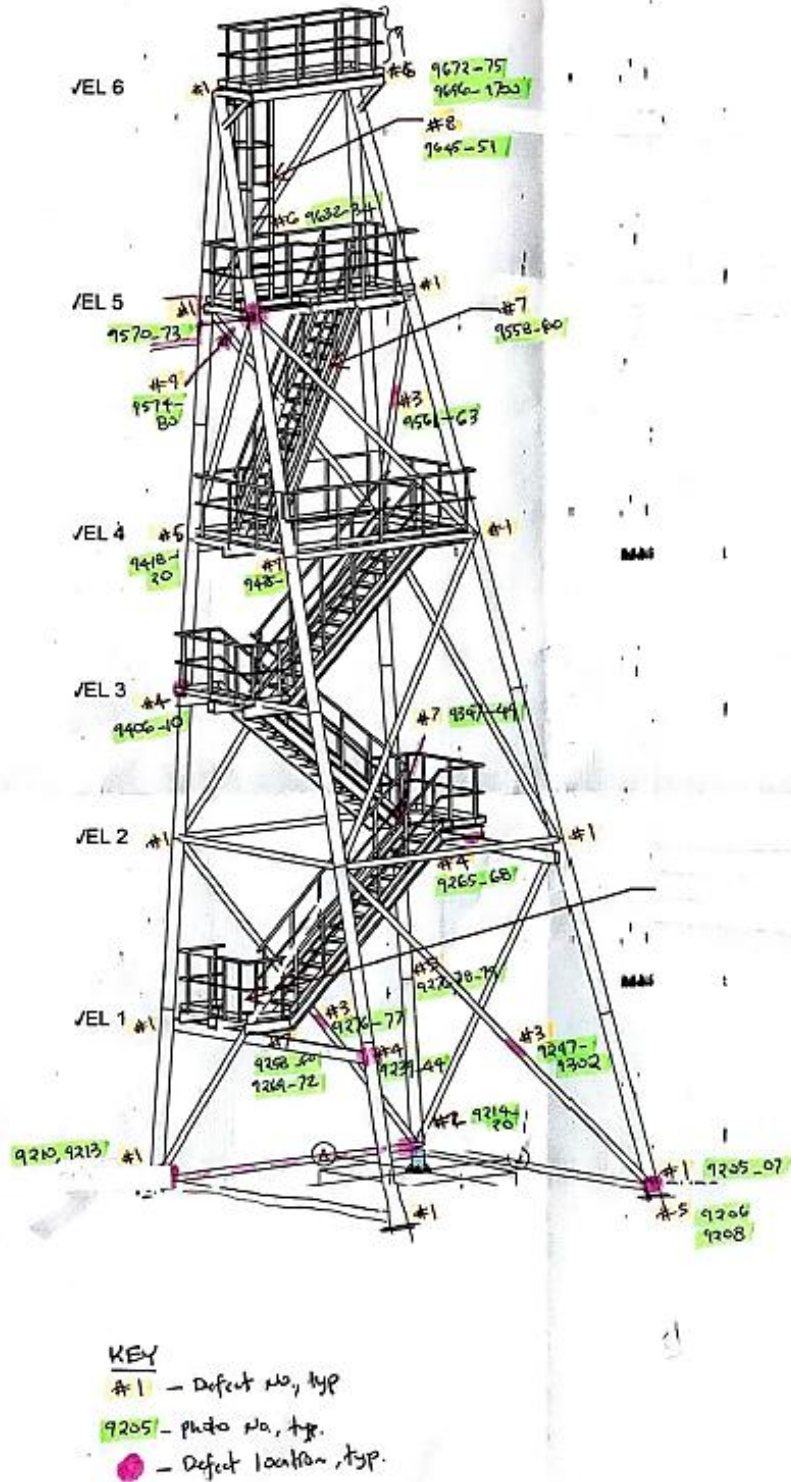
Figure 3 Defect locations

[#]Refer to Figure 3 for typical defect locations

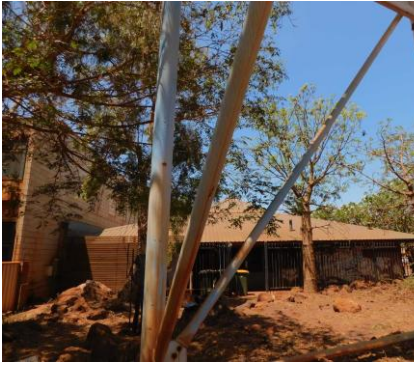
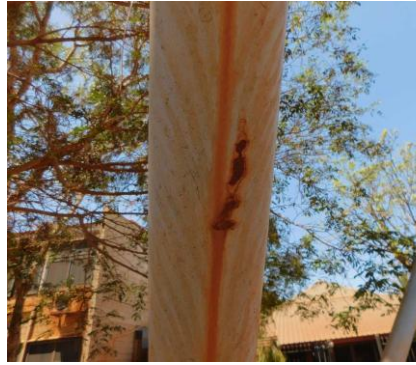
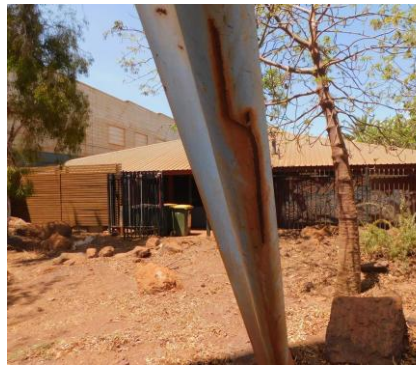
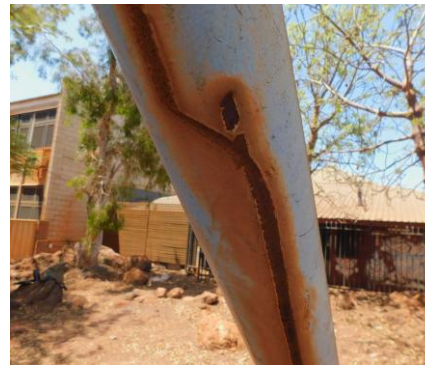
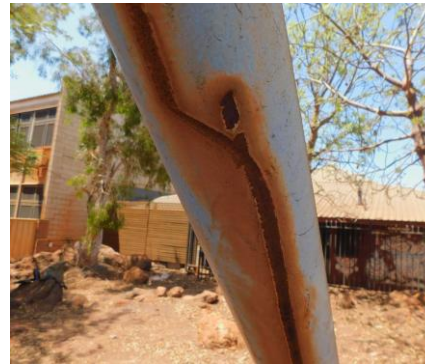
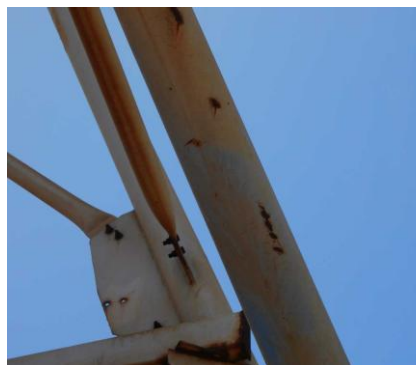
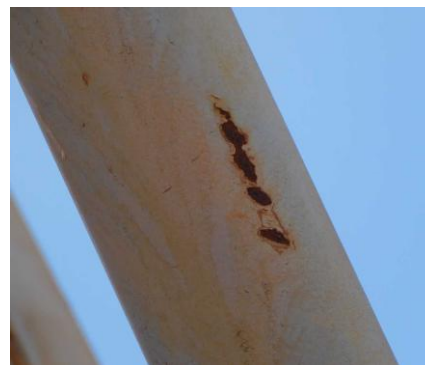
Defect ID 3

Defect ID	Location#	Element Description	Defect Description	Possible Cause/Recommended Action*	Priority Ranking	Photo Nr's
1	Connections	Fasteners and connection plates	Protective coating breach (PCB) and Level 3 corrosion in multiple locations (all connections).	Clean areas of deterioration, prepare surfaces and re-apply protective coating as per manufacturer's recommendations and to AS 2312.1. If more defects or severe deterioration is found during remediation, contact AIE for further direction.	P3	9205-9207 9210, 9213 9270-9273
2	Bracing	Horizontal bracing	Level 5 corrosion at an isolated area/connection of ground level bracing. Bracing disconnected from connection.	Replace bracing like-for-like.	P1	9214-9220
3	Bracing	Diagonal bracing	PCB and Level 3 corrosion in multiple locations.	Prepare surface and re-apply protective coating as per manufacturer's recommendations and to AS 2312.1. If more defects or severe deterioration is found during remediation, contact AIE for further direction.	P3	9276-9277 9297-9302 9561-9563

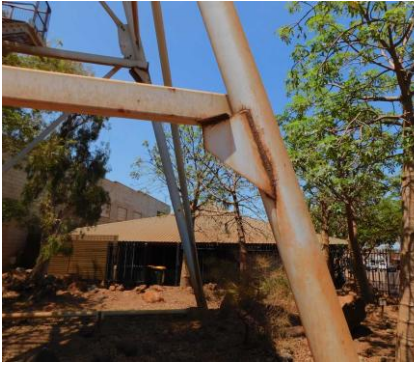
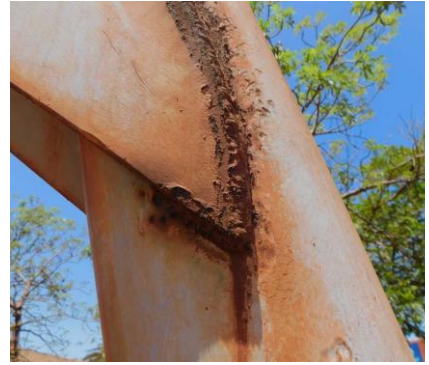
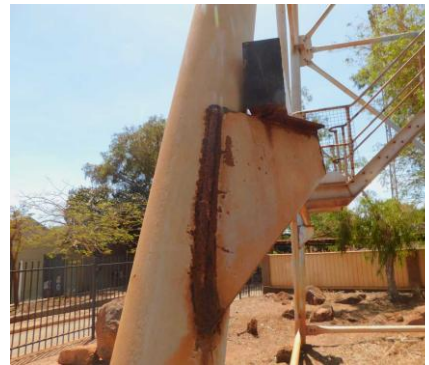
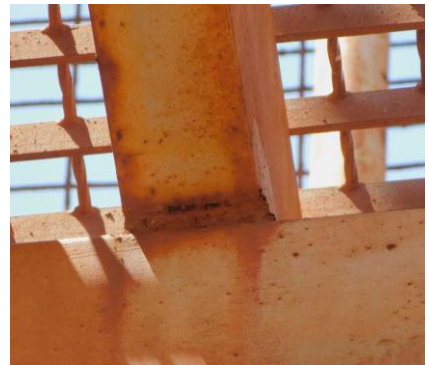
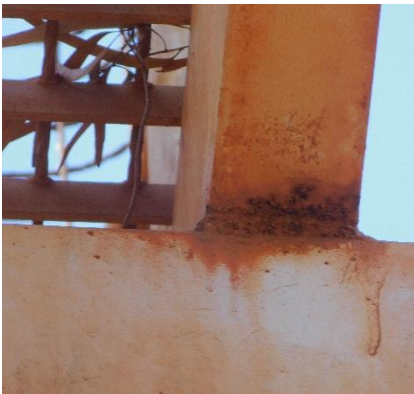
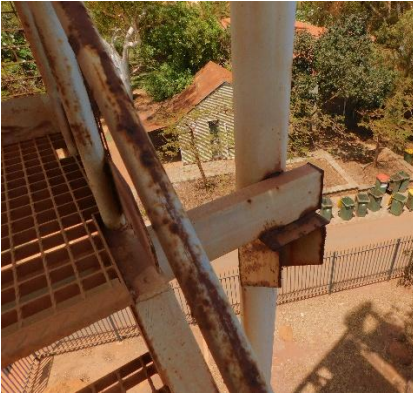
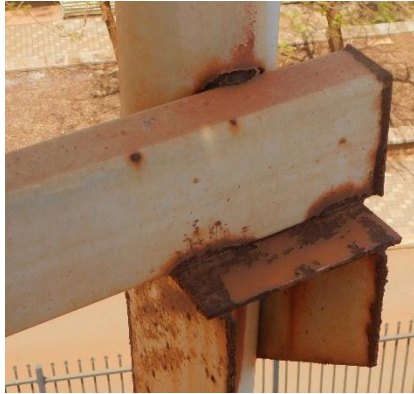
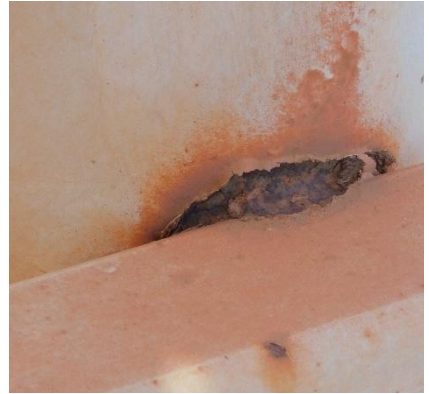
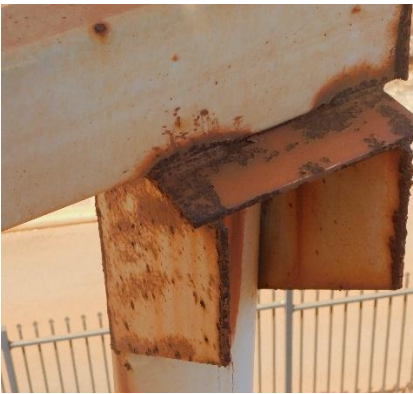
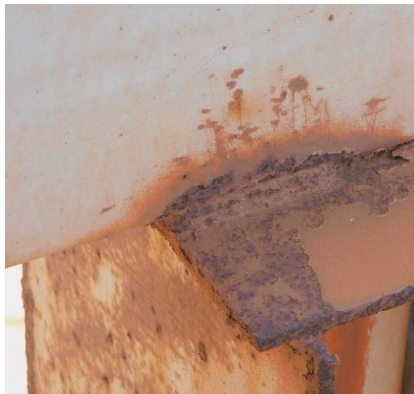
Defect ID 4

4	Connections	Welds	PCB and Level 3 corrosion in multiple locations.	Clean areas of deterioration using a wire brush and further determine extent of corrosion per location, prior to remediation by either: <ul style="list-style-type: none"> Grinding the weld connection and re-welding following AS/NZS 1554.1 Preparing surfaces and re-applying protective coating following manufacturer's recommendations and to AS 2312.1. 	P3	9239-9244 9265-9268 9406-9410

- Multiple welds have widespread protective coating breach and Level 3 corrosion. It is recommended that the deteriorated areas be cleaned using a wire brush (or similar), and further assessment be undertaken to determine the extent of corrosion per location prior to remediation by either,

- Grinding the weld connection and re-welding following AS/NZS 1554.1
 - Preparing surfaces and re-applying protective coating following manufacturer's recommendations and to AS 2312.1.

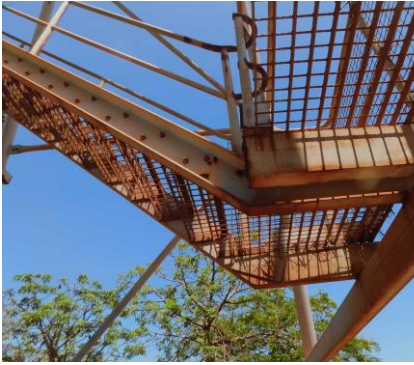
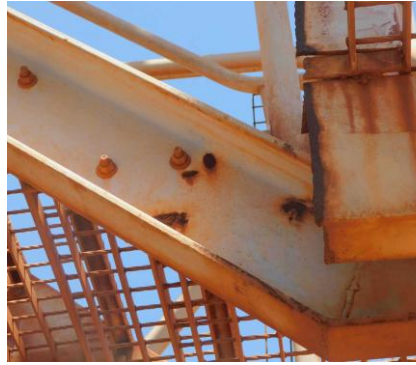
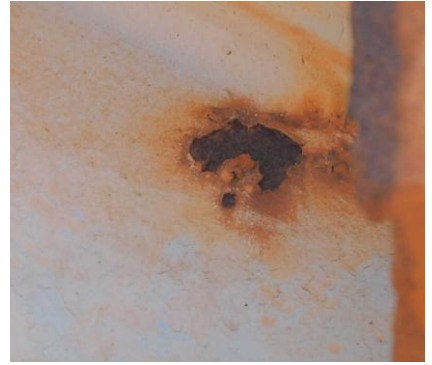
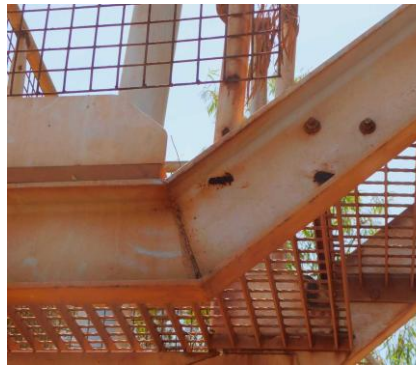
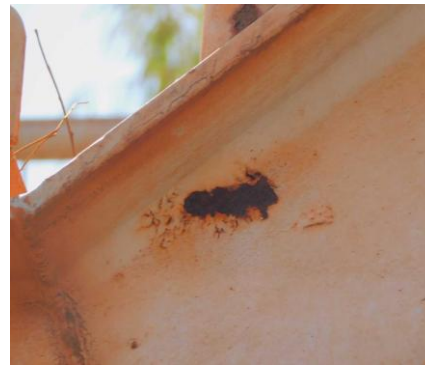
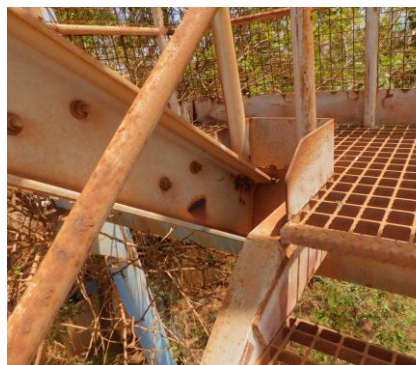
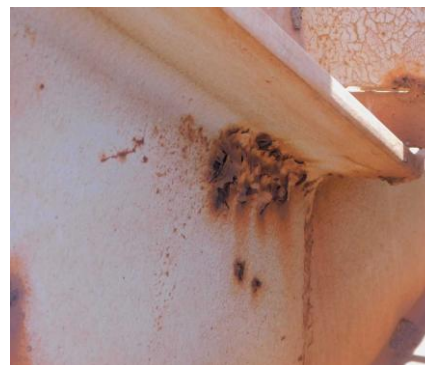
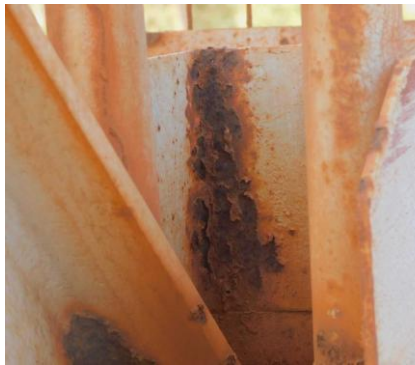
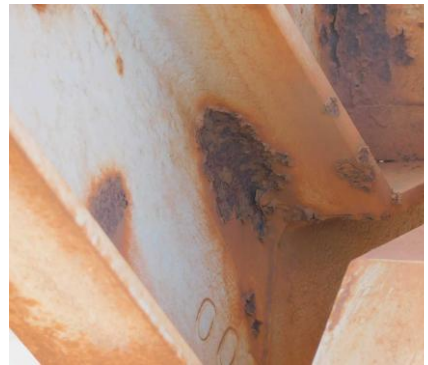
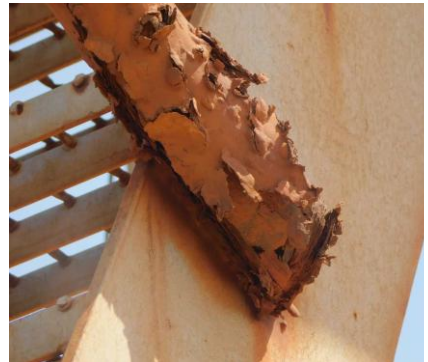
Defect ID 7

Defect ID	Location#	Element Description	Defect Description	Possible Cause/Recommended Action*	Priority Ranking	Photo Nr's
5a	Columns	Columns	PCB and Level 2 corrosion in multiple locations.	Prepare surfaces and re-apply protective coating following manufacturer's recommendations and to AS 2312.1.	P4	9206-9208 9276 9278-9279
5b	Columns	Columns	Level 5 corrosion (with holing) identified in an isolated area.	Remediate defect by overplating. Contact AIE for further structural analysis/remediation details.	P1	9418-9420
6	Handrails	Handrails, incl. kick plates	PCB and Level 5 corrosion (with holing) in multiple locations.	Replace handrails and kick plates like-for-like.	P1	9335-9336 9382-9385 9476-9478 9483-9486 9497-9501 9518-9519 9521 9603-9606 9617-9619 9632-9634 9672-9675 9696-9700
7	Stairs	Stairs on all levels	PCB and Level 3 corrosion in multiple locations.	Prepare surfaces and re-apply protective coating following manufacturer's recommendations and to AS 2312.1.	P3	9258-9260 9269-9272 9347-9349 9394 9400-9402 9558-9560

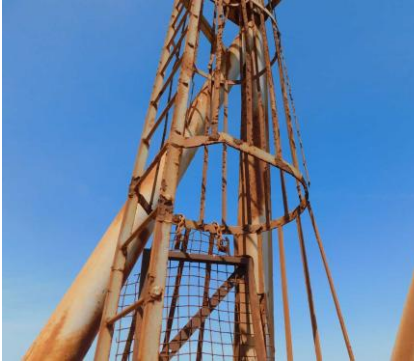
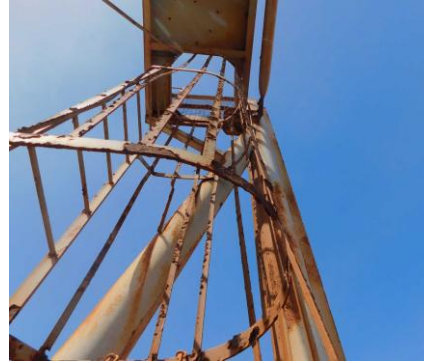
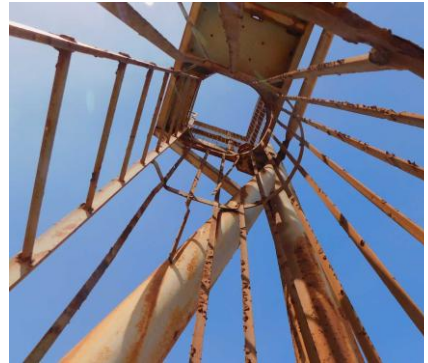
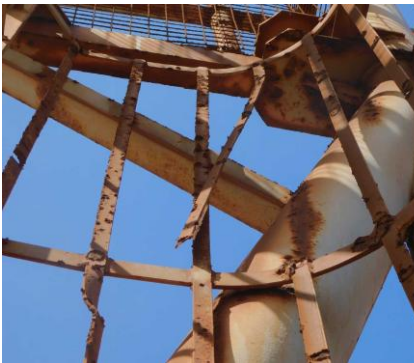
Defect ID 8

- The ladder on Tower Level 5 – 6 has Level 5 corrosion in multiple locations.
 - The platform floor on Tower Level 5 has Level 5 corrosion (with holing) in multiple locations.

8	Ladder	Ladder on level 5 – 6	PCB and Level 5 corrosion in multiple locations.	Replace ladder like-for-like.	P2	9645-9651

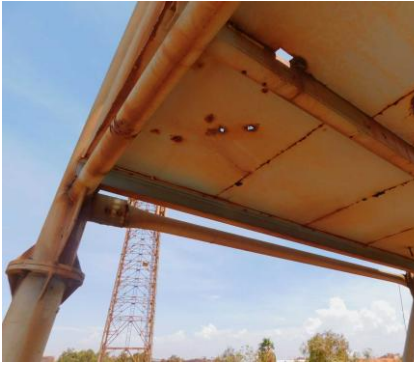
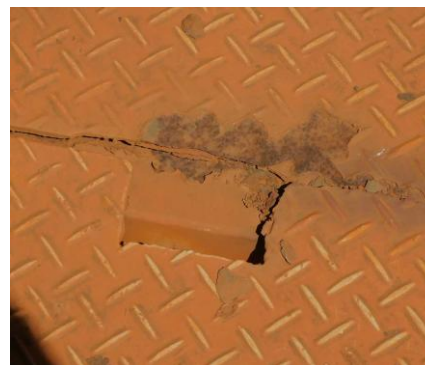
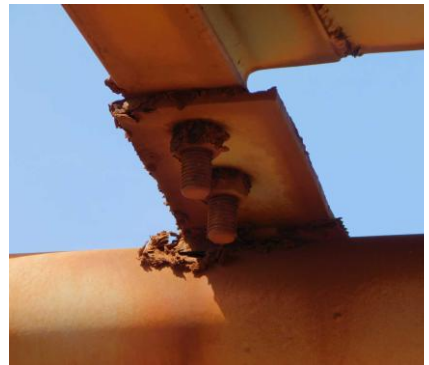
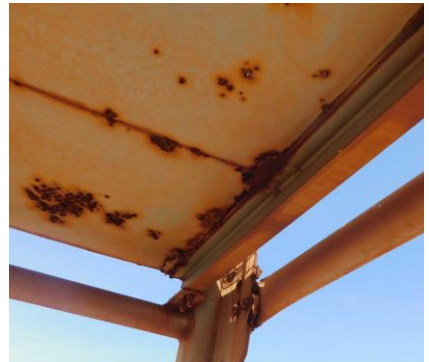
Defect ID 9

Defect ID	Location [#]	Element Description	Defect Description	Possible Cause/Recommended Action*	Priority Ranking	Photo Nr's
9	Platforms	Platform floor on Tower Level 5	PCB and level 5 corrosion (with holing) in multiple locations.	Replace platform floor plate sheeting like-for-like.	P2	9435 9442-9443 9448-9449 9538-9542 9574-9580
