Local Water Management Strategy

Stage 3 (The Stables)
East Port Hedland

Prepared for LandCorp
April 2015

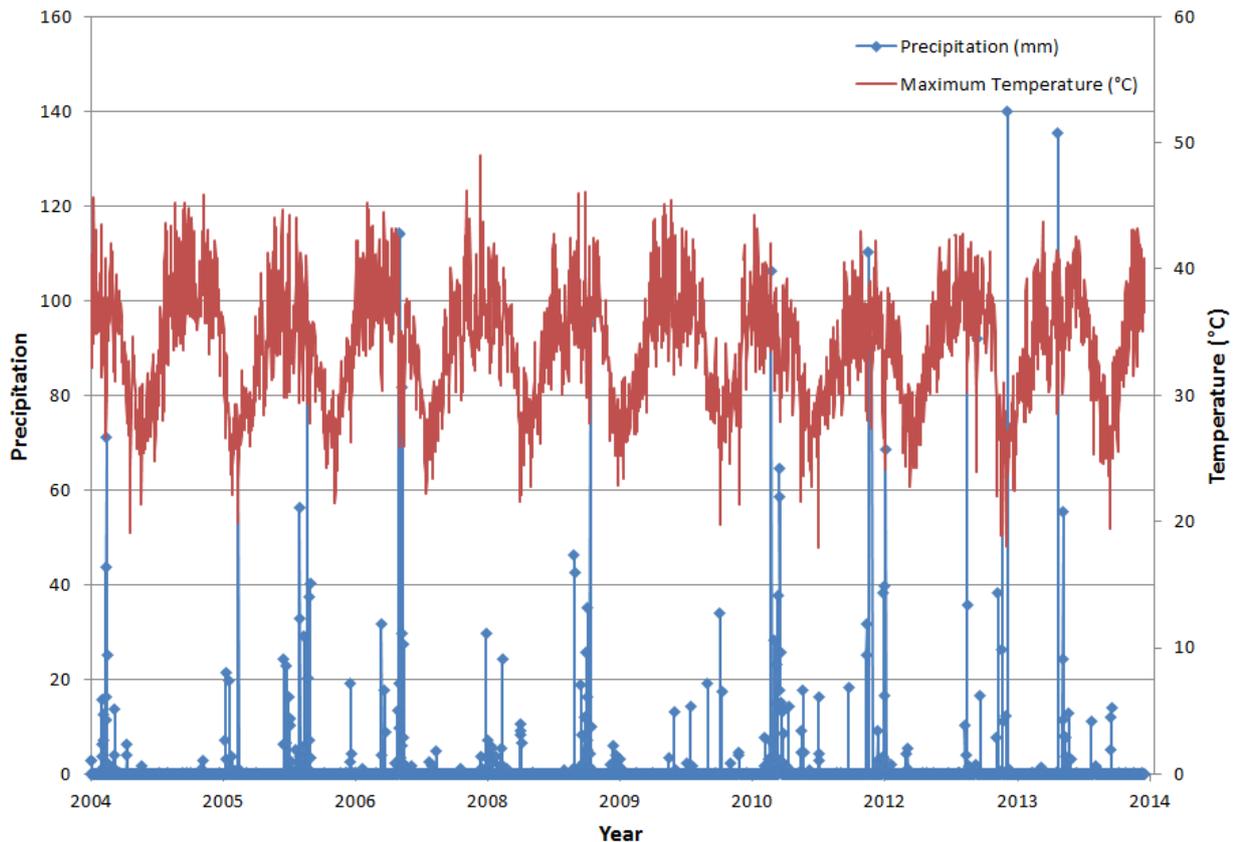
Chart 1 Climate Data for the Port Hedland Airport from 2004 - 2014

Precipitation trends for the Port Hedland Airport have also remained relatively constant through the previous 10 years. The average precipitation for this period (356 mm) has been relatively constant except for 2013 where there was a significant rise (713 mm). This significant increase in rainfall is attributable to the fact that three of the ten greatest rainfall volumes over the past 30 years occurred in 2013 (BoM, 2014).

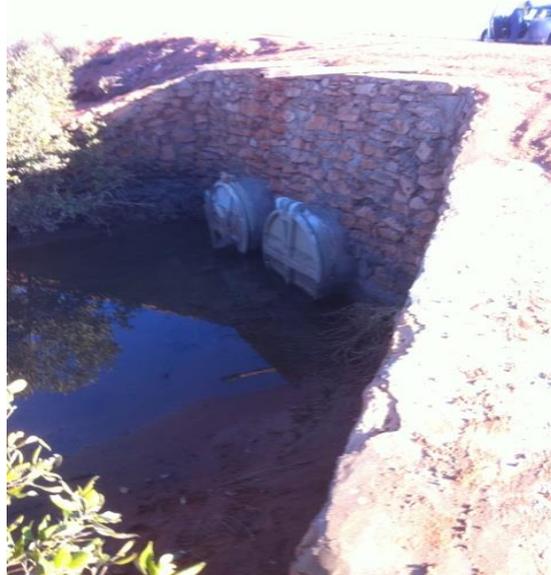
Plate 1 Culverts under Cooke Point Drive

An existing culvert is located 50 m north of the northwest corner of the Site. The culvert connects an existing drain on the west of Cooke Point Drive to the Pretty Pool Estuary. The drain conveys runoff from a large catchment west of Cooke Point Drive. The Cooke Point Drive culverts consist of two 0.825 m circular culverts with one way flood gates on the downstream end (Plate 1). Once surface water passes through the culverts, its natural route is northeast towards Pretty Pool Estuary. Flooding from this culvert should not affect the site but will need to be reassessed once planning has been completed (Cardno, 2011a).

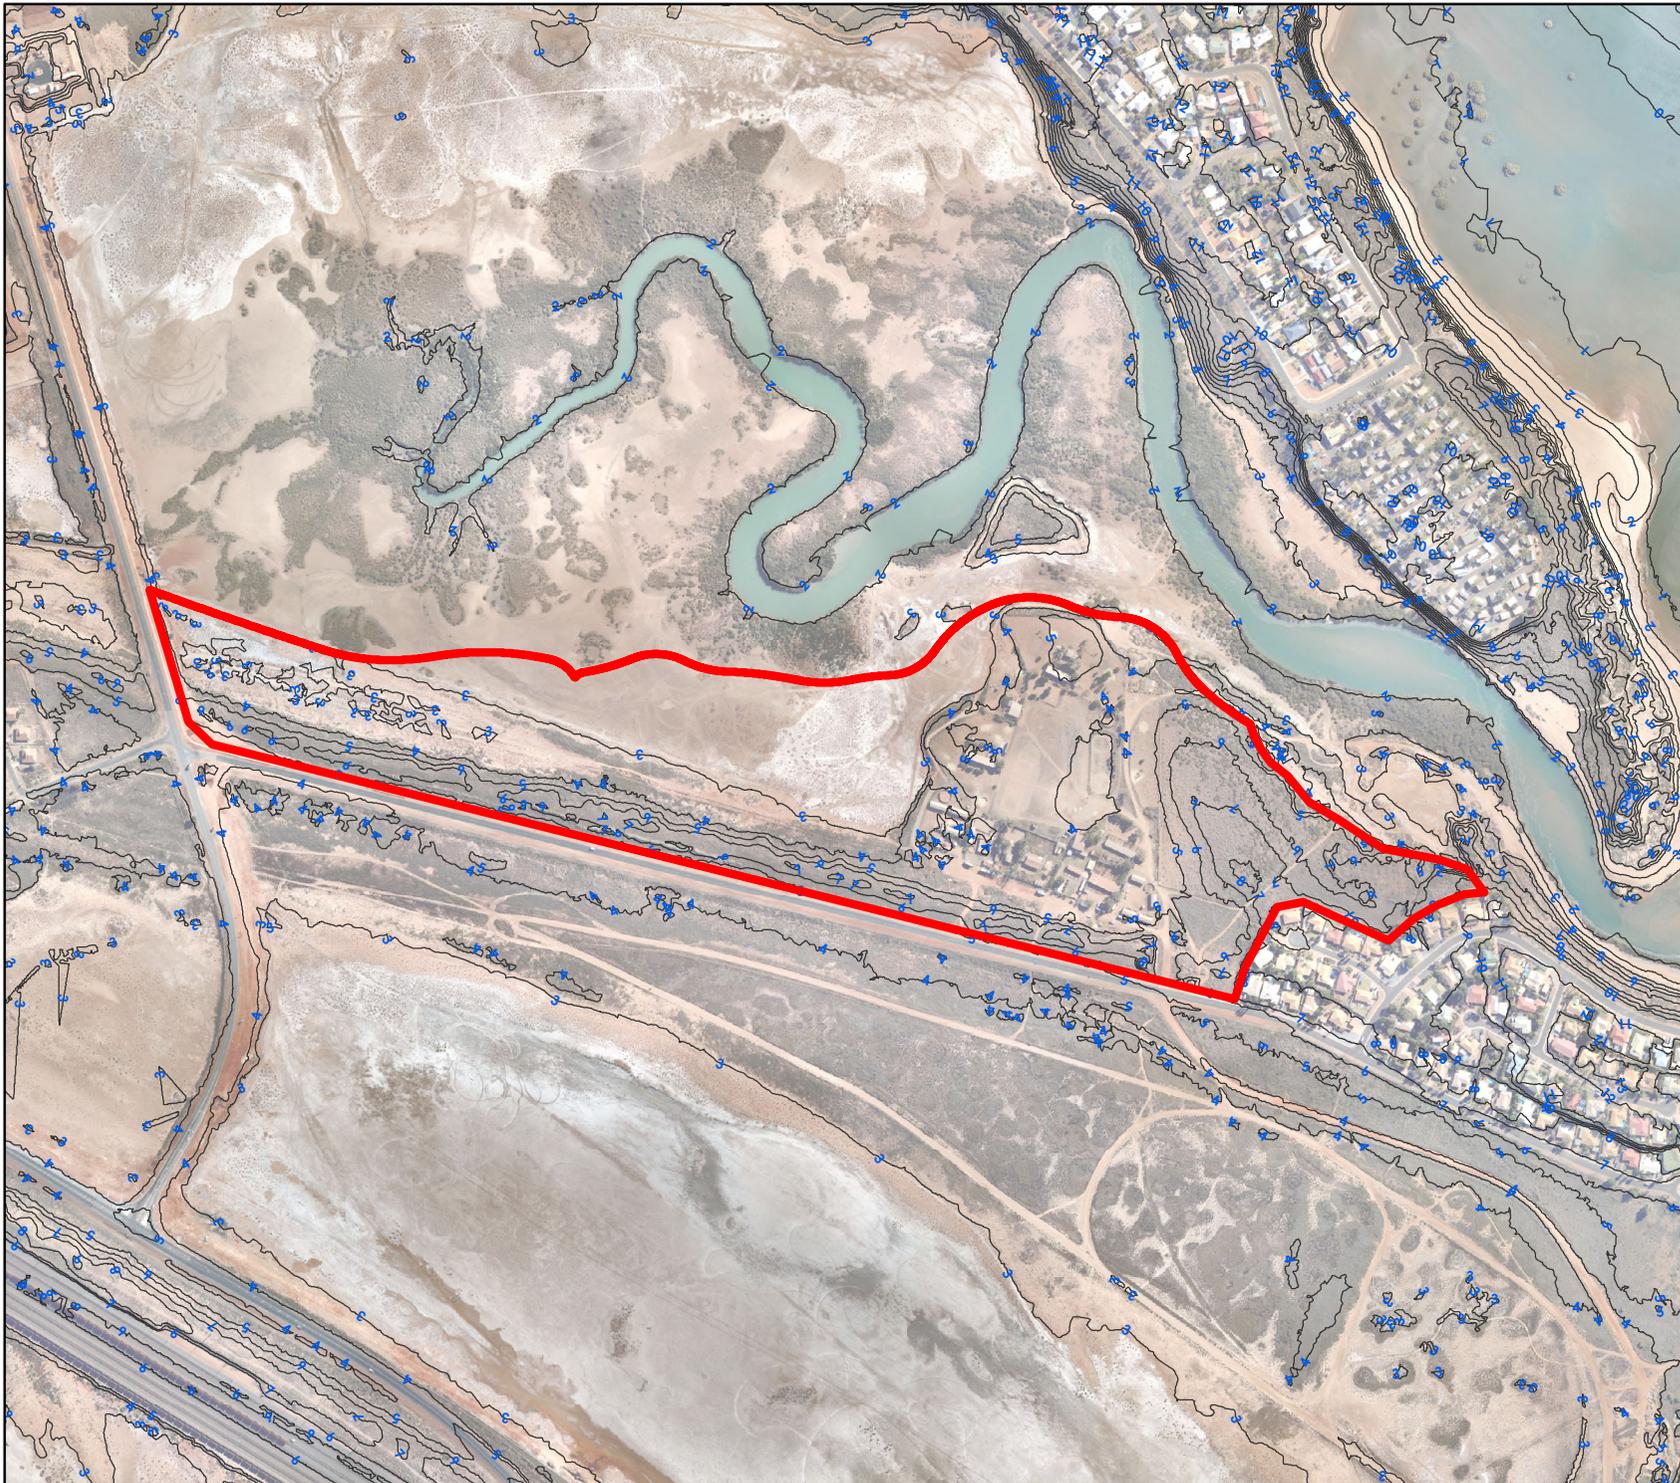
Topography

The Site falls south and north from a high ridge line between 7.5 and 8.0 mAHD located approximately 50 m north of Styles Road. The Site falls to 2.5 mAHD just inside the northern border. From here it slopes into the mangroves and Pretty Pool Creek. A topographic map of the Site and its immediate surrounds can be found in Figure 3.

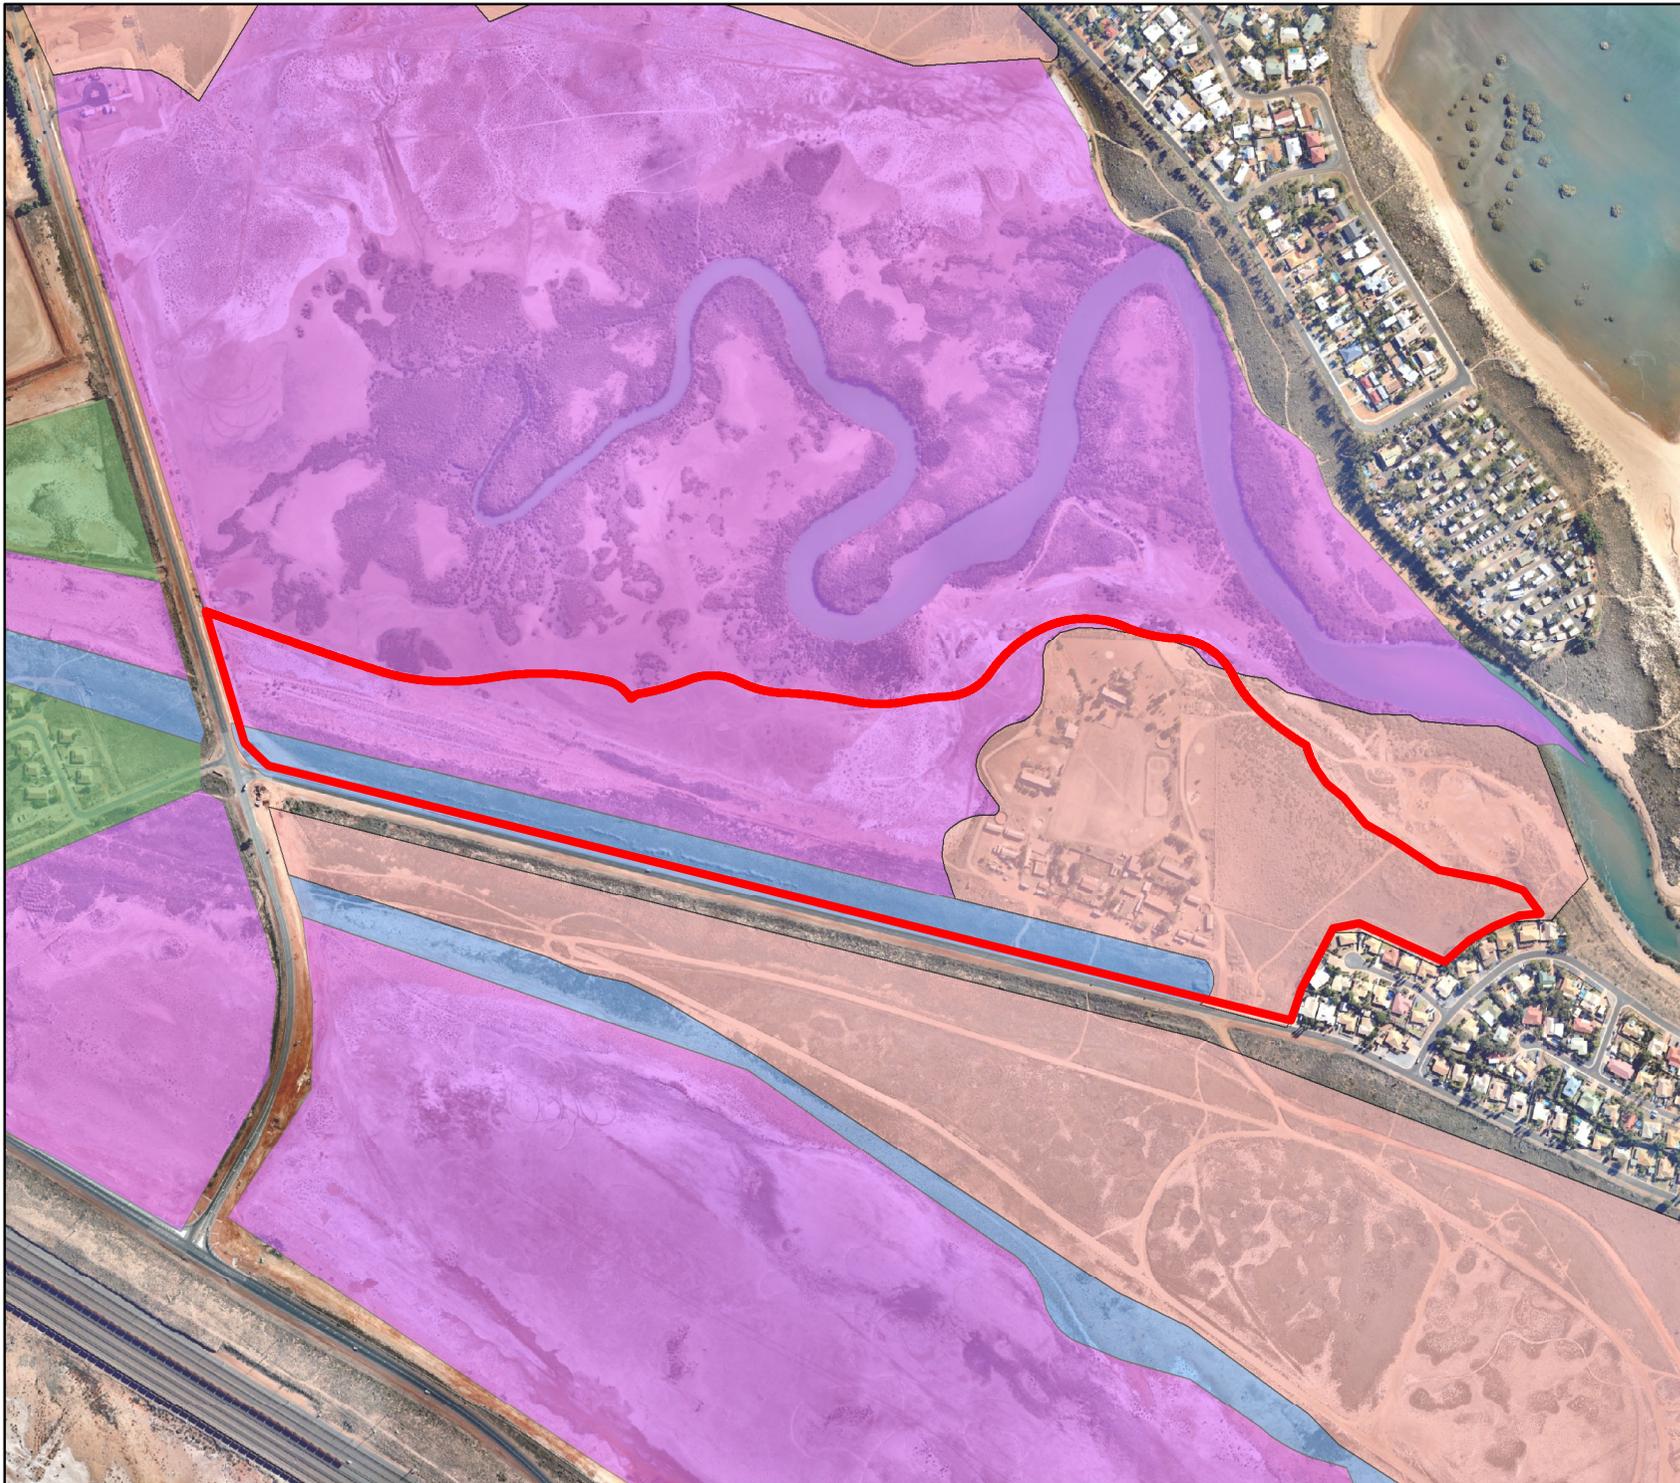
Surface Geology

Ground conditions have been generalised into three areas for subsurface profiles. These subsurface profiles consist of:

- > Dune sand – fine to coarse grained sand of loose to medium density located on the eastern half of the northern half of the Site;
- > Estuarine deposits – low to high plasticity sandy clay/clay that is typically very soft located on the western half of the northern half of the Site; and
- > Limestone – well cemented calcarenite and calcisilite of low to high strength spanning the southern half of the Site.

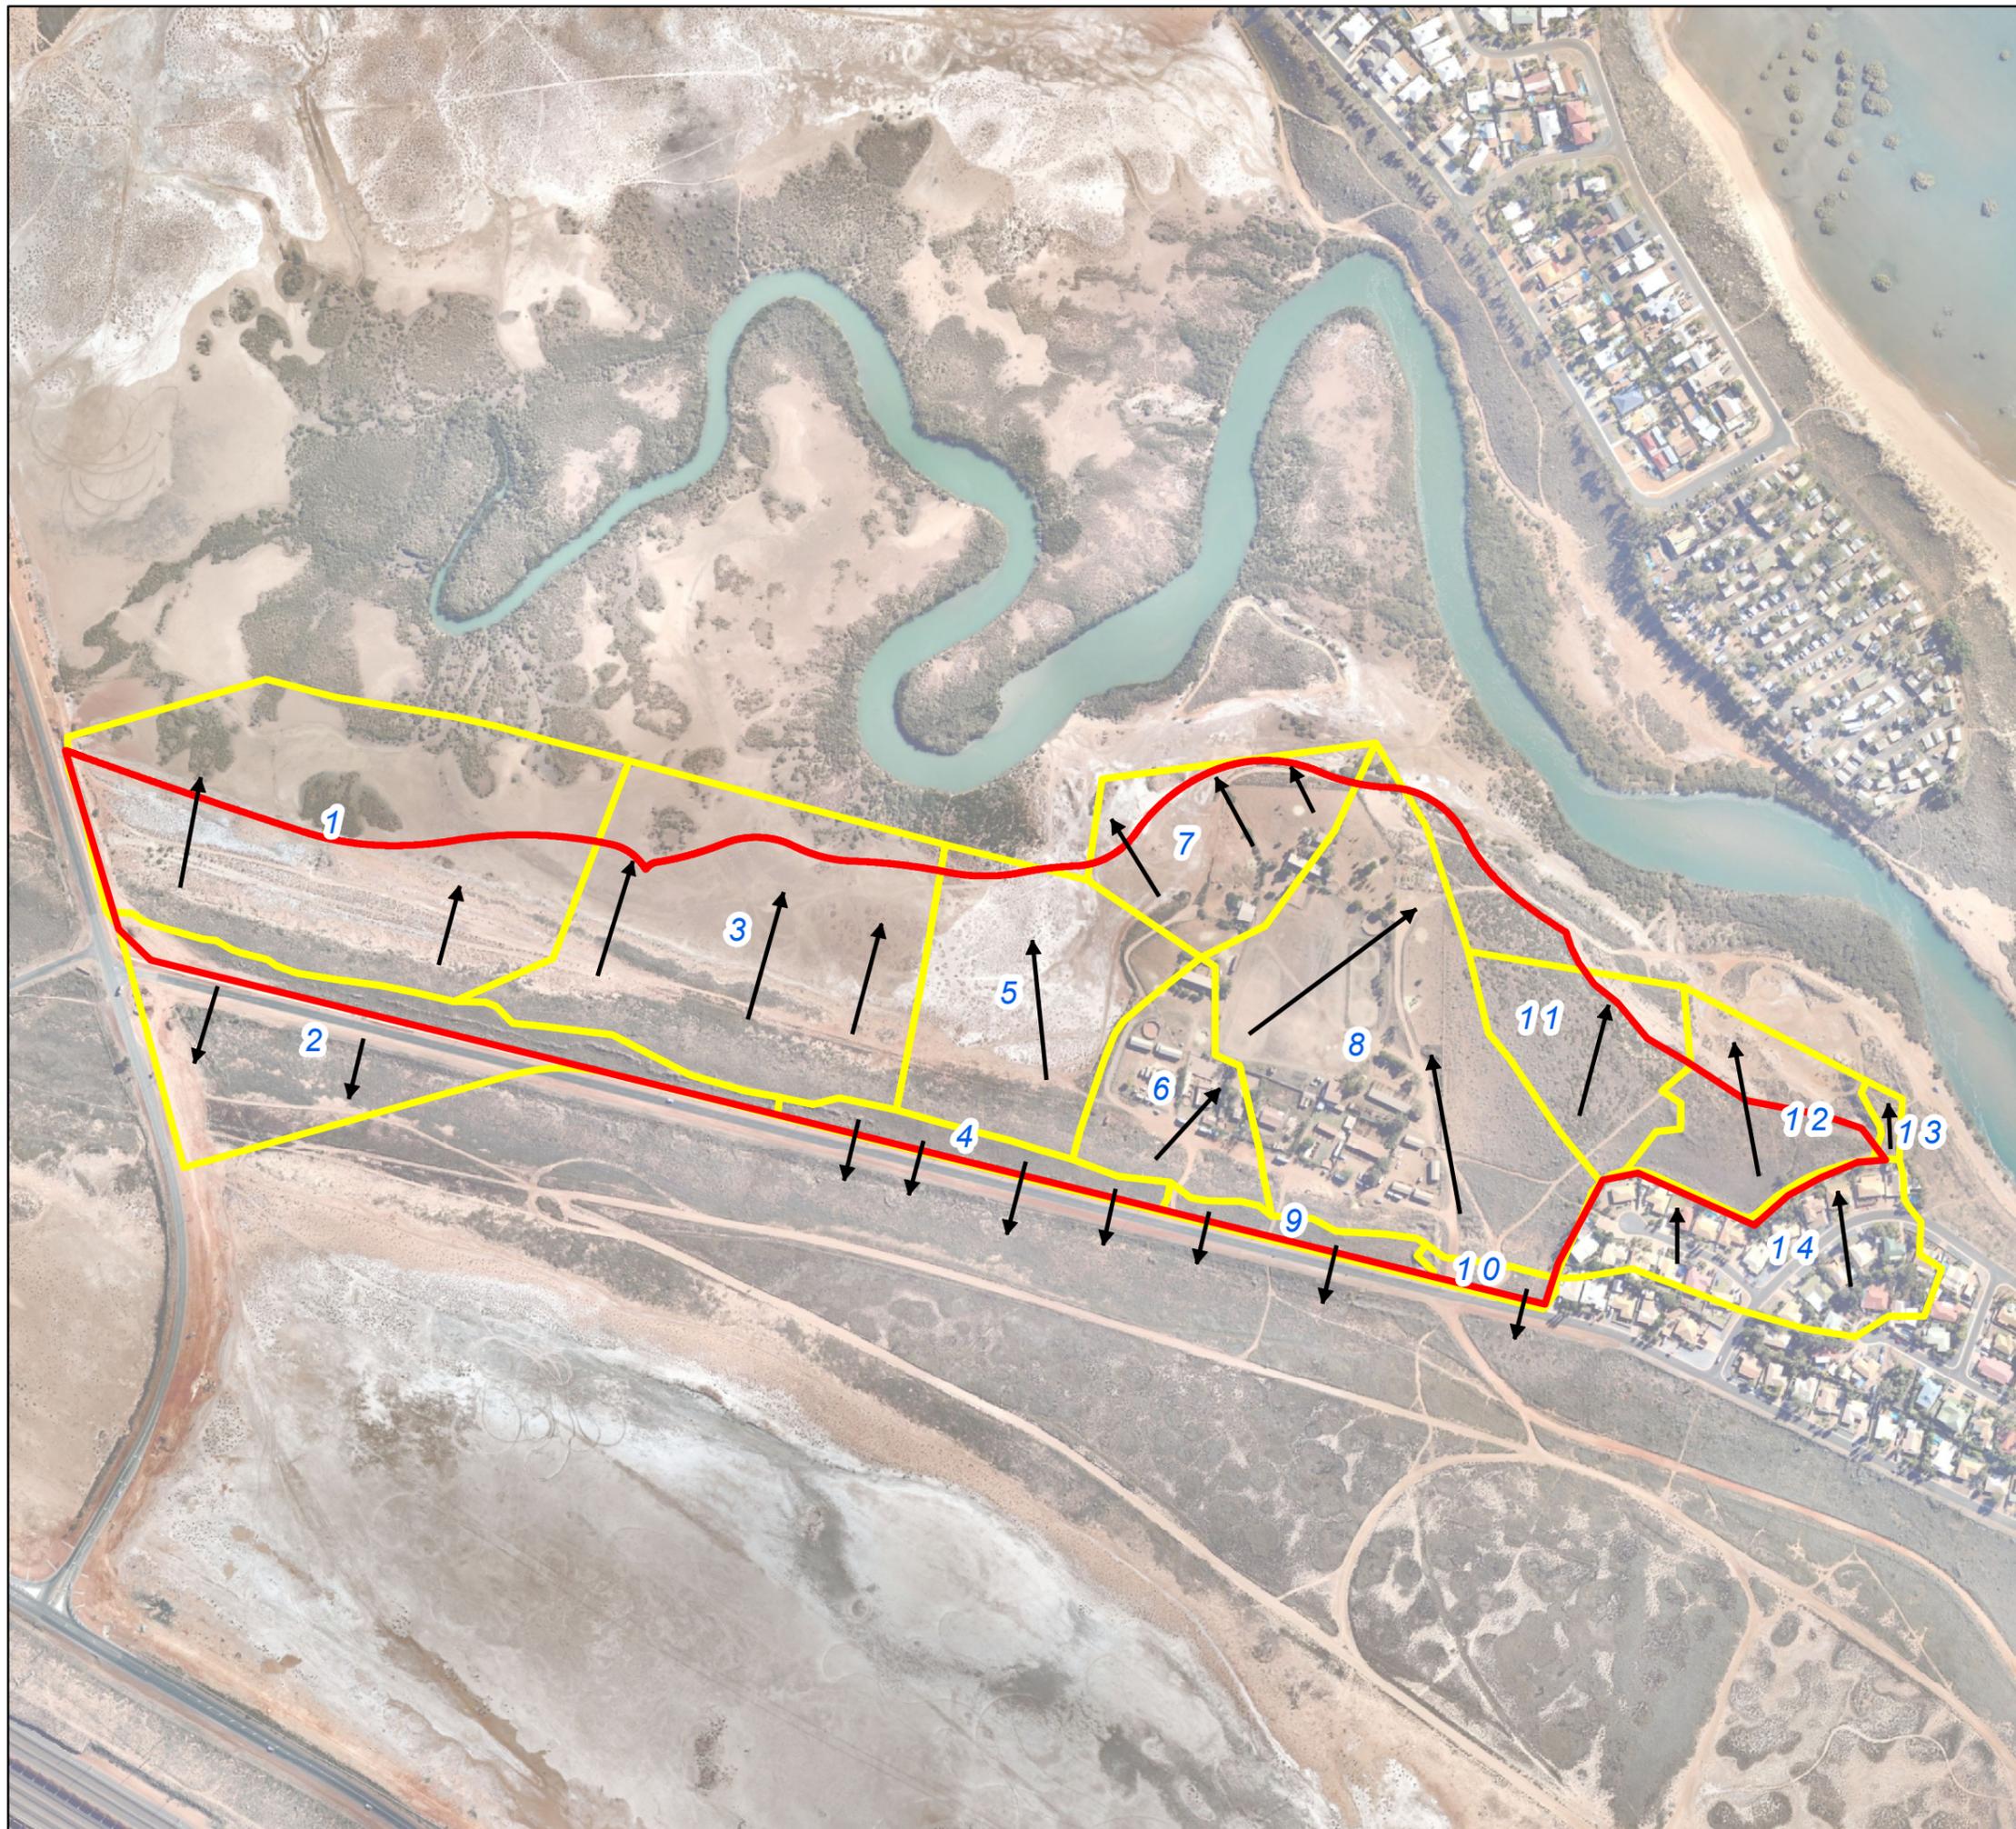
1:5,000 Scale at A3

Modelling of the post development environment for both development options outlined in Section 3.1 has been undertaken using XPSWMM in order to demonstrate the performance of the proposed drainage strategy. These models were built to characterise the hydrological behaviour of the post development environment for each option. Each option involved the division of the Site into 11 catchments as demonstrated in Figure 7 and Figure 8. Modelling parameters and assumptions are provided in Appendix E.

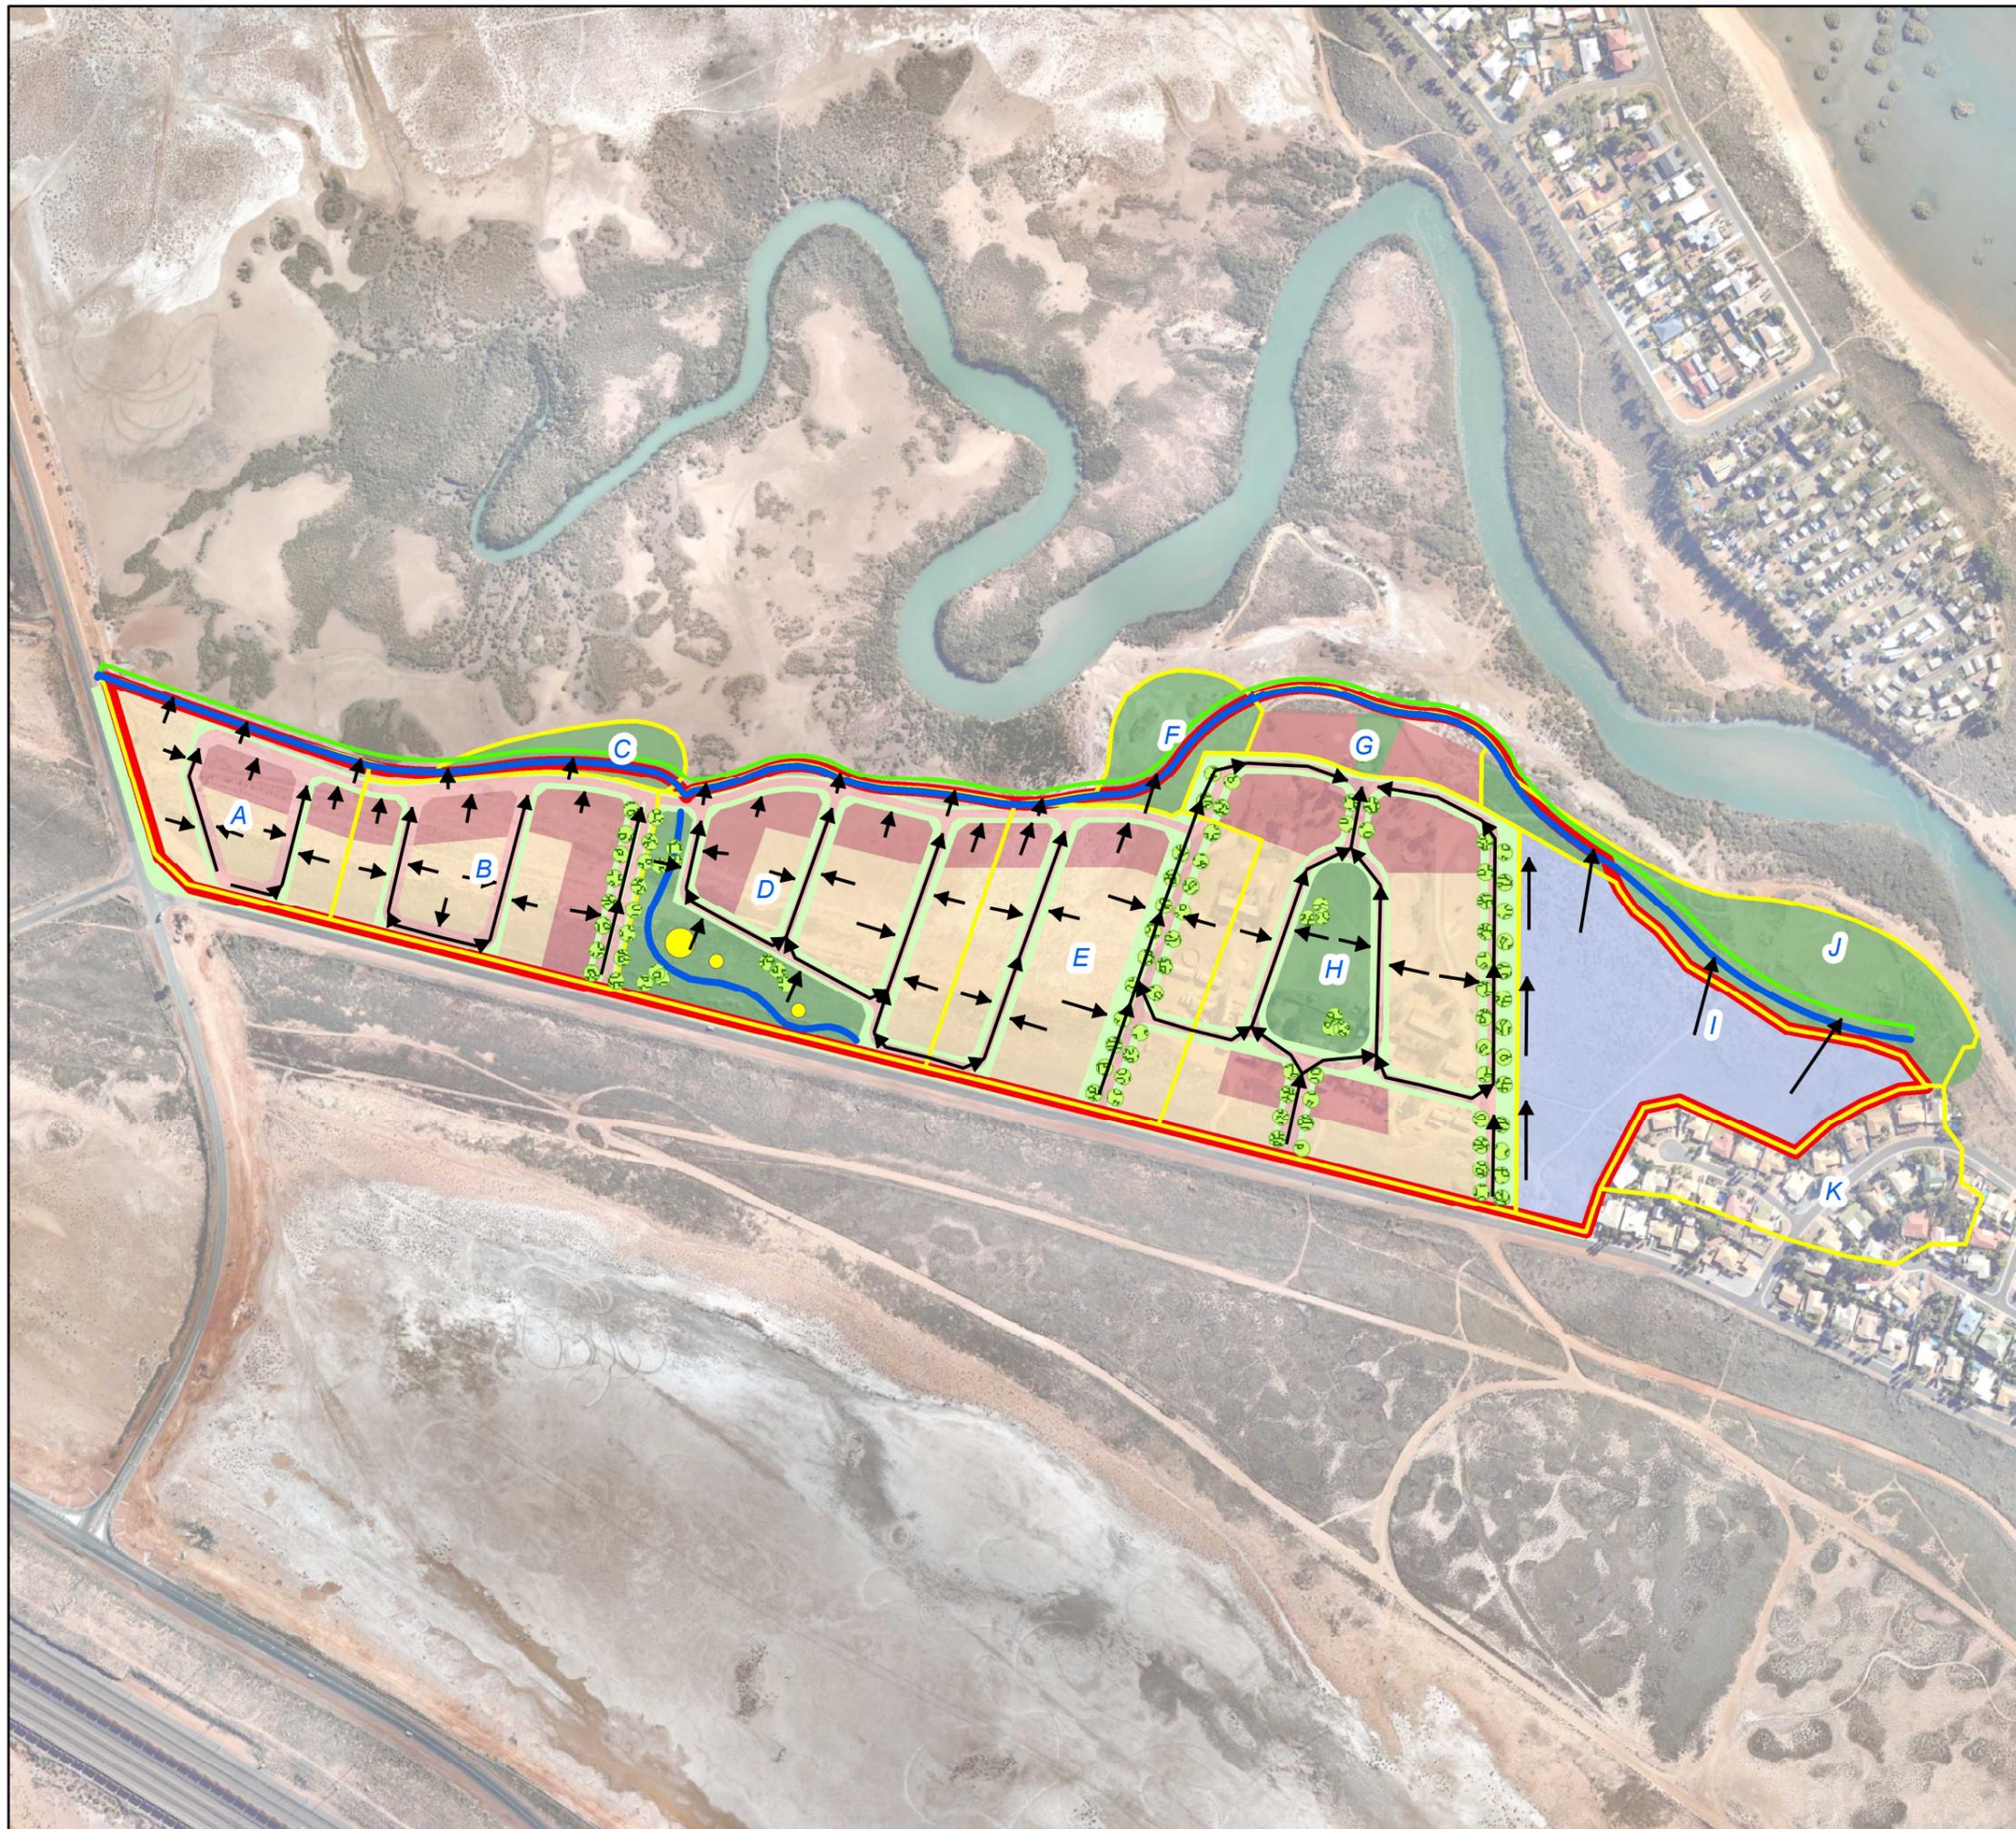
FIGURE 7

Post Development Catchments and Flow Paths of Conceptual Development Option 1

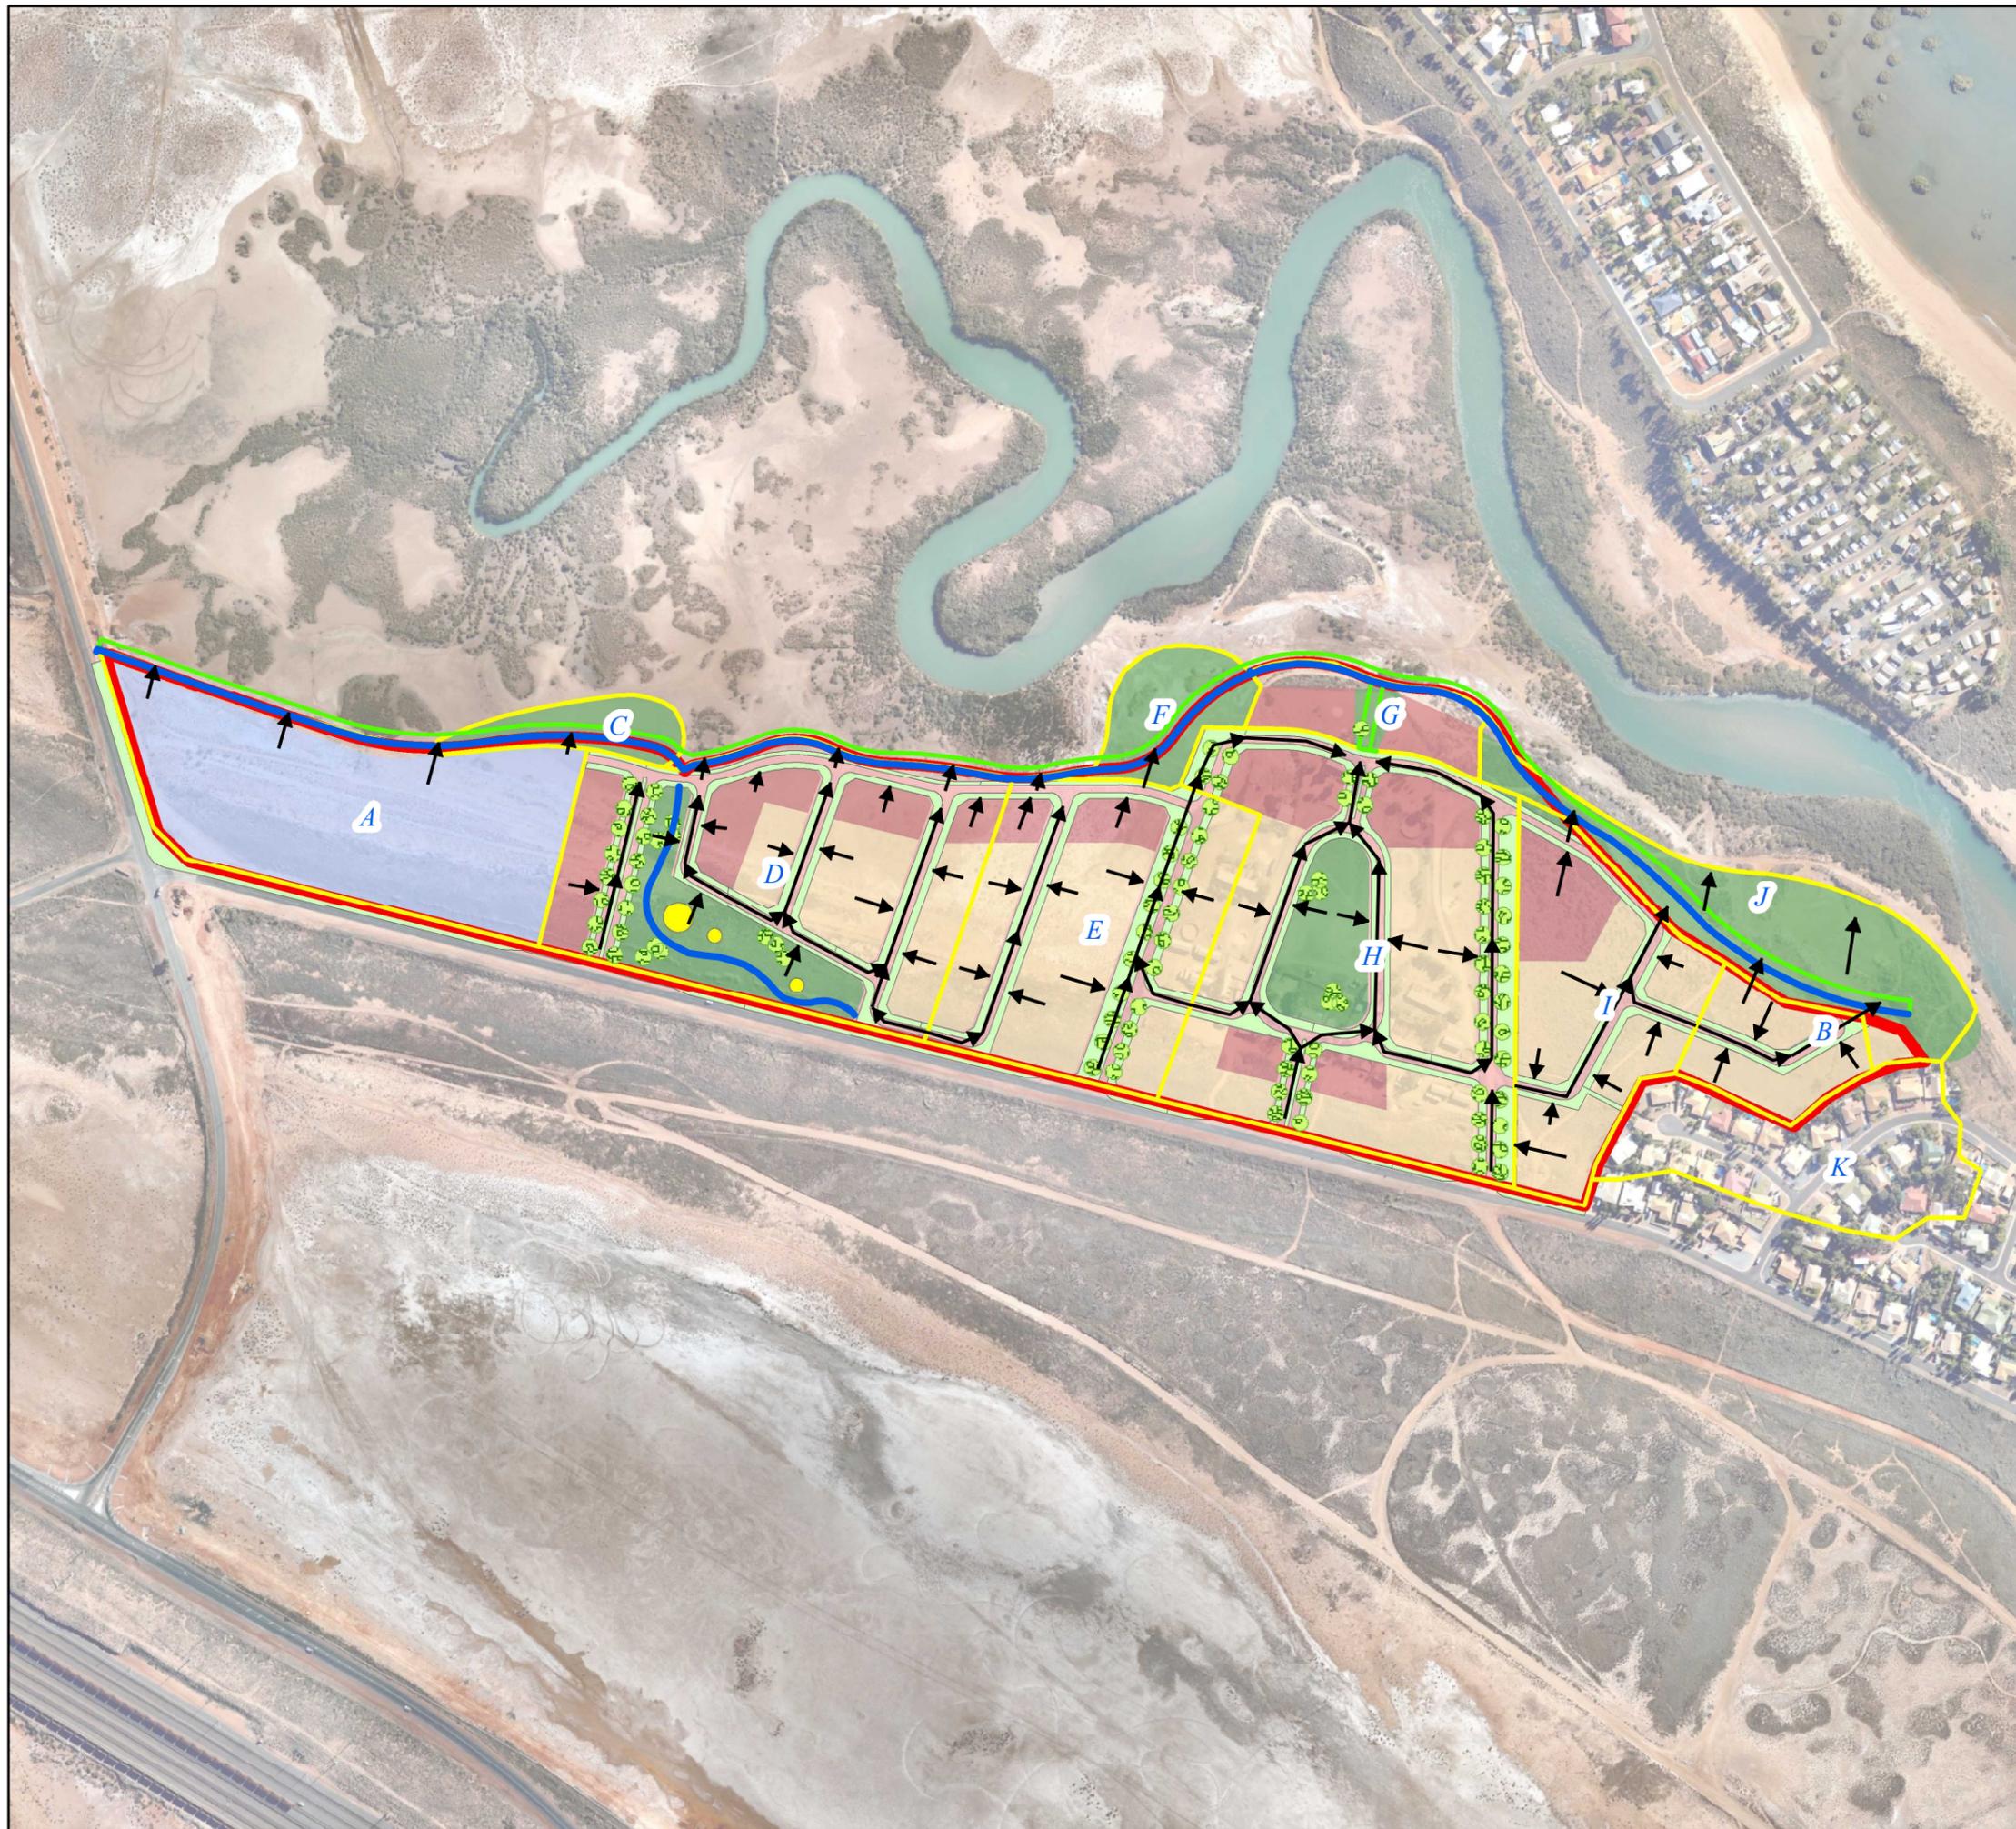
FIGURE 8

Post Development Catchments and Flow Paths of Conceptual Development Option 2

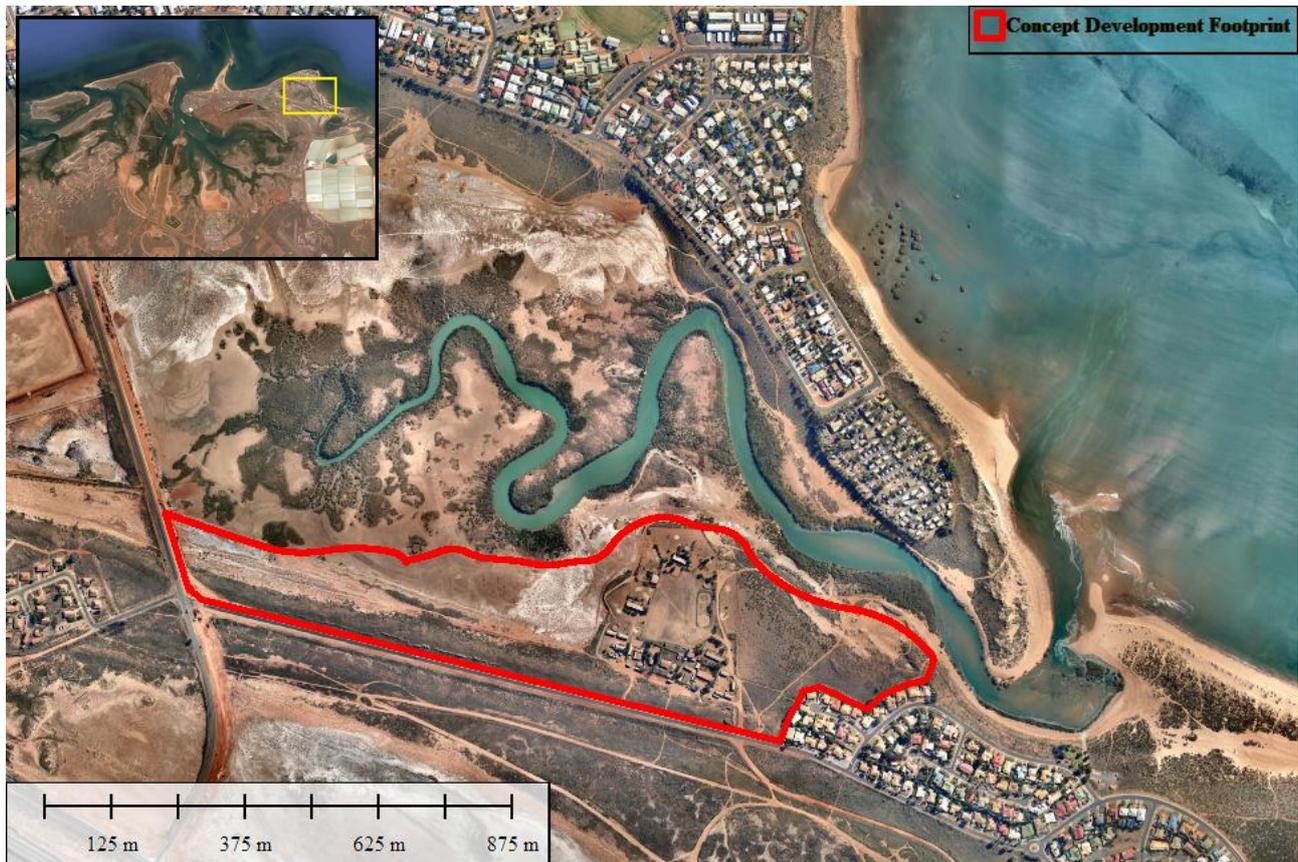
Figure 1-1 Development locality plan. The Stables (Stage 3) outlined in red (Image source – Nearmap & Google Earth)

Port Hedland has been identified in the Pilbara Cities Program as an area that should be supported to diversify and grow economically to support a population of 50,000 permanent residents. LandCorp has received funding from the Northern Planning Program to undertake concept planning, and initiate a Scheme Amendment to allow development of Stage 3 (The Stables) East Port Hedland (the site). This is located on the southern side of Pretty Pool Creek, as outlined by the red outline in Figure 1-1.

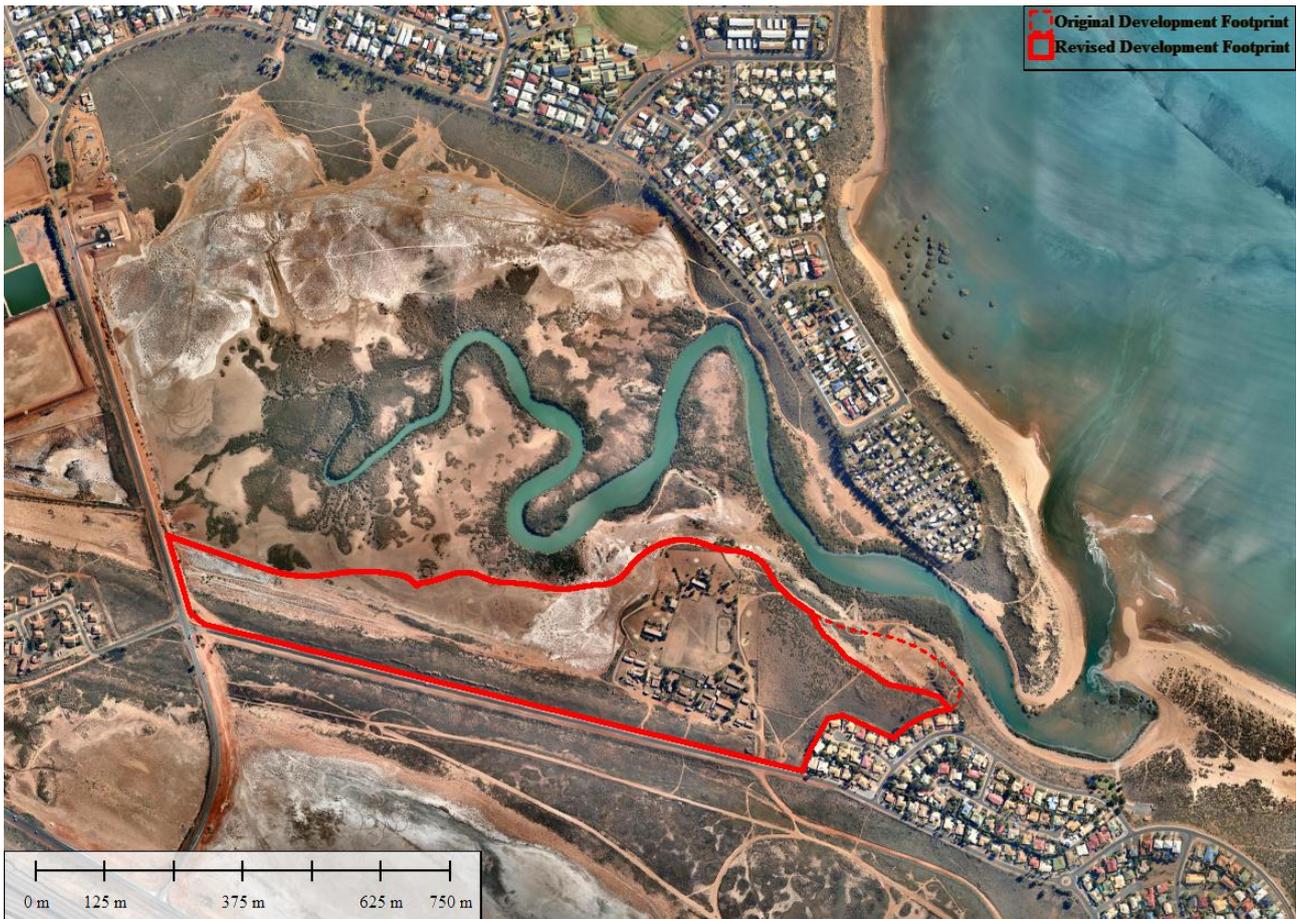
Figure 1-2 Development locality plan. The revised Stables (Stage 3) development footprint outlined in red; original footprint is dashed red line. (Image source – Nearmap & Google Earth)

This report assesses the revised footprint, together with the Athol Street footprint. The results herein present the revised Stables development in place of the original footprint presented in Cardno (2014). The revised footprint is presented in Figure 1-2 below. The dashed line shows the original development outline.

The difference in inundation depth and current speed between the three options and the existing (base) case are presented in Figure 2-5 and Figure 2-6 respectively. Each option showed improvement compared to the original development footprint (as reported in Cardno 2014a). As negligible differences were observed between Options 2 and 3, Option 2 was considered optimal for the channel width, and selected as the revised development footprint for further analysis. This is the footprint displayed in Figure 1-2 in Section 1.2.

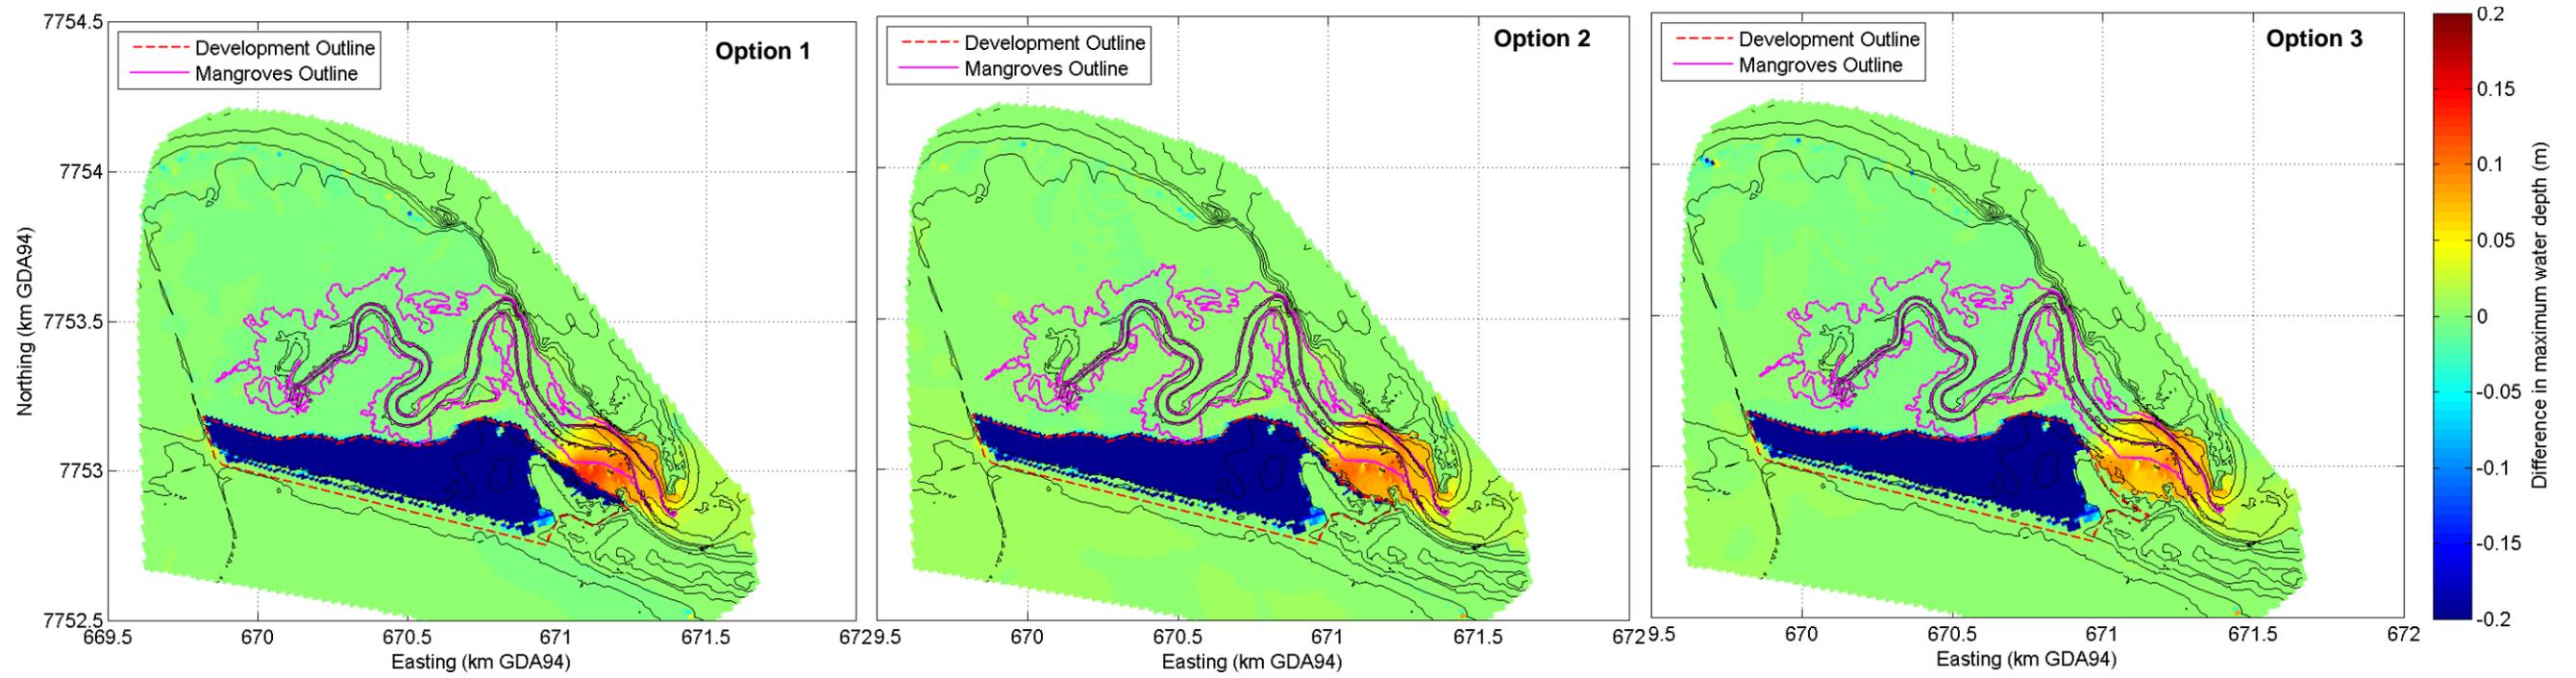
Figure 2-5 Differences in maximum inundation depth for 500-years ARI storm conditions. Positive change indicates that the depth is greater for the Design Case. The dark blue areas indicate regions that are no longer inundated
