Local Water Management Strategy

Stage 3 (The Stables)
East Port Hedland

Prepared for LandCorp
April 2015

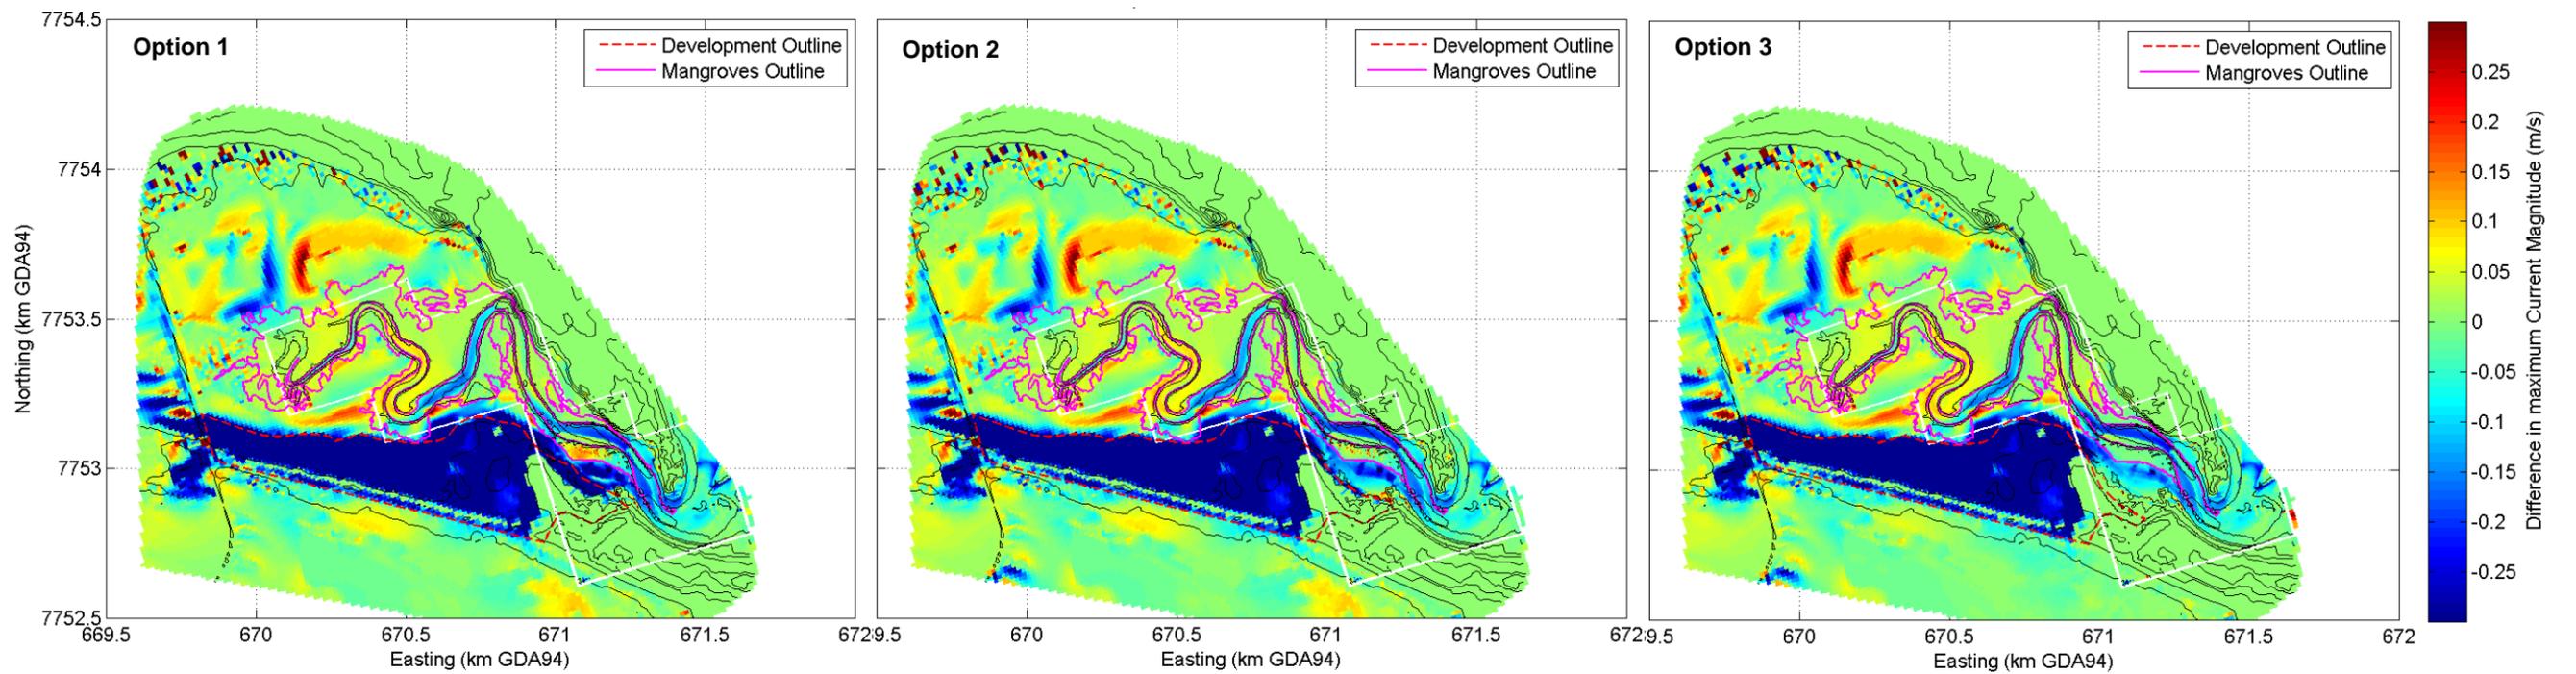
Figure 2-6 Differences in maximum current magnitude for 500-years ARI storm conditions. Positive change indicates that the current magnitude is greater for the Design Case. White outline is the boundary between domains

The difference in inundation depth and current speed between the three options and the existing (base) case are presented in Figure 2-5 and Figure 2-6 respectively. Each option showed improvement compared to the original development footprint (as reported in Cardno 2014a). As negligible differences were observed between Options 2 and 3, Option 2 was considered optimal for the channel width, and selected as the revised development footprint for further analysis. This is the footprint displayed in Figure 1-2 in Section 1.2.

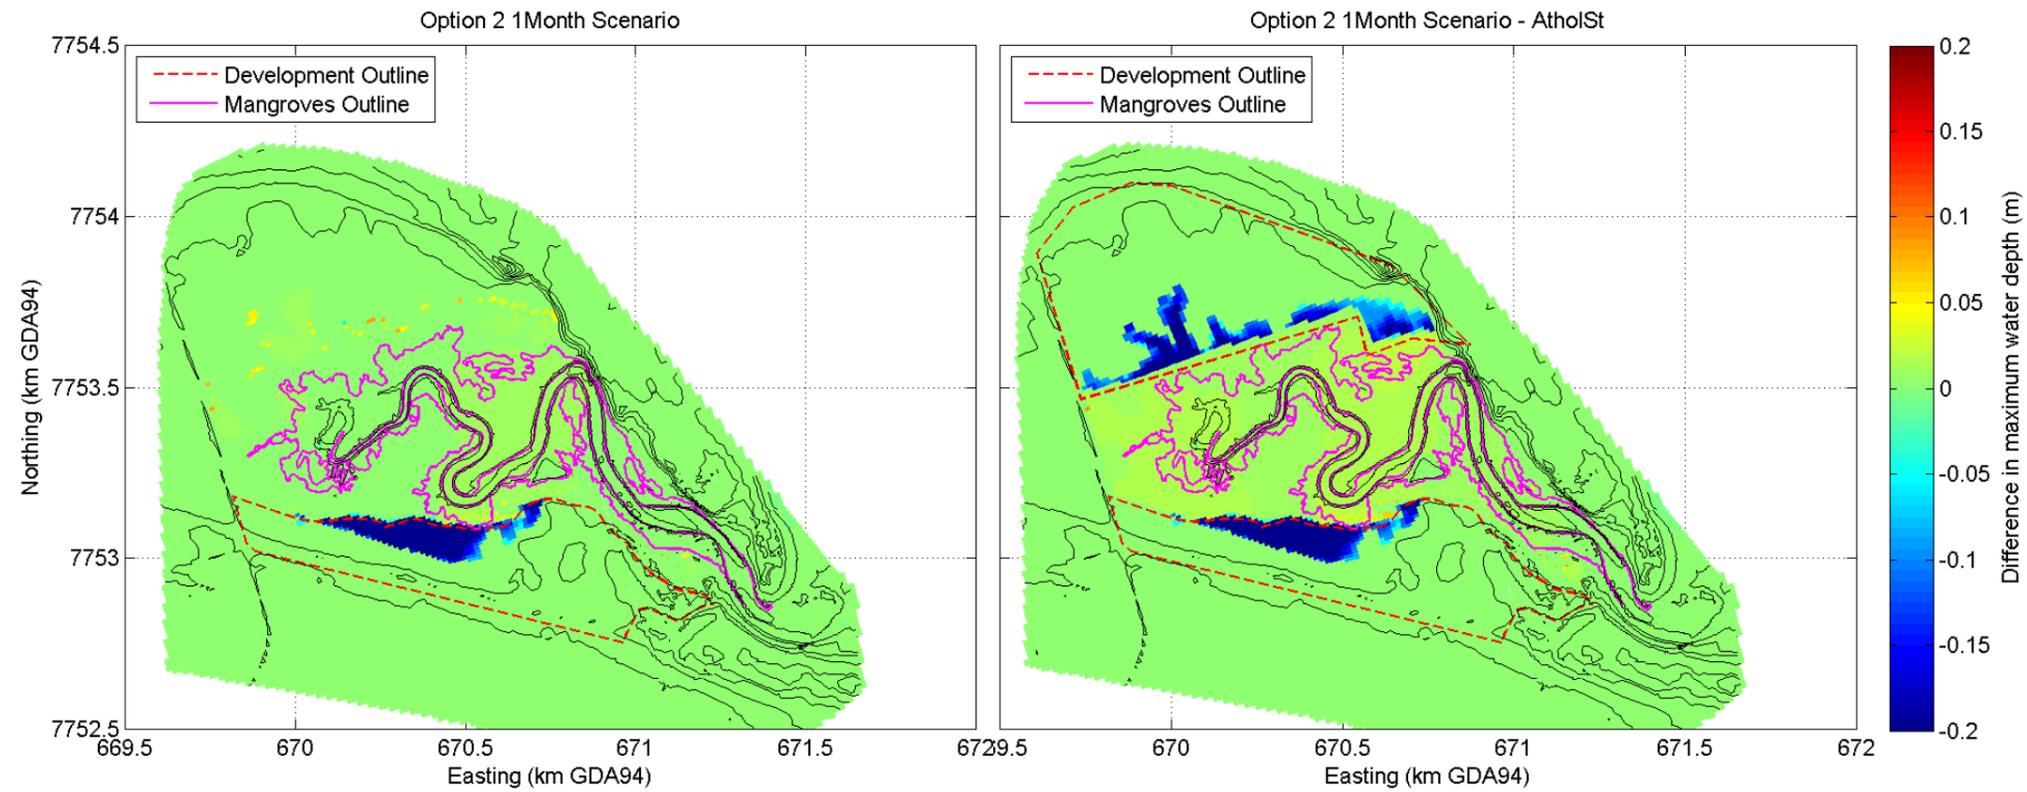
For the Athol Design Case, there is an increase in water depth throughout the area of approximately 3 cm due to the reduced area available for inundation. The currents are similar for both the Design Case and the Athol Design Case.

Figure 2-10 Differences in maximum inundation depth for Scenario 1 - Design and Athol Design Cases. Positive change indicates depth greater for Design Cases. Dark blue areas indicate regions no longer inundated

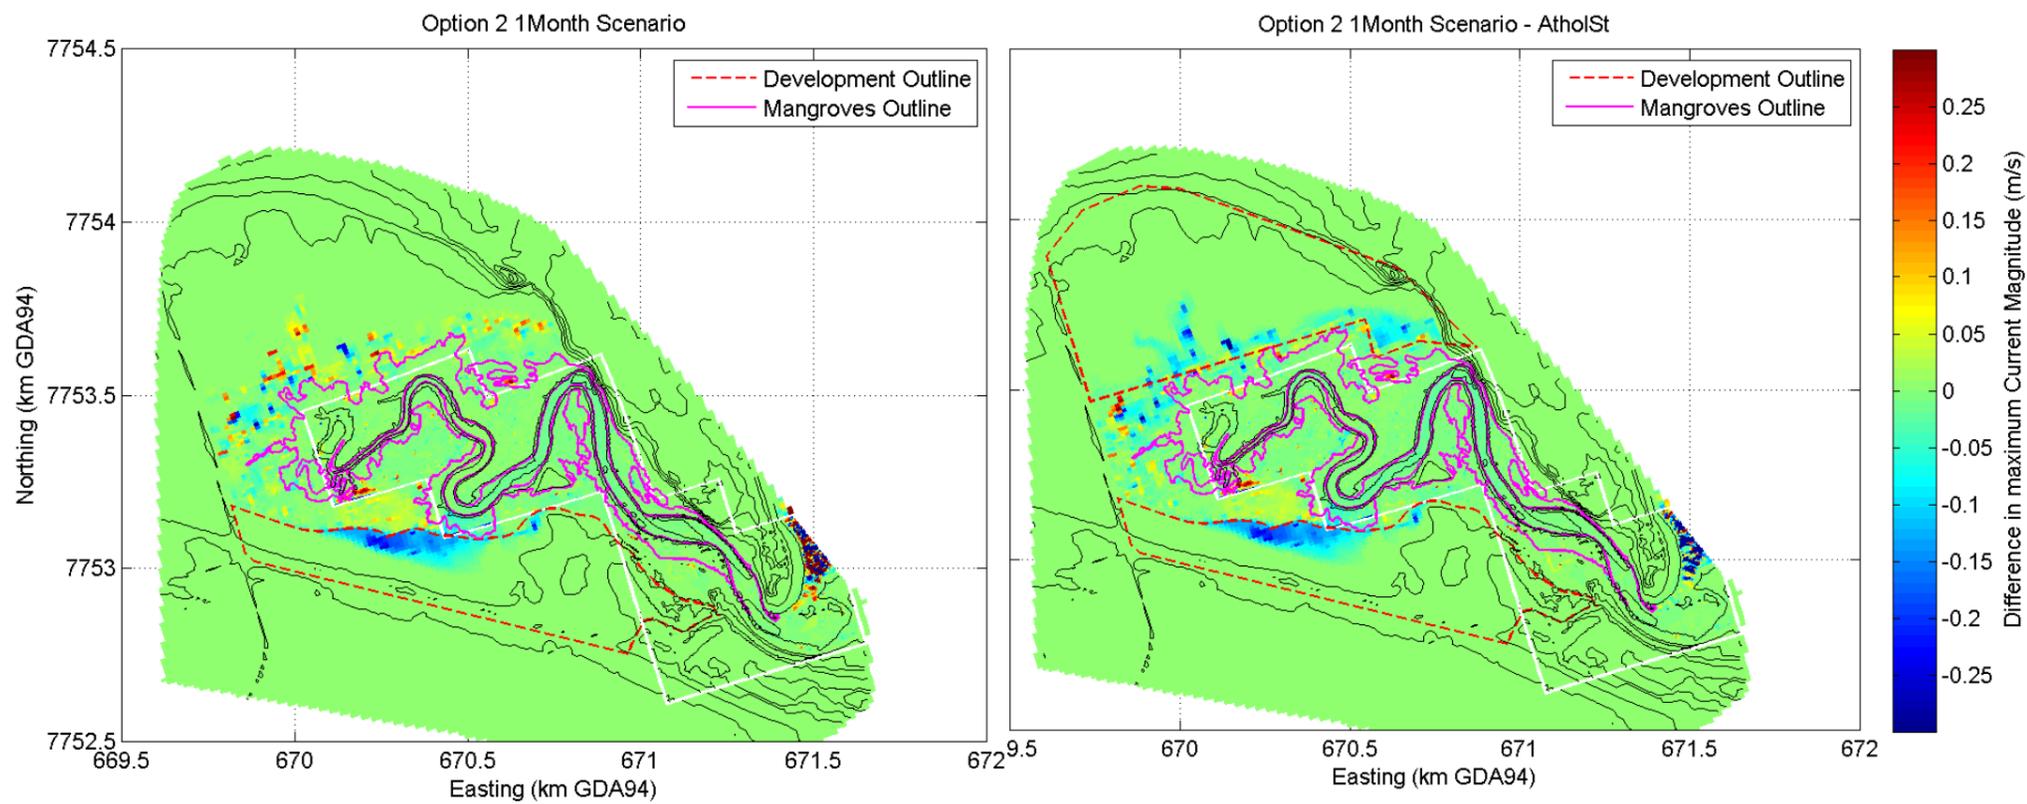
Figure 2-11 Differences in maximum current magnitude for Scenario 1 - Design and Athol Design Cases. Positive change indicates current magnitude greater for Design Cases. White outline is boundary between domains

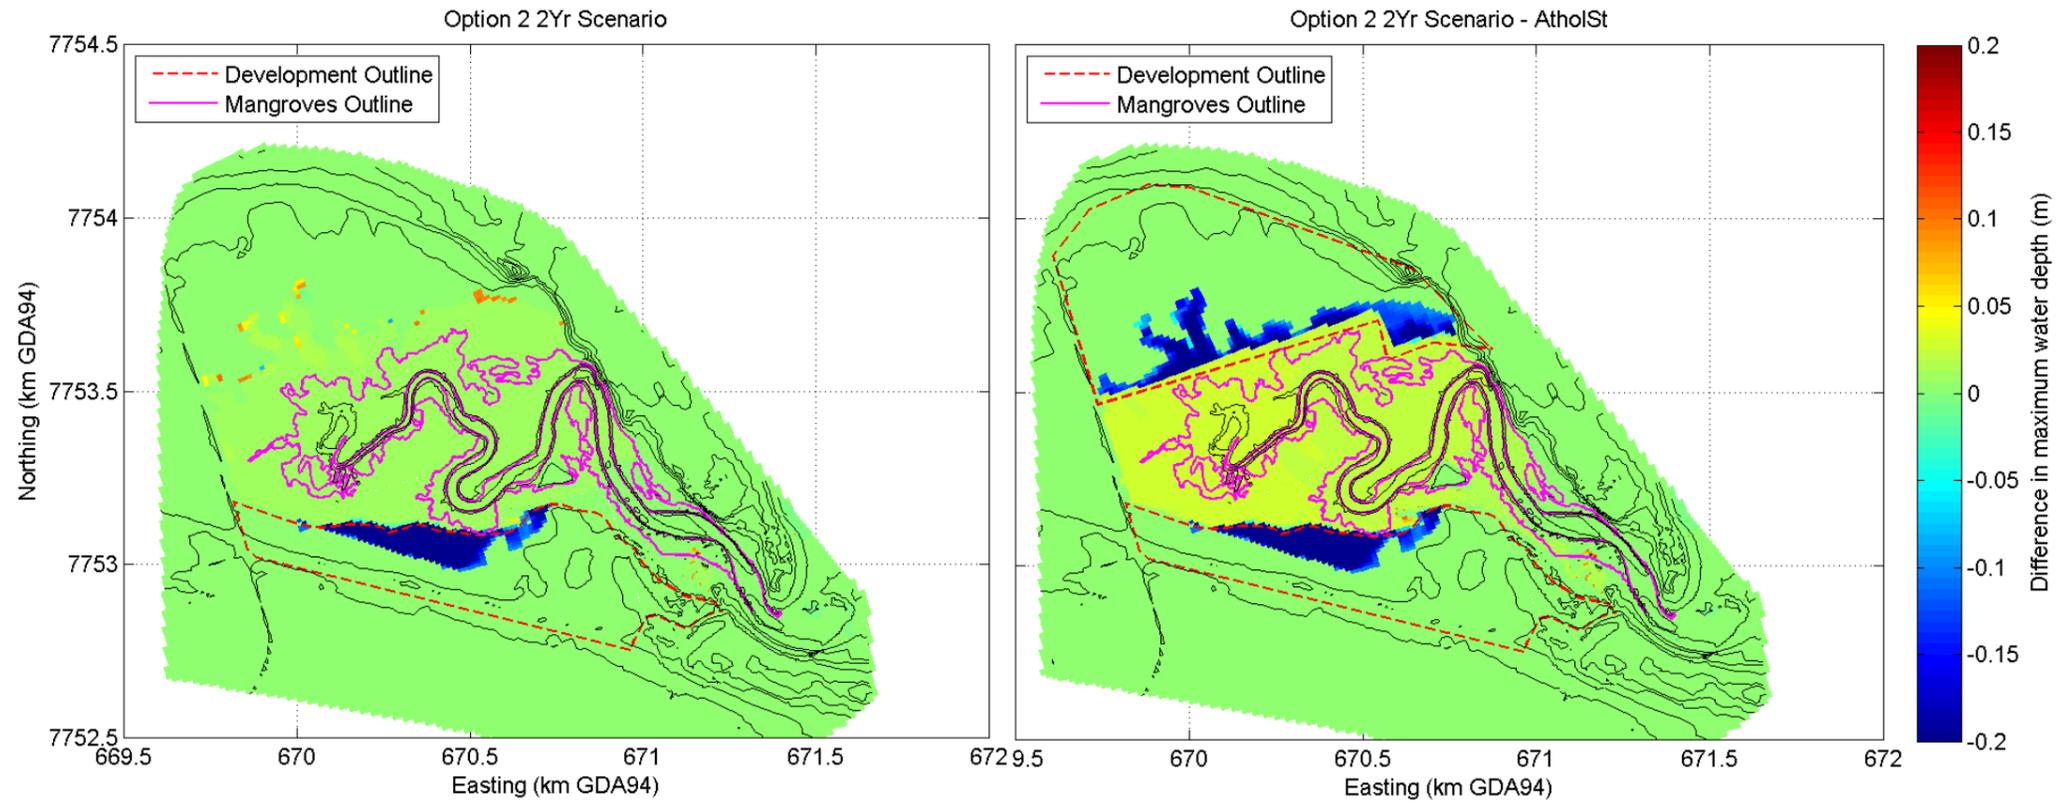
For the Athol Design Case, there is an increase in water depth throughout the area of approximately 4 cm due to the reduced area available for inundation. The currents are similar for both the Design Case and the Athol Design Case.

Figure 2-12 Differences in maximum inundation depth for Scenario 2 - Design and Athol Design Cases. Positive change indicates depth is greater for Design Cases

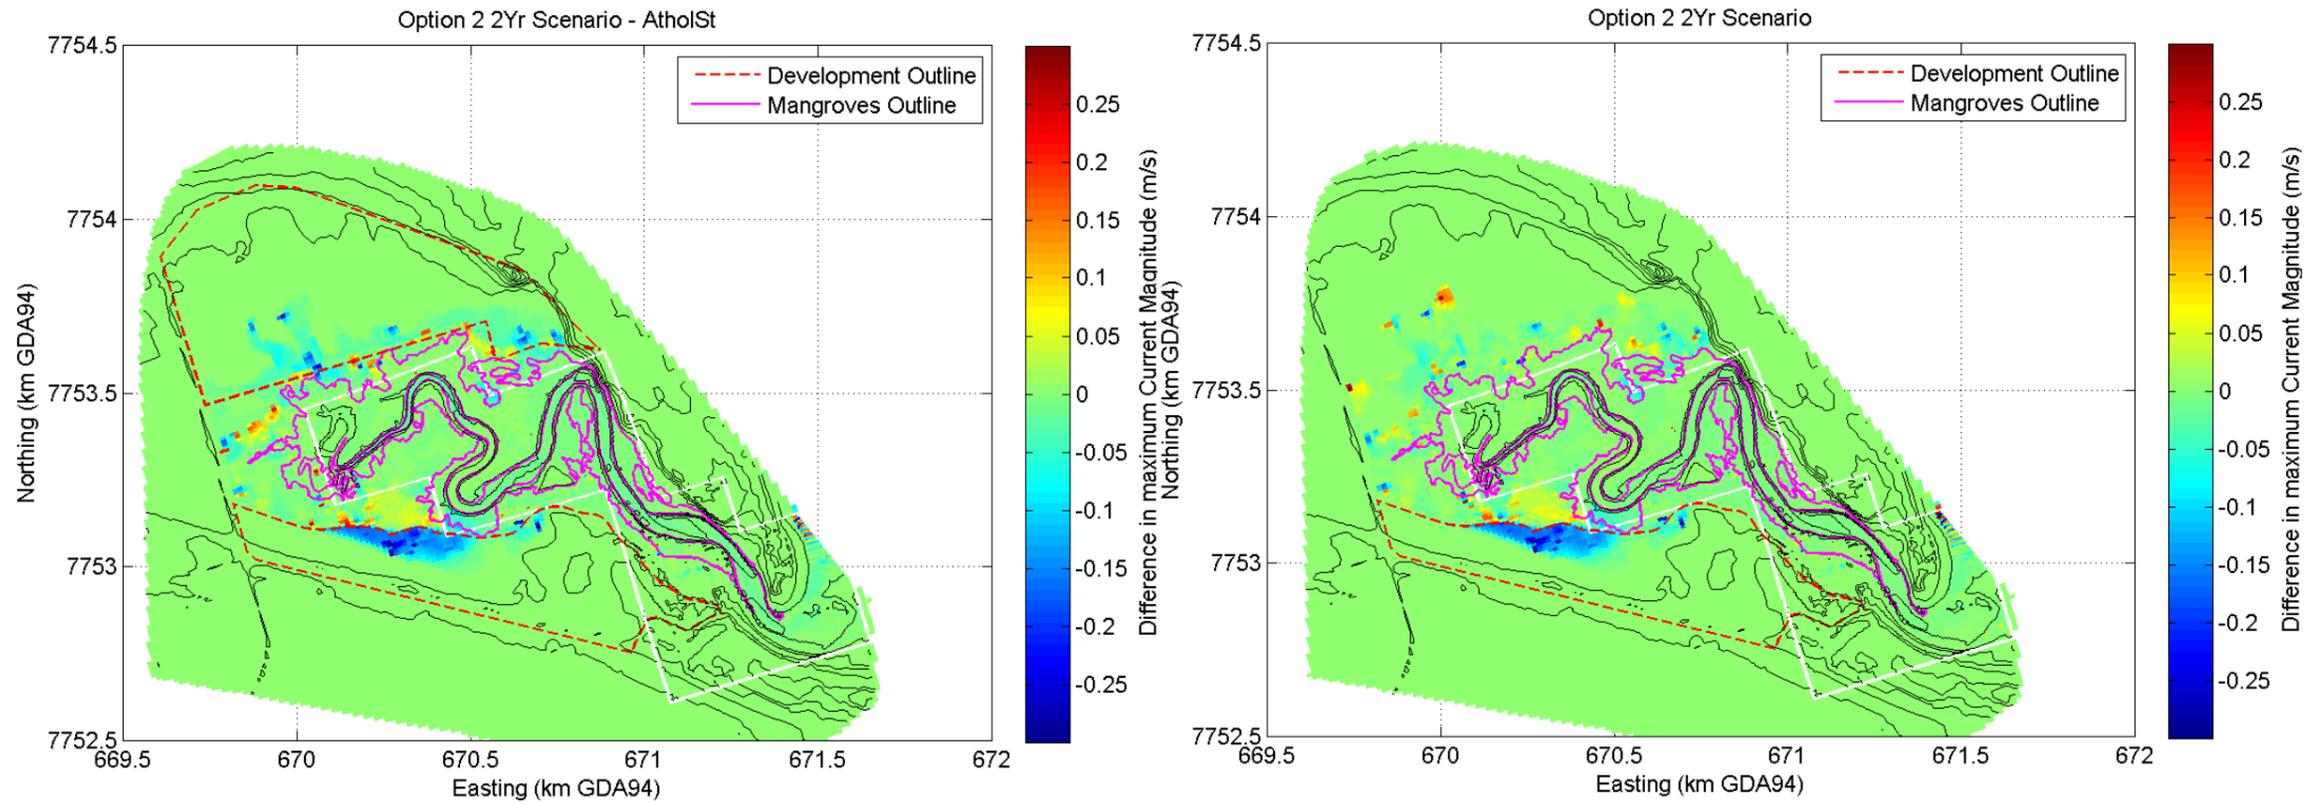
Figure 2-13 Differences in maximum current magnitude for Scenario 2 - Design and Athol Design Cases. Positive change indicates current magnitude is greater for Design Cases. White outline is boundary between domains

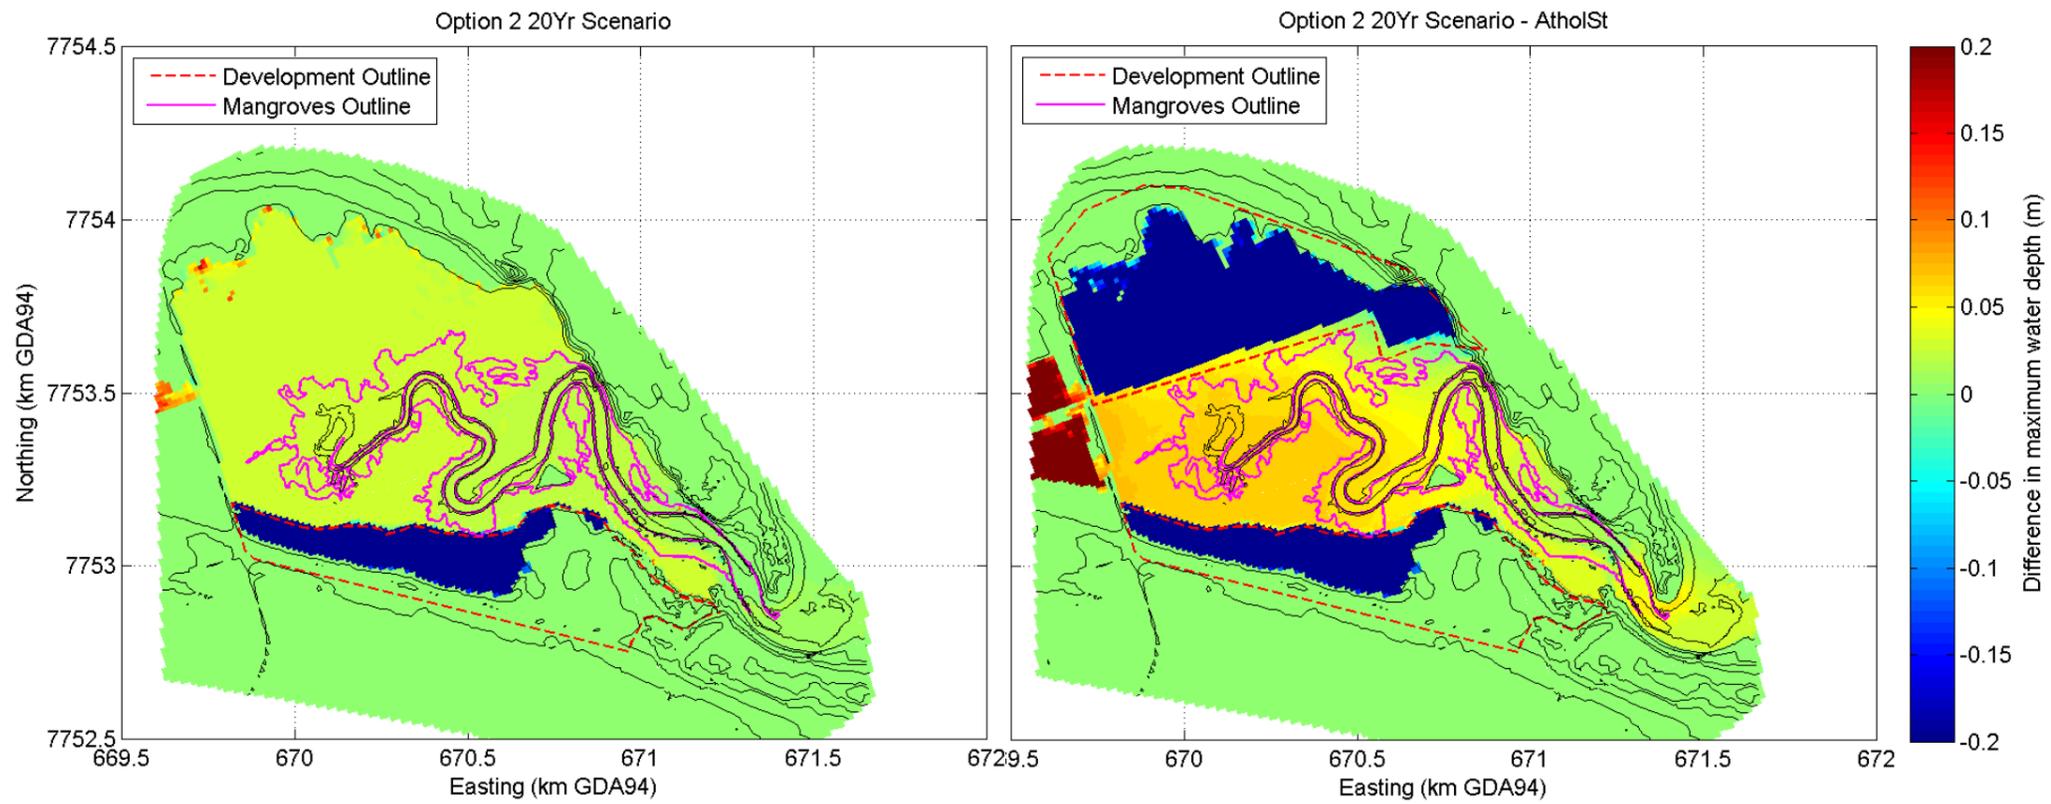
Figure 2-14 Differences in maximum inundation depth for Scenario 3 - Design and Athol Design Cases. Positive change indicates depth is greater for the Design Cases

Due to the predicted increased water levels within the proximity of Pretty Pool Creek resulting from the Design and Athol Design Case developments, alterations to the inundation of adjacent areas can occur (Figure 2-18). Overtopping of Cook Point Drive is predicted to occur in the 20-year ARI event leading to approximately 20 cm of inundation over an increased area to the west of Cook Point Drive compared to the existing layout for both the Design Cases. The inclusion of the Athol Street development (Athol Design Case) results in a significantly broader area being inundated compared to the Design Case alone. The corresponding change to current magnitude is also included in Figure 2-19 for this zoomed-out view.

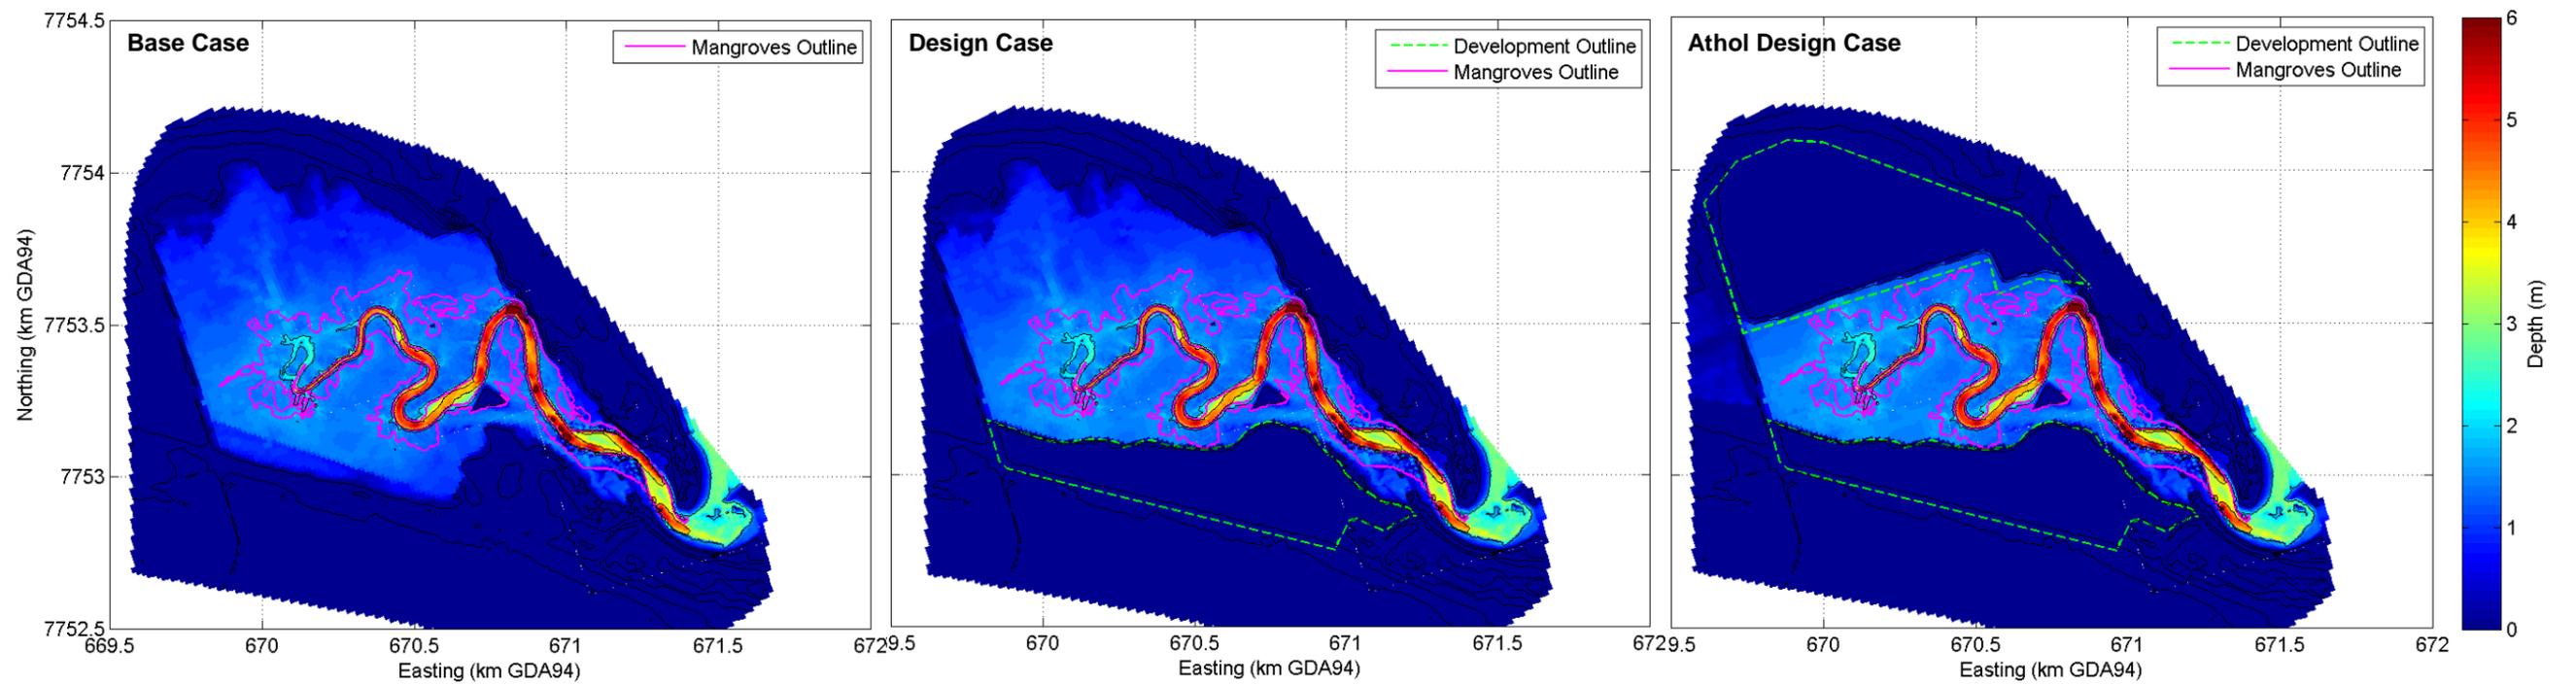
Figure 2-15 Maximum water depth for Base, Design and Athol Design Cases for Scenario 3

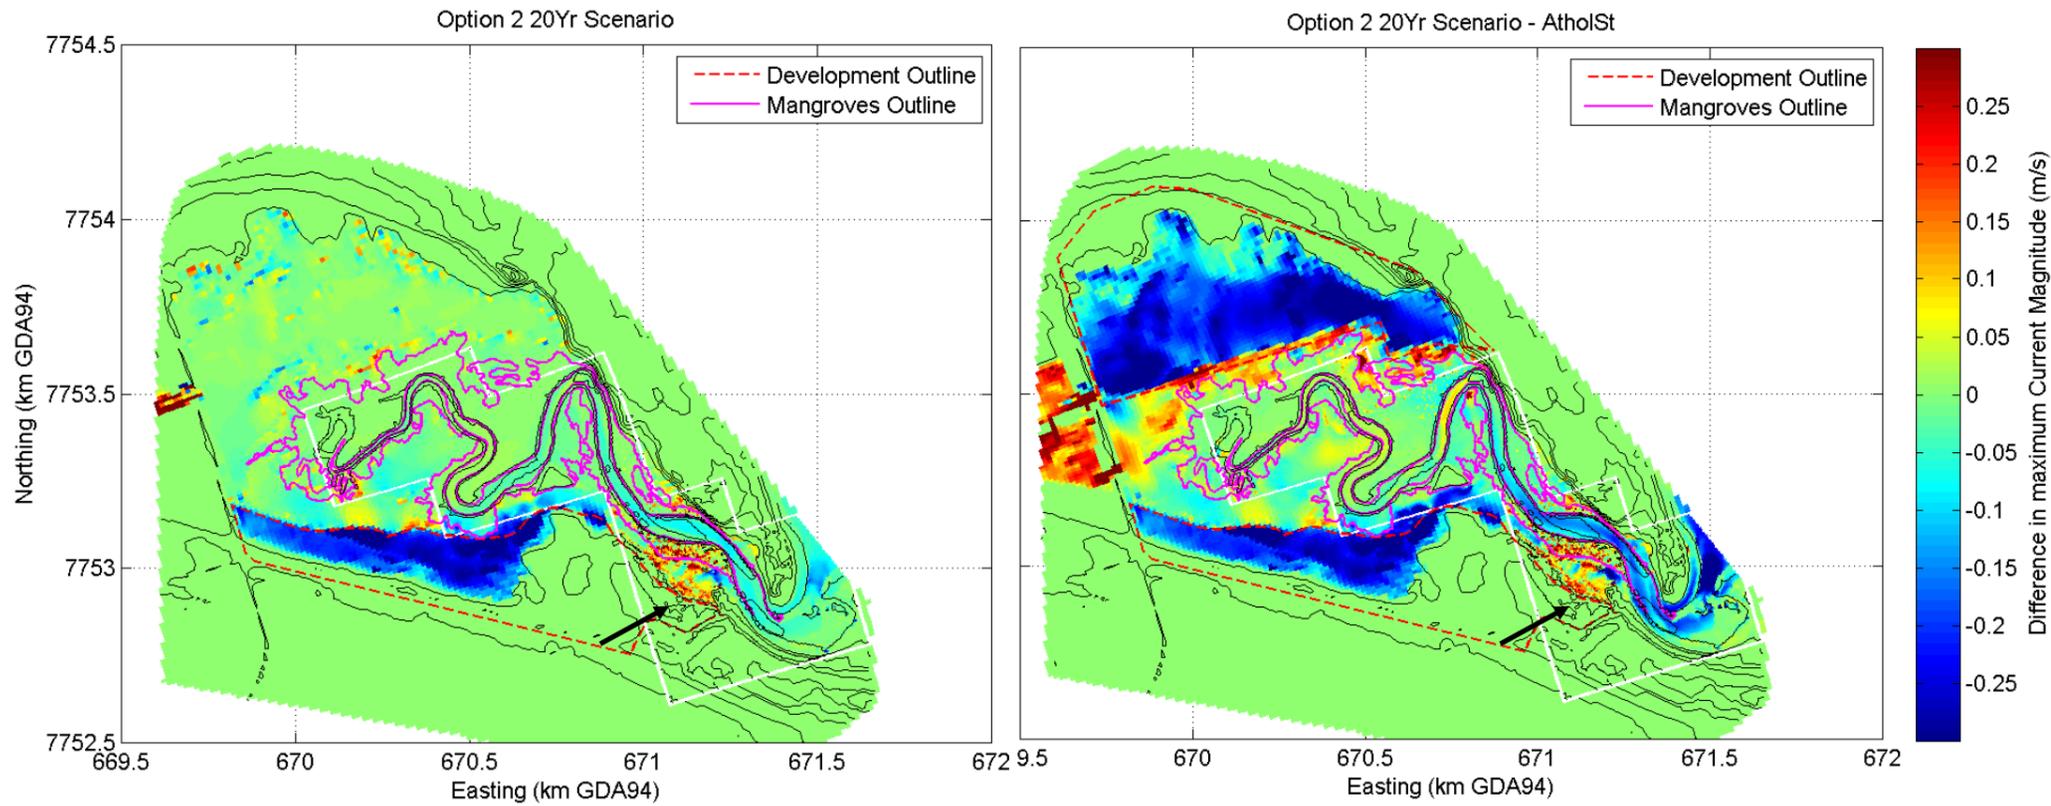
Figure 2-16 Differences in maximum current magnitude for Scenario 3 - Design and Athol Design Cases. Positive change indicates current magnitude is greater for Design Cases. White outline is boundary between domains. Arrow indicates current variability at entrance due to modelled wetting/drying processes

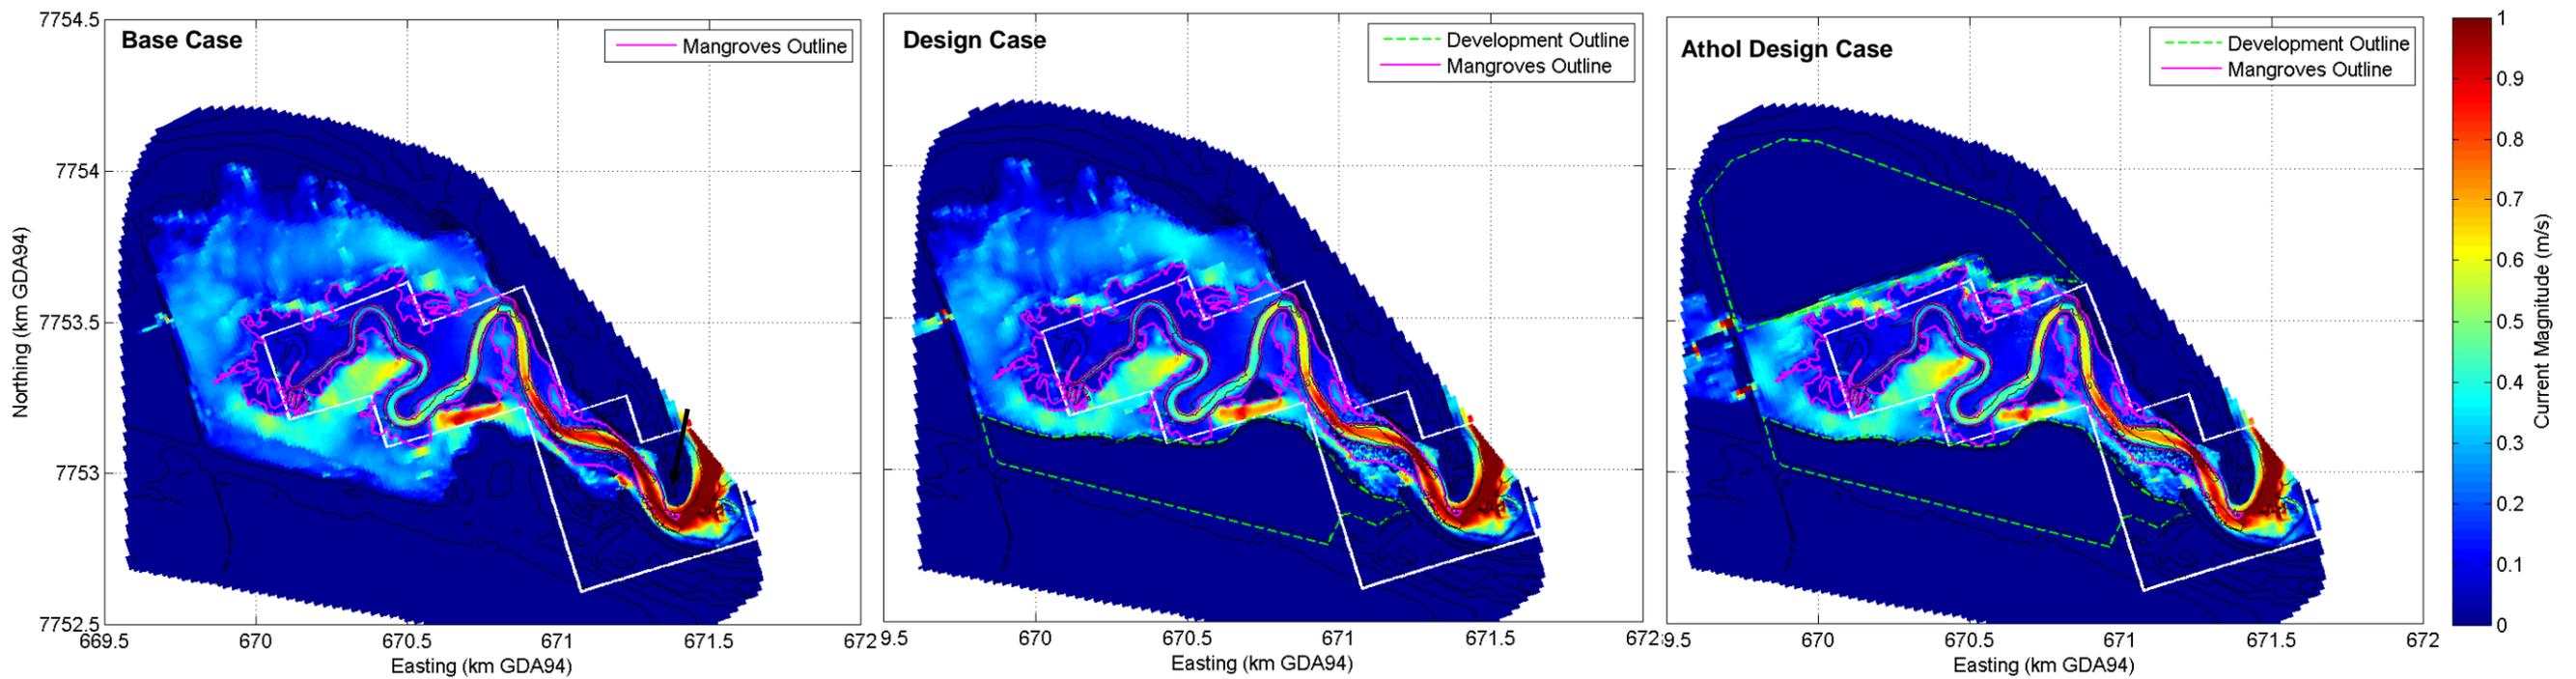
Figure 2-17 Maximum current magnitude for Base, Design and Athol Design Cases for Scenario 3. White outline is boundary between domains

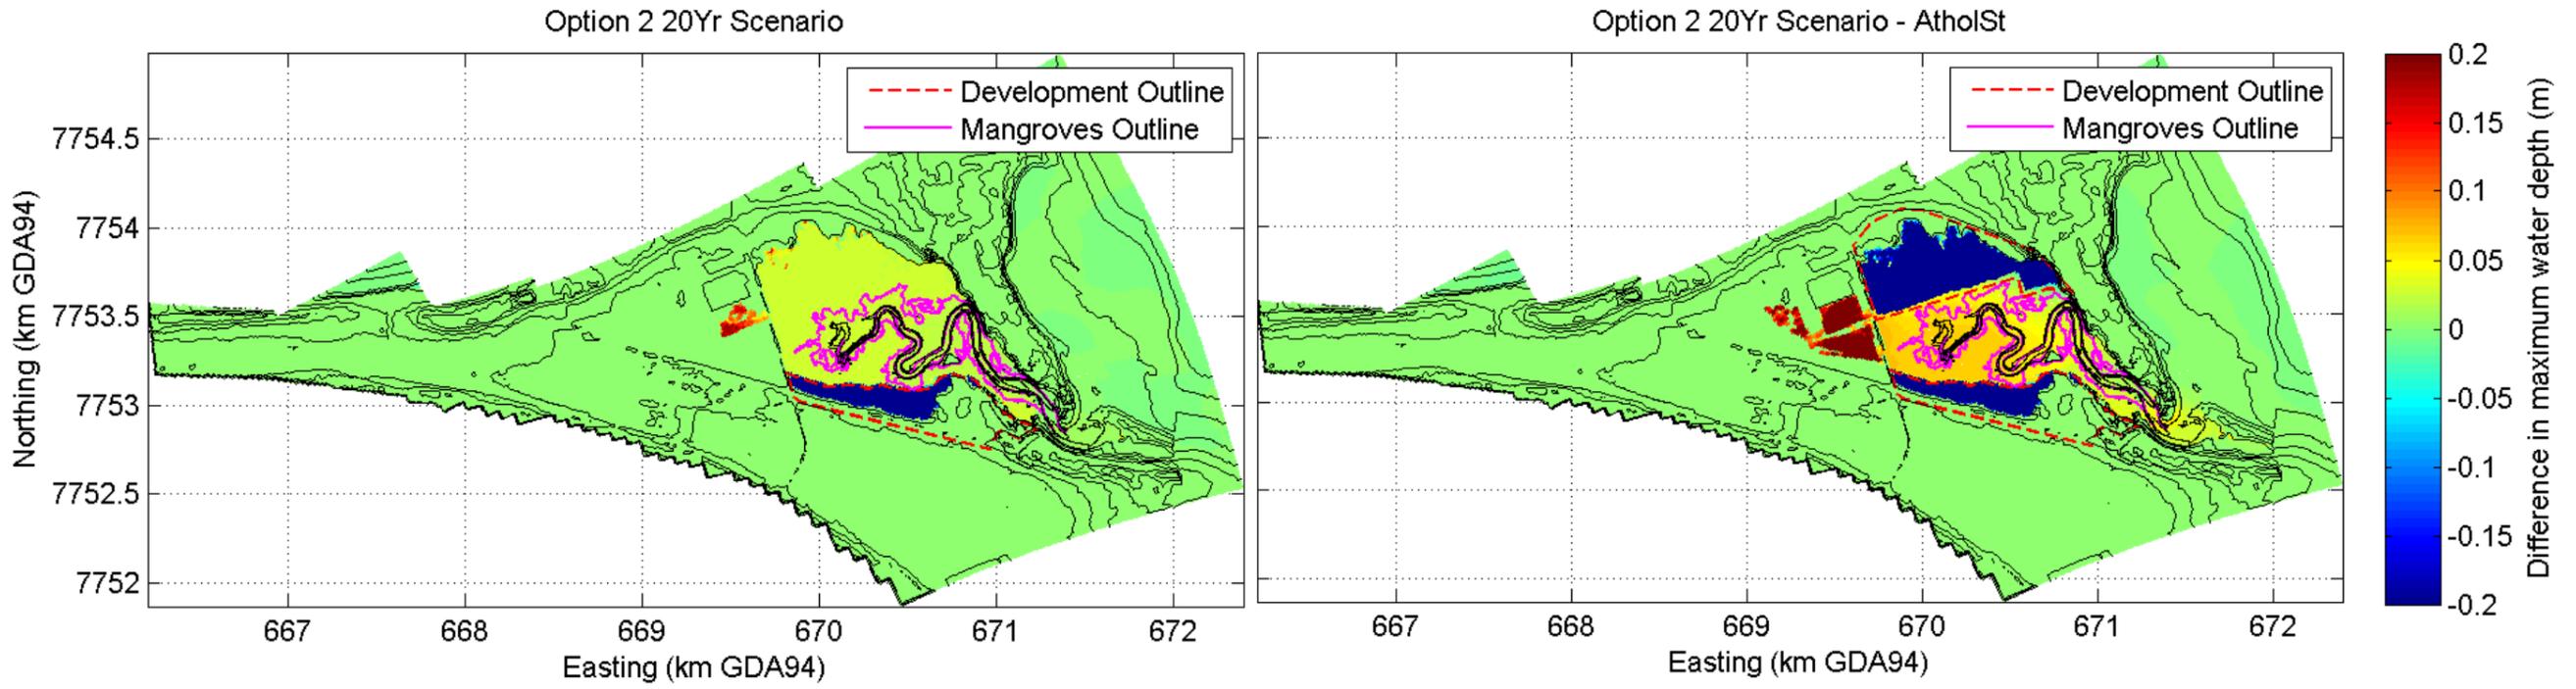
Figure 2-18 Differences in maximum inundation depth for Scenario 3 - Design and Athol Design Cases, zoomed-out view. Positive change indicates depth is greater for the Design Cases

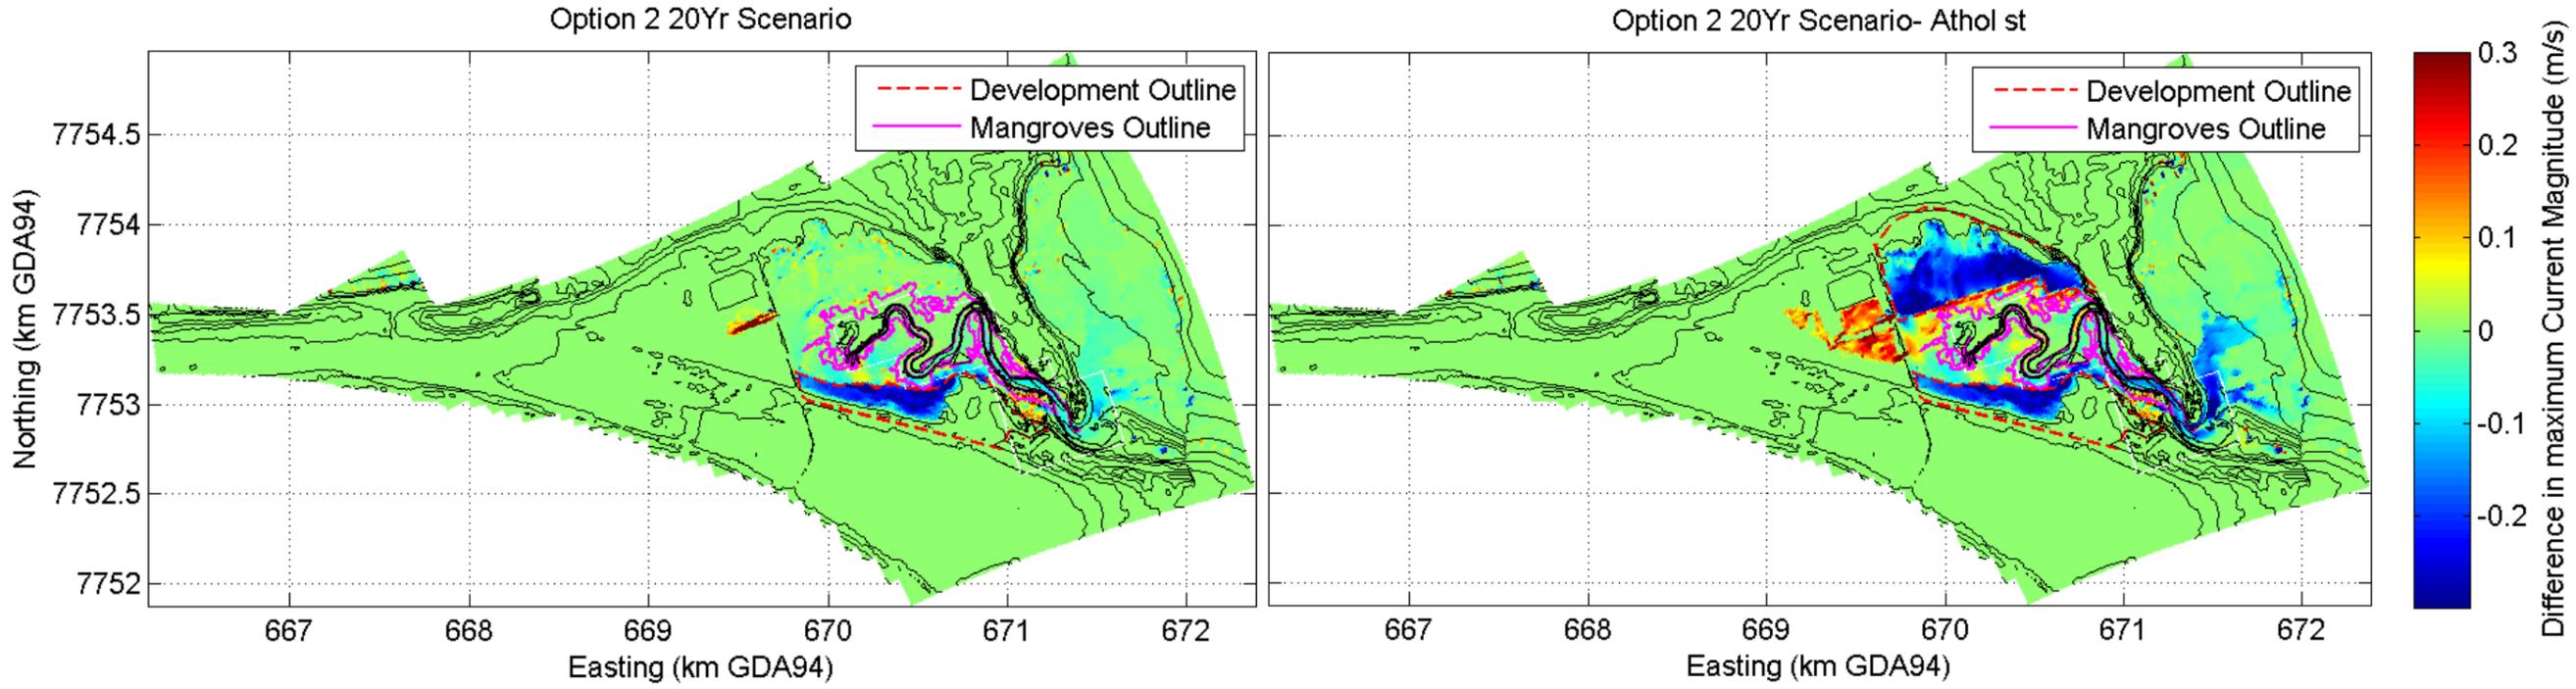
Figure 2-19 Differences in maximum current magnitude for Scenario 3 - Design and Athol Design Cases, zoomed-out view. Positive change indicates current magnitude is greater for the Design Cases

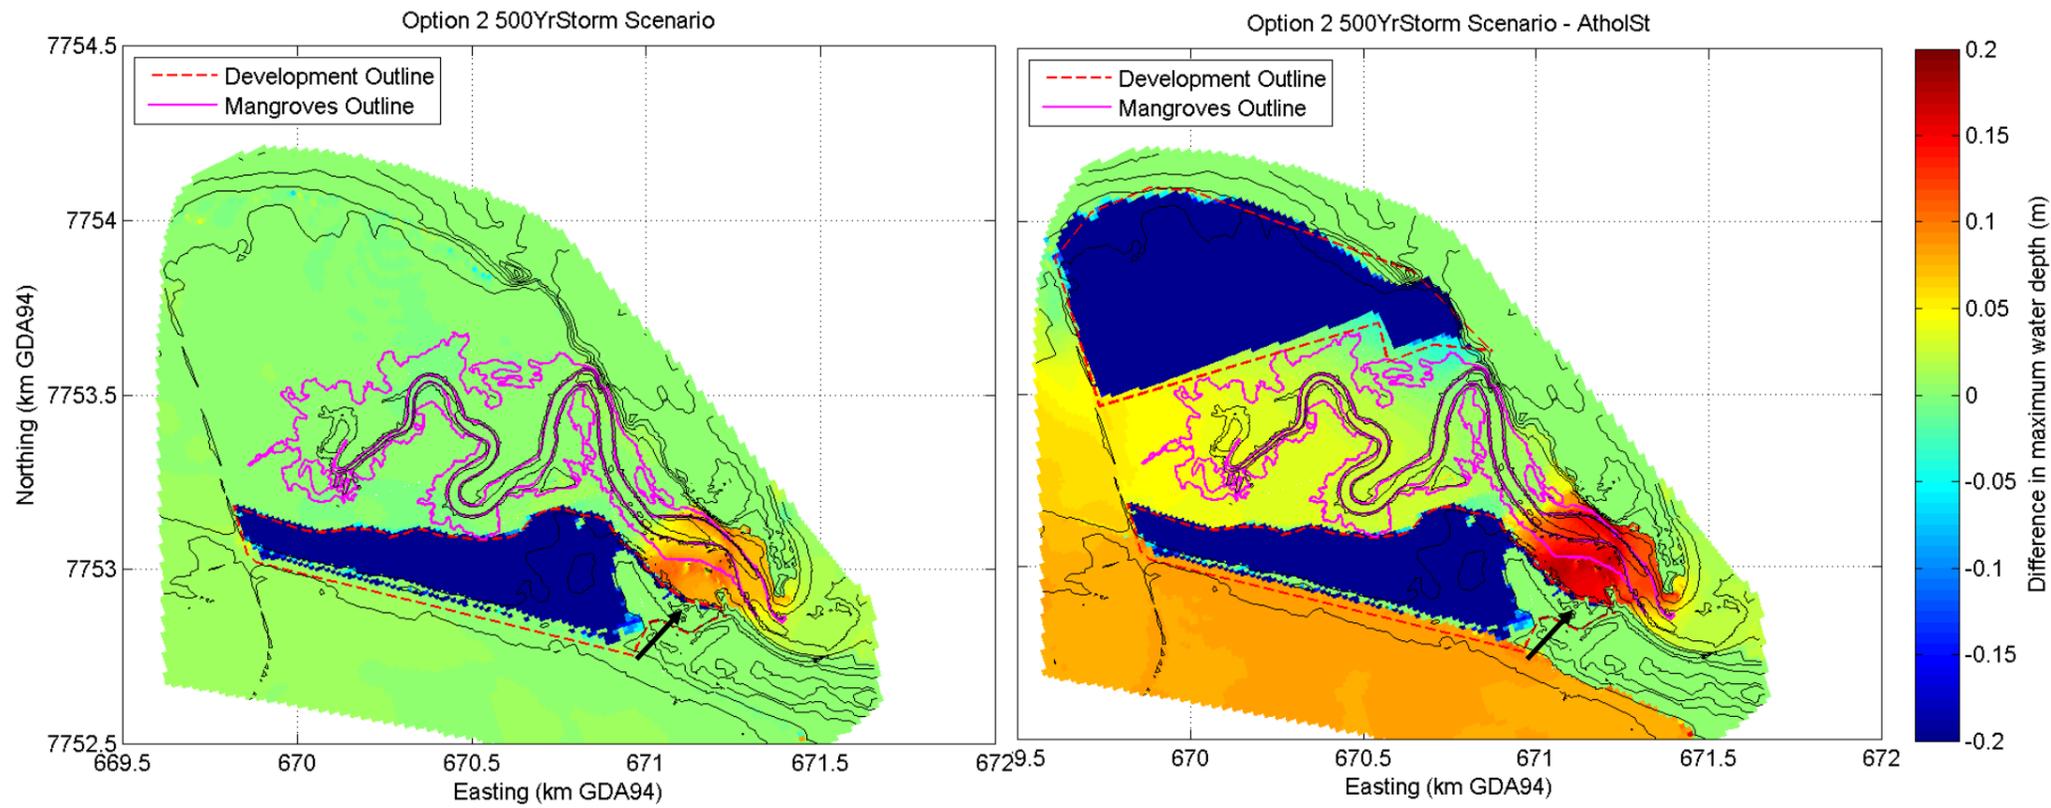
Figure 2-20 Differences in maximum inundation depth for Scenario 4 - Design and Athol Design Cases. Positive change indicates depth is greater for Design Cases
