Local Water Management Strategy

Stage 3 (The Stables)
East Port Hedland

Prepared for LandCorp
April 2015

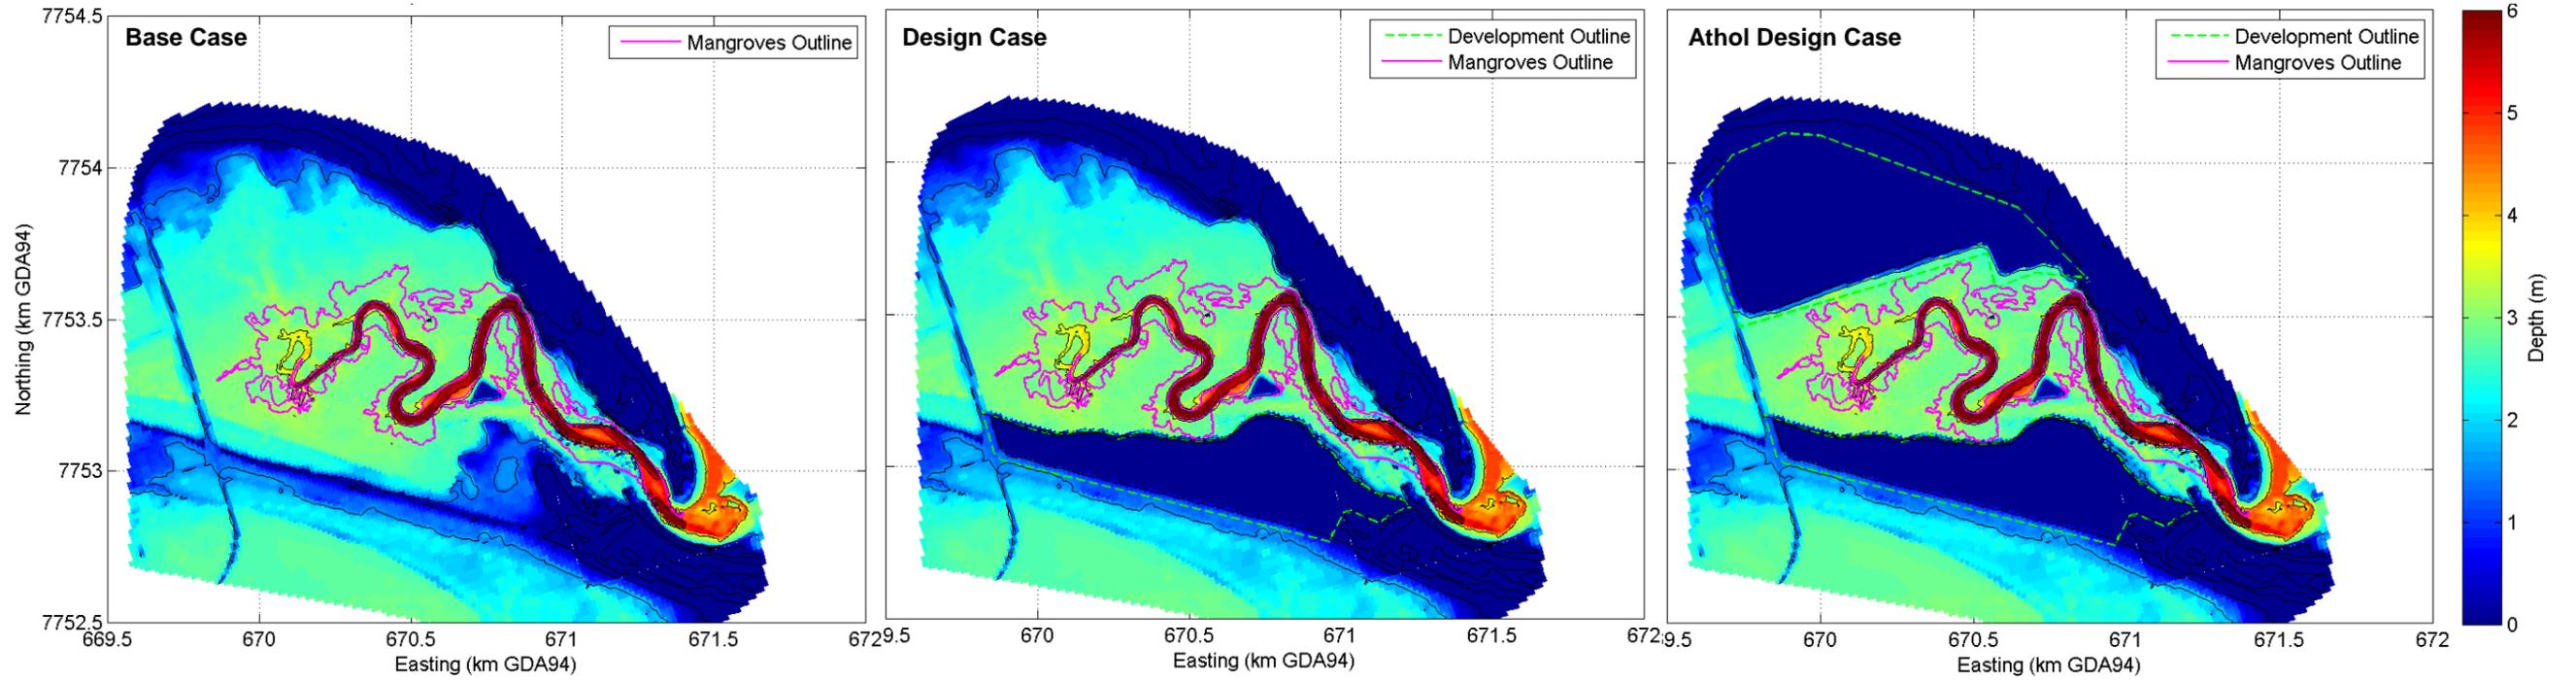
Figure 2-21 Maximum water depth for Base, Design and Athol Design Cases for Scenario 4

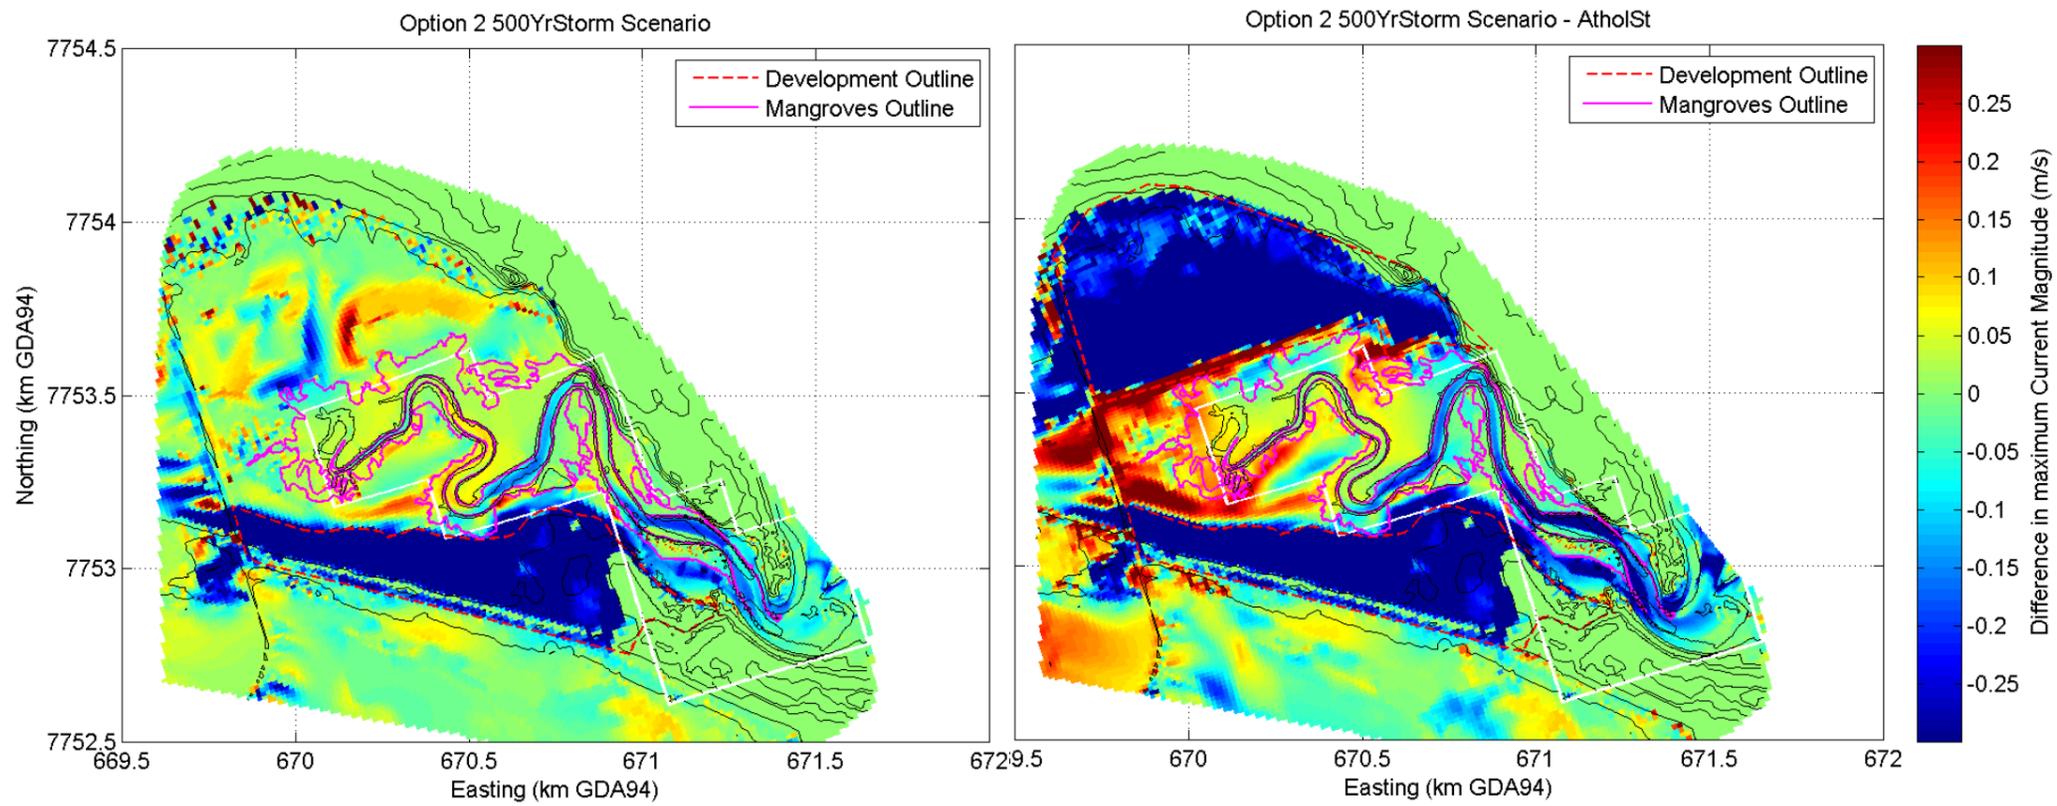
Figure 2-22 Differences in maximum current magnitude for Scenario 4 - Design and Athol Design Cases. Positive change indicates current magnitude is greater for Design Cases. White outline is boundary between domains

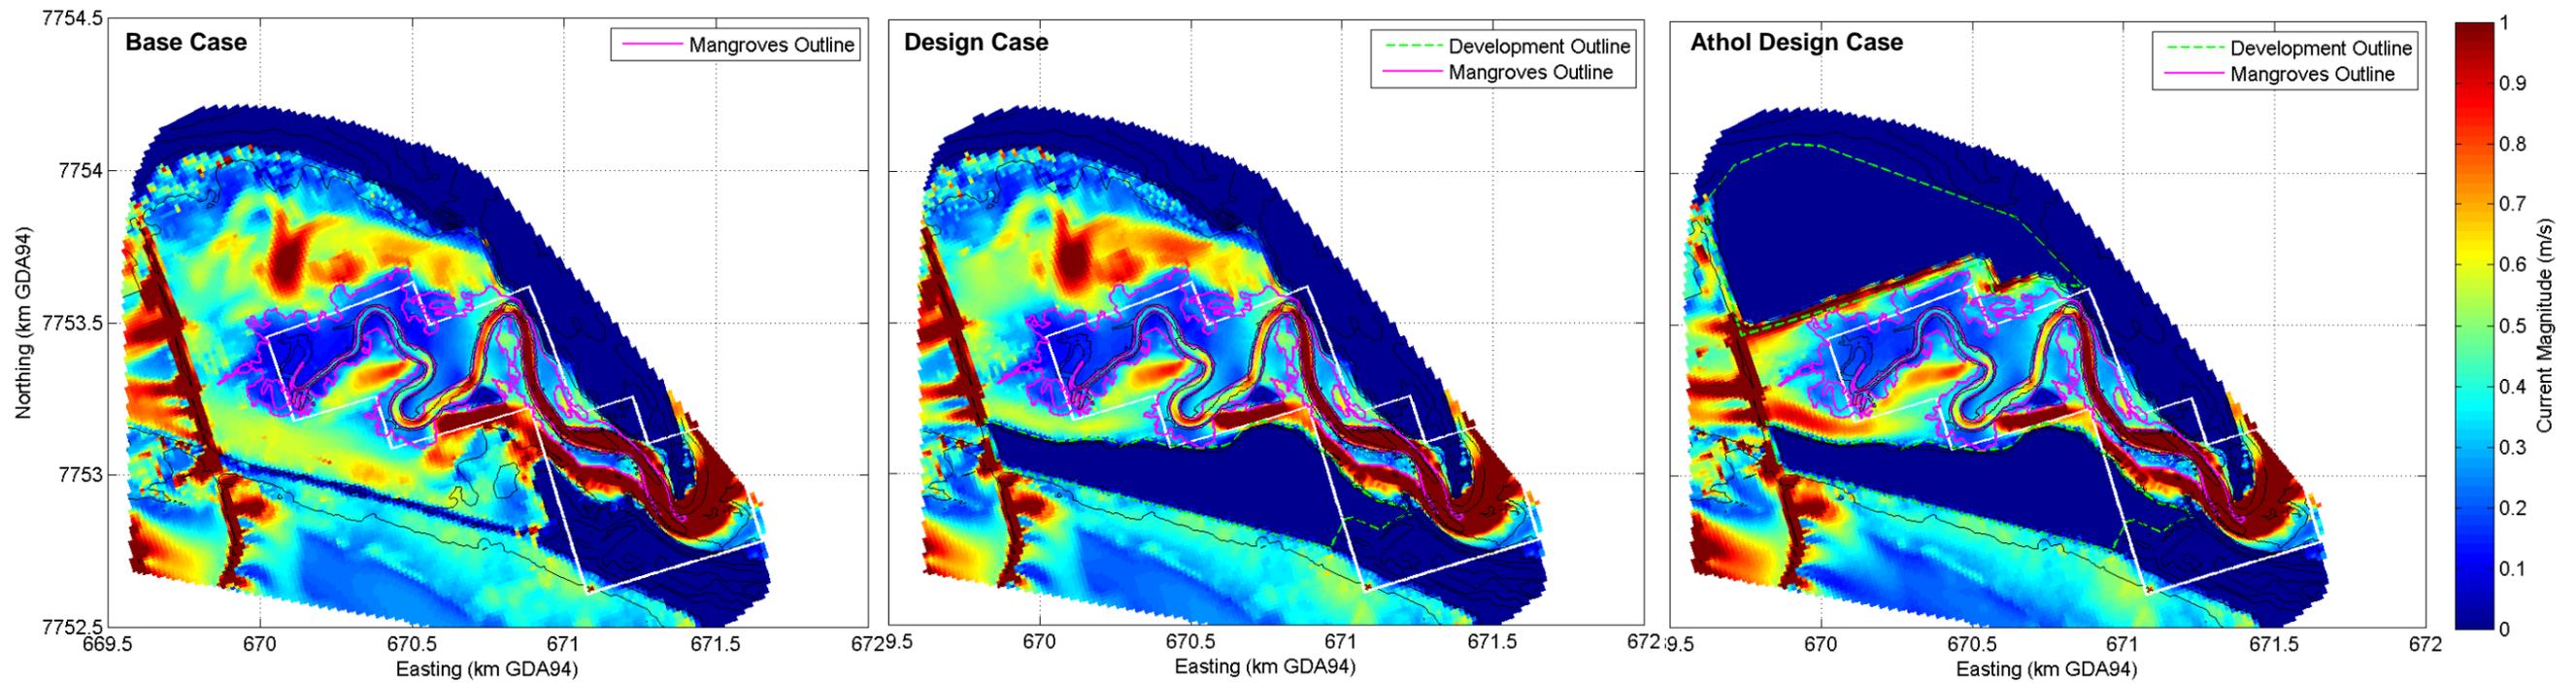
Figure 2-23 Maximum current magnitude for the Base, Design and Athol Design Cases for Scenario 4. White outline is boundary between domains

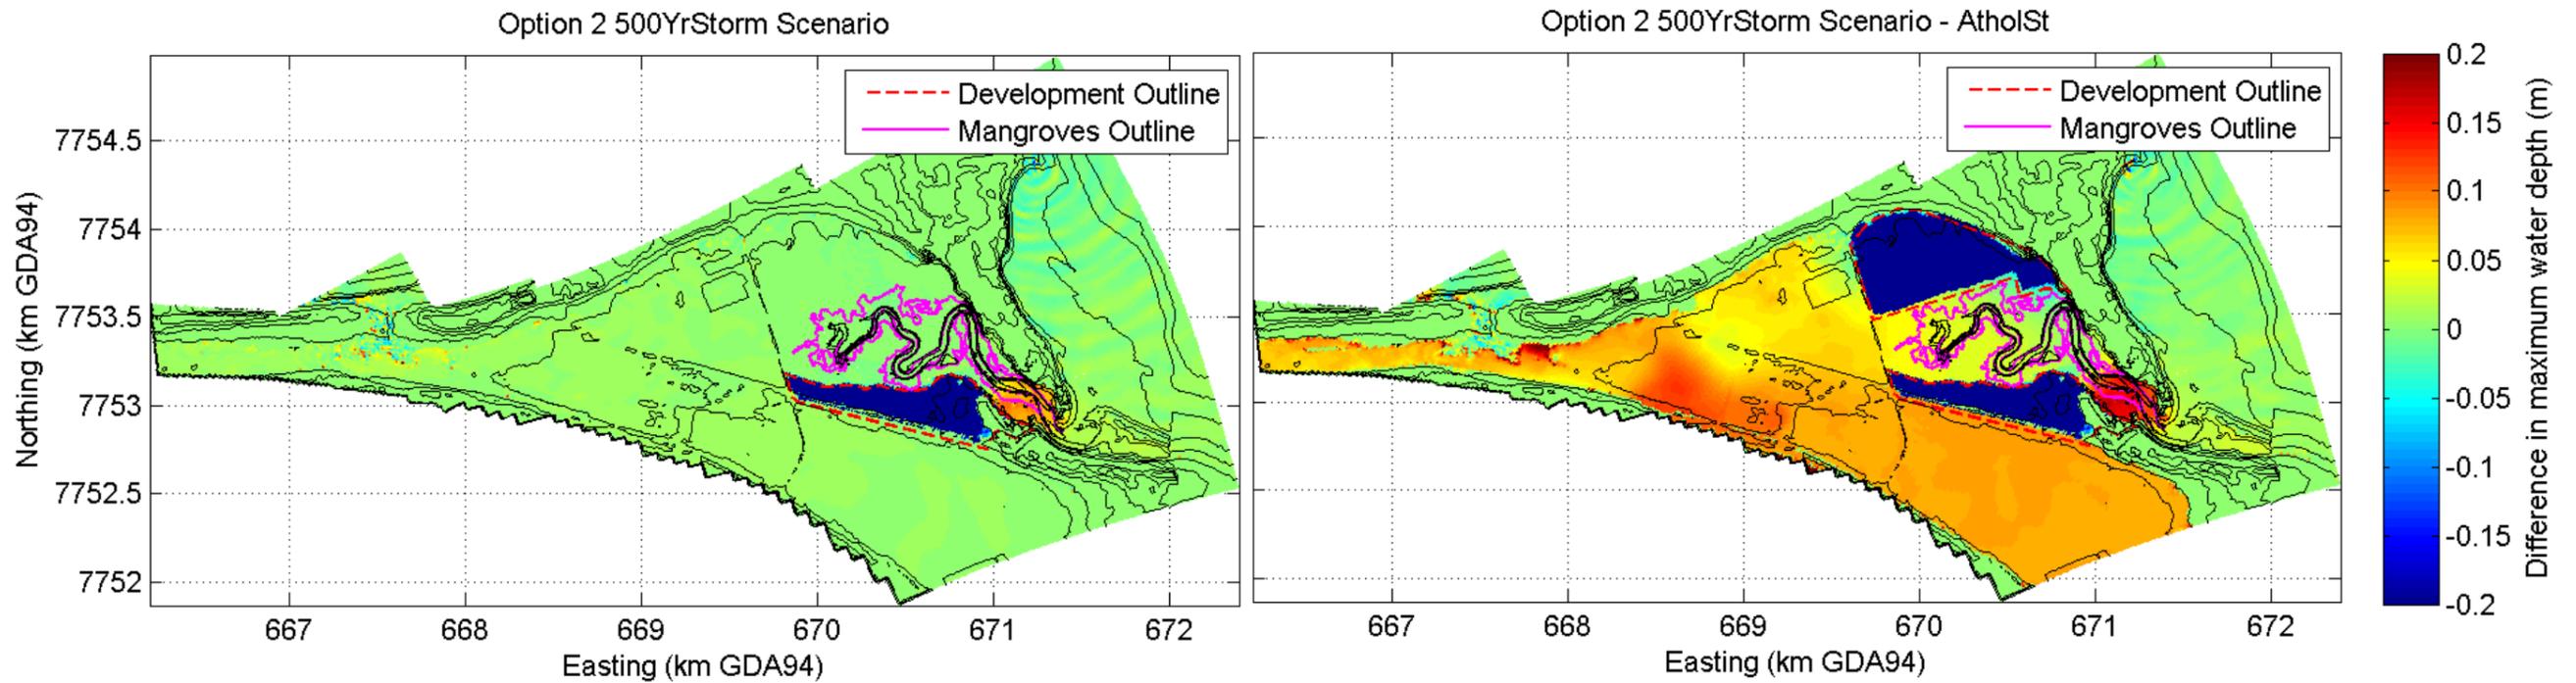
Figure 2-24 Differences in maximum inundation depth for Scenario 4 - Design and Athol Design Cases, zoomed-out view. Positive change indicates depth is greater for the Design Cases

For the Design Case, there is negligible change in the overall depth of flooding for areas adjacent to the development (Figure 2-24). This is in contrast to the results of the Athol Design Case (and that assessed in Cardno 2012) where additional flood depth (up to 15 cm) is exhibited adjacent to the rail loop to the west (Figure 2-24). This is due to the overall smaller development footprint of the Design Case within the tidal flats compared to both the Athol Design Case and the Athol Street development assessed in Cardno (2012). For the Athol Design Case, the depth is predicted to increase by up to 15 cm. These changes are shown in Figure 2-24 and Figure 2-25 for the water depths and currents respectively.

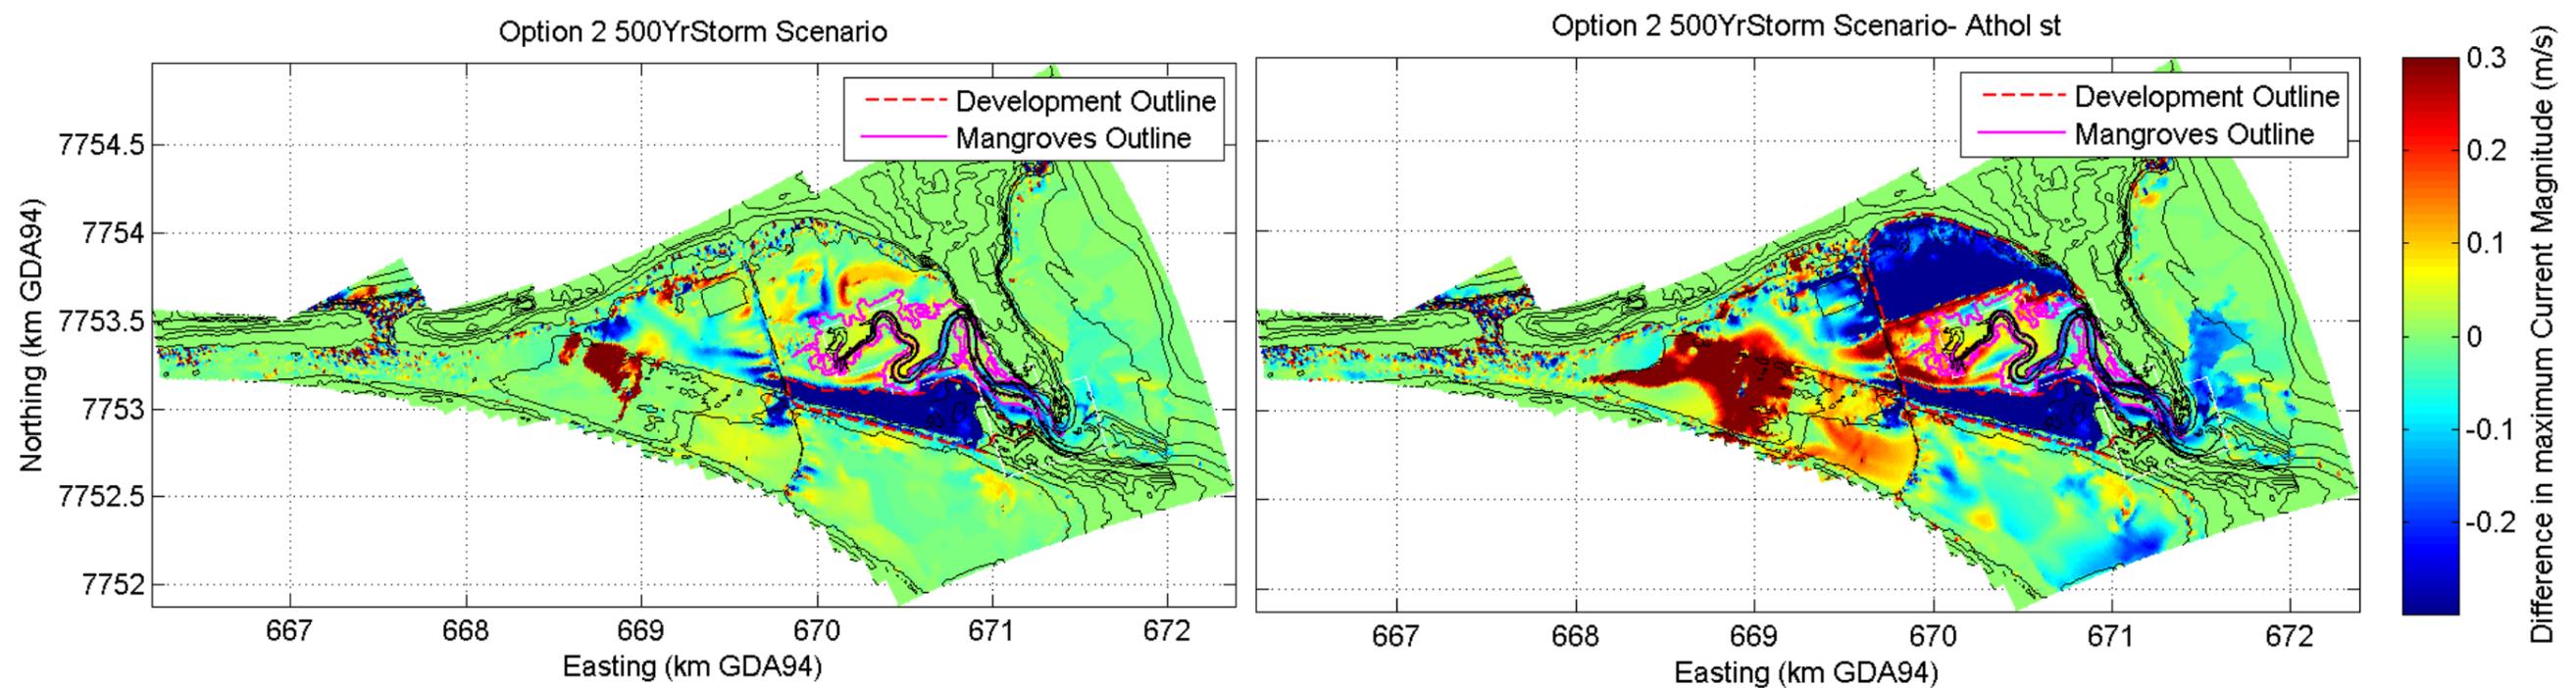
Figure 2-25 Differences in maximum current magnitude for Scenario 4 - Design and Athol Design Cases, zoomed-out view. Positive change indicates current magnitude is greater for the Design Cases

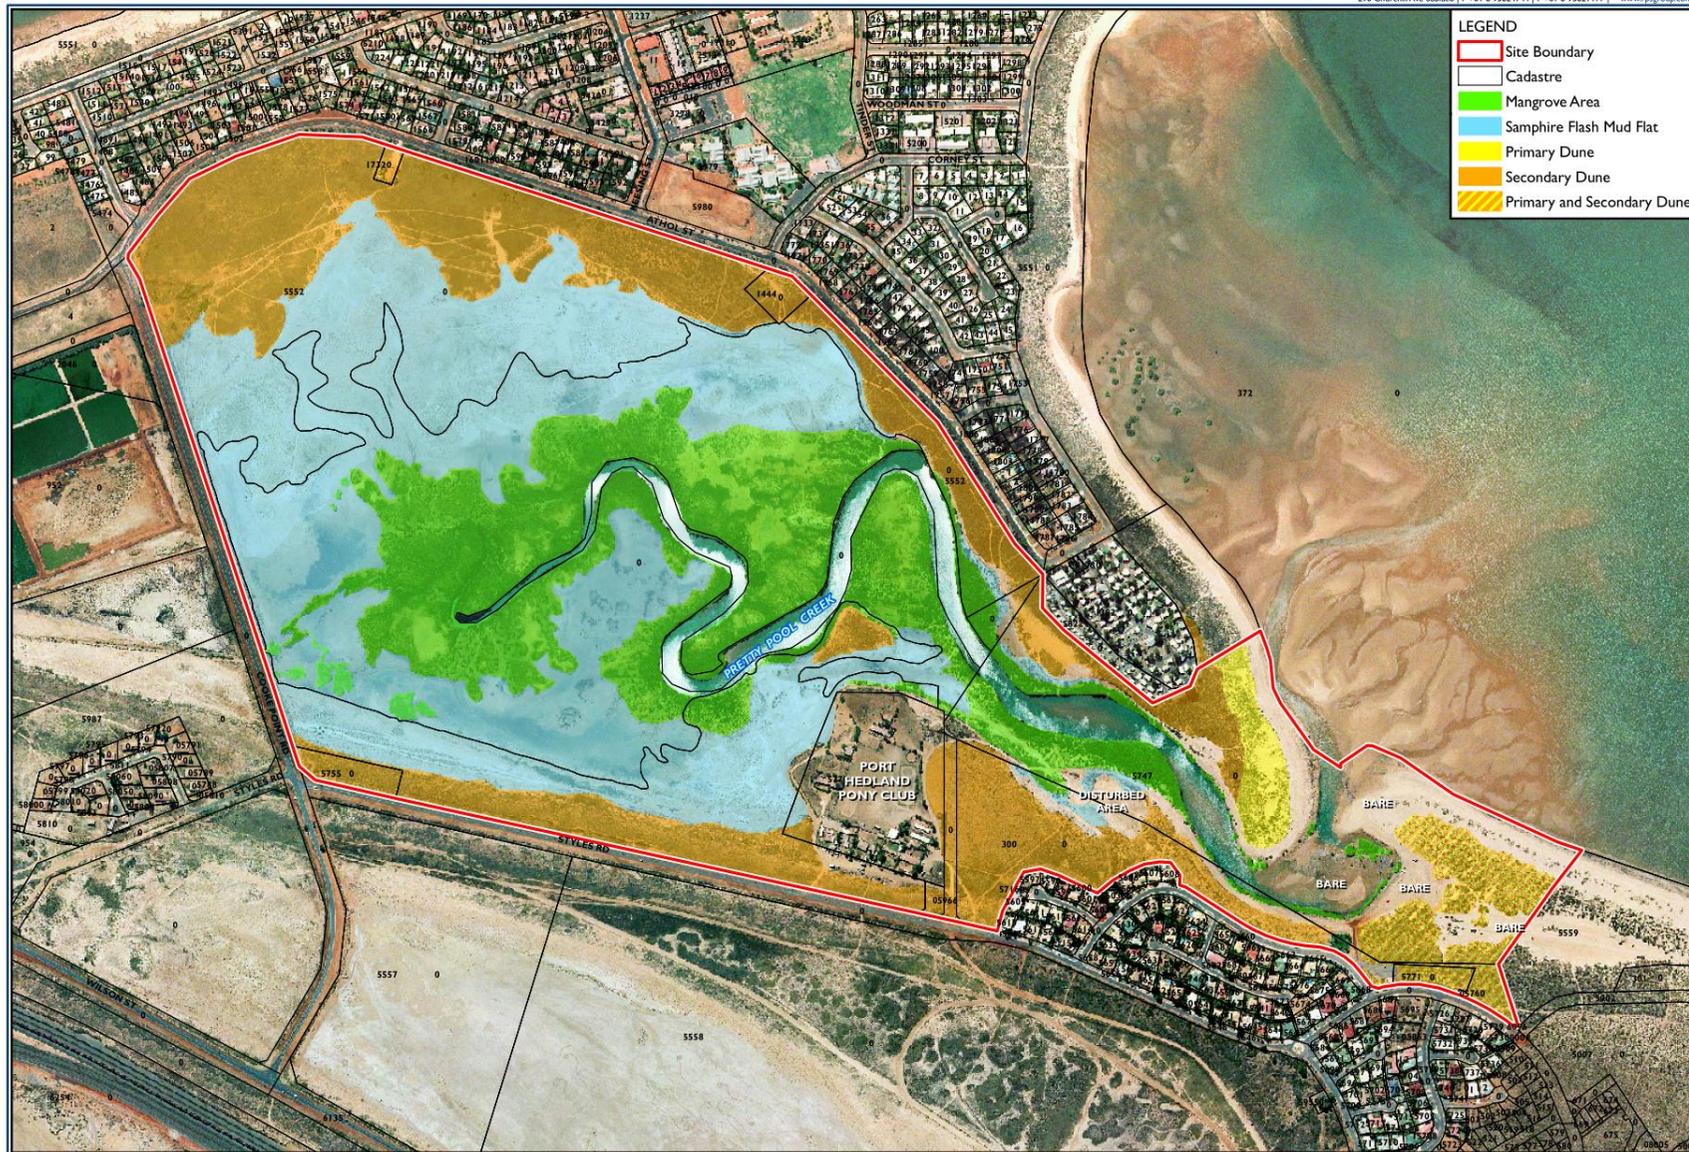
Figure 4-1 Mangrove spatial distribution (figure provided by RPS, 2014)

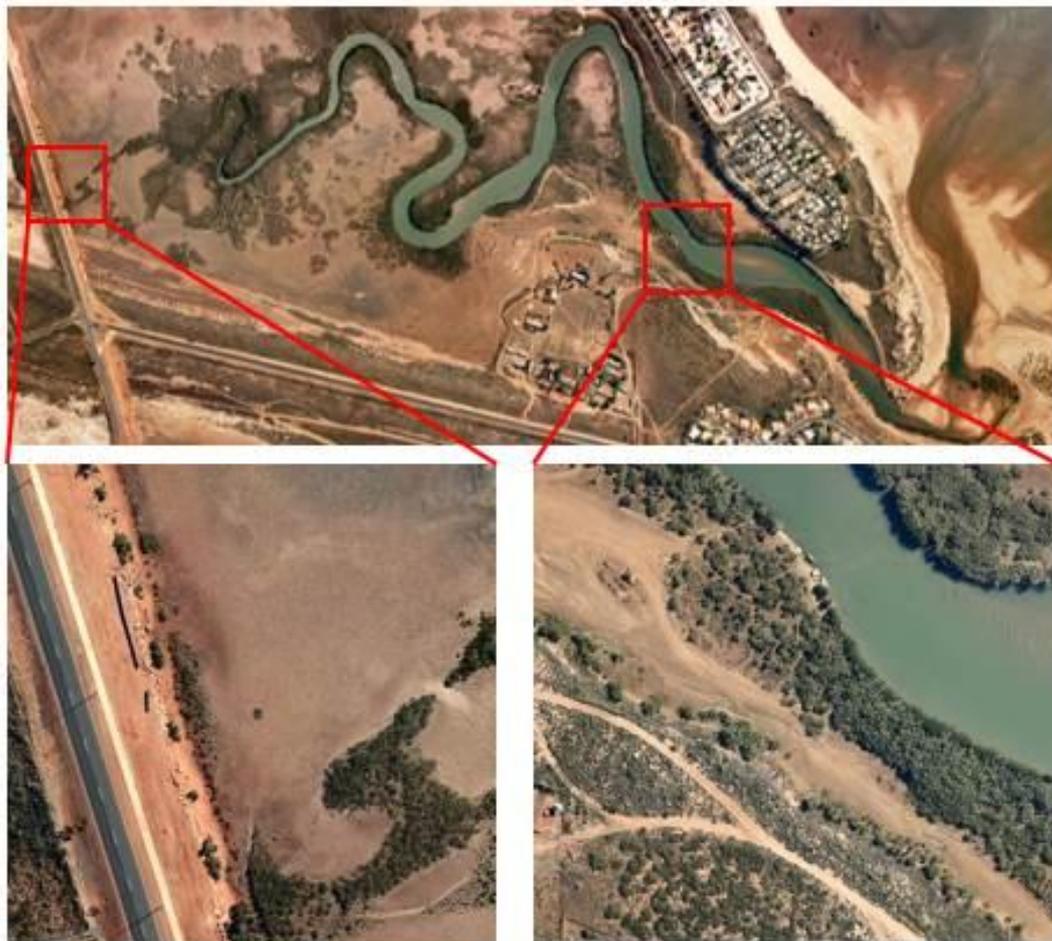
Figure 4-2 Examples of mangroves growing along the hinterland margin in the Study Area (Image source – Nearmap * Google Earth).

Mangroves may also grow along the hinterland margin of salt flats. This is more pronounced in mangroves growing in the wet tropics, however it also occurs in the Pilbara. Figure 4-2 displays examples of this for the study area. Two examples are shown, one of which shows a naturally-occurring example and the second is an example of how this effect can also be created by structures, such as roads, which are constructed over salt flats. In these areas, fresh ground and surface water flows into the mudflats, reducing the salinity of the sediments to below the tolerance limit for mangrove survival (Semeniuk et al. 1978).

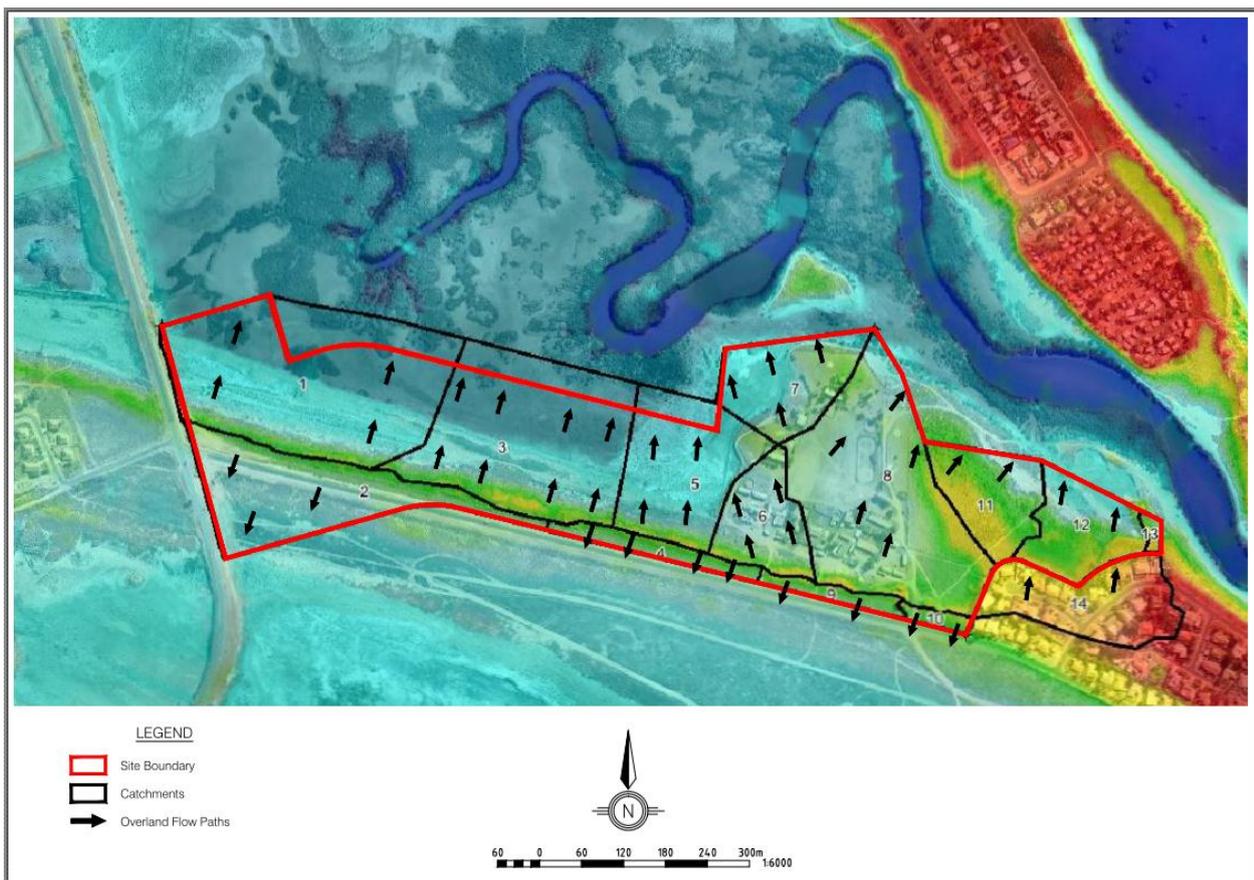
Figure 4-3 Surface water flow paths (Cardno 2014b).

The modelling found that currently stormwater flows from the high ridgeline in the south of the Site north towards Pretty Pool Creek. There is also a small amount of runoff which flows south towards Styles Road. In significant storm events there will be sheet runoff across the Site from south to north into the Pretty Pool Creek. Under the current site conditions no runoff is detained onsite. Although runoff from the residential land (Catchment 14) to the south east does flow onto the Site, it flows through Catchment 12 north into Pretty Pool Creek. Flow paths associated with the Site are presented in Figure 6.

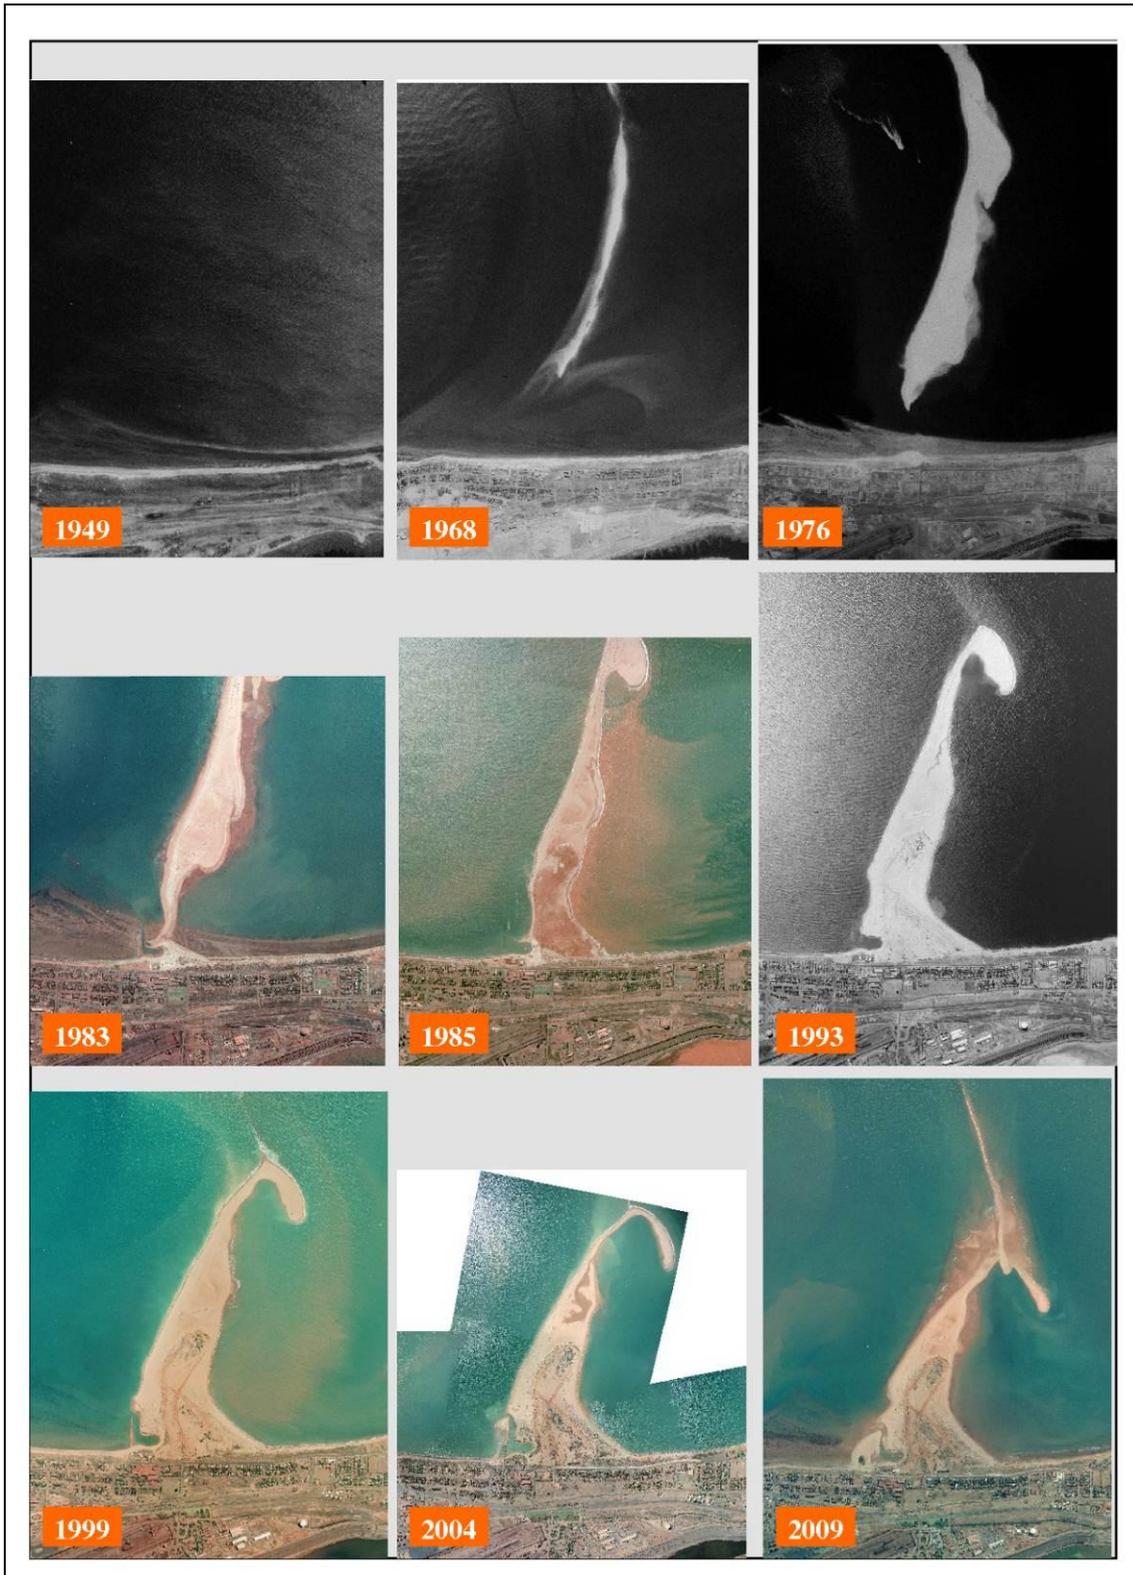
Figure 5-1 Evolution of the Spoil Bank 1968 to 2009 - Port Hedland (Cardno 2011)

The northern end of the spoil bank curves to the east suggesting that eastward sediment transport is the dominant sediment transport direction, associated with the prevailing swell direction. The evolution of the spoil bank between the years 1949 to 2009 is shown in Figure 5-1.

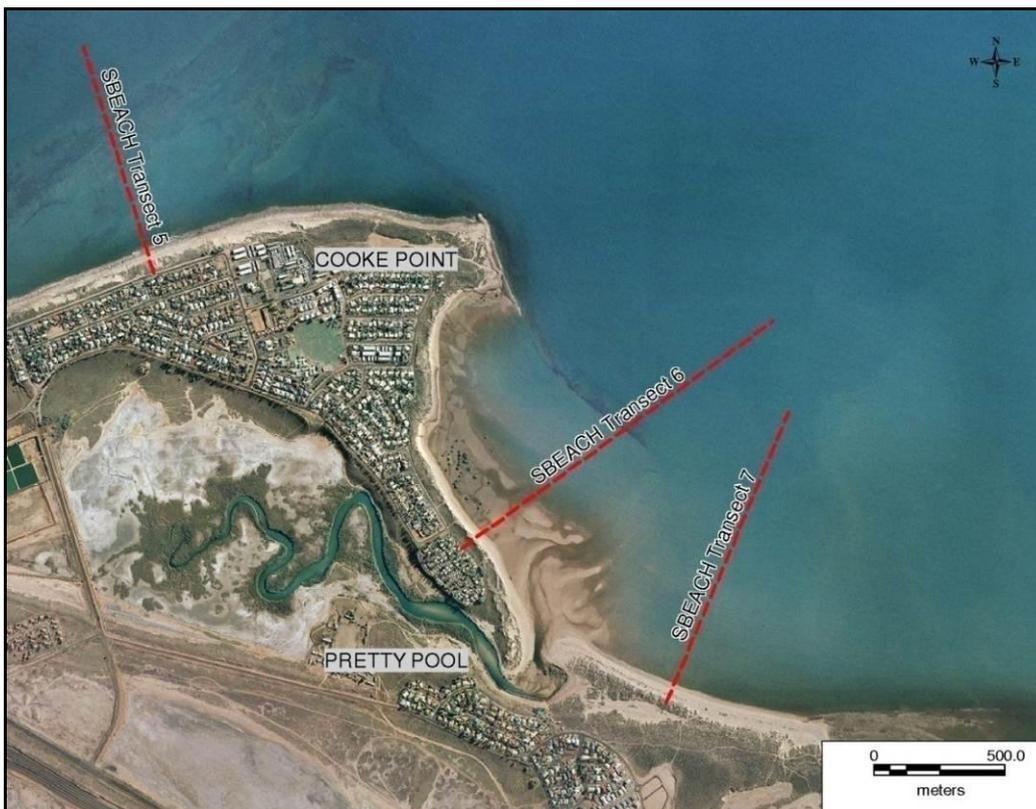
Figure 5-2 SBEACH transect locations from PHCVS

The response of the beach profile was assessed for short-term erosion based on design storms representative of a Category 5 Cyclone. This was selected as per the earlier revision of the State Coastal Planning Policy, current at the time of writing the PHCVS. The 500-year design storm was run three times consecutively. The latest SPP 2.6 recommends the 100-year ARI design storm, as discussed in Section 5.2. For comparison purposes, SBEACH modelling of Cyclone Connie and Cyclone John was additionally undertaken on each SBEACH profile and presented along with the 500-years design storm results. Cyclones Connie and John are two of the three most severe events recorded at Port Hedland as of 2011.

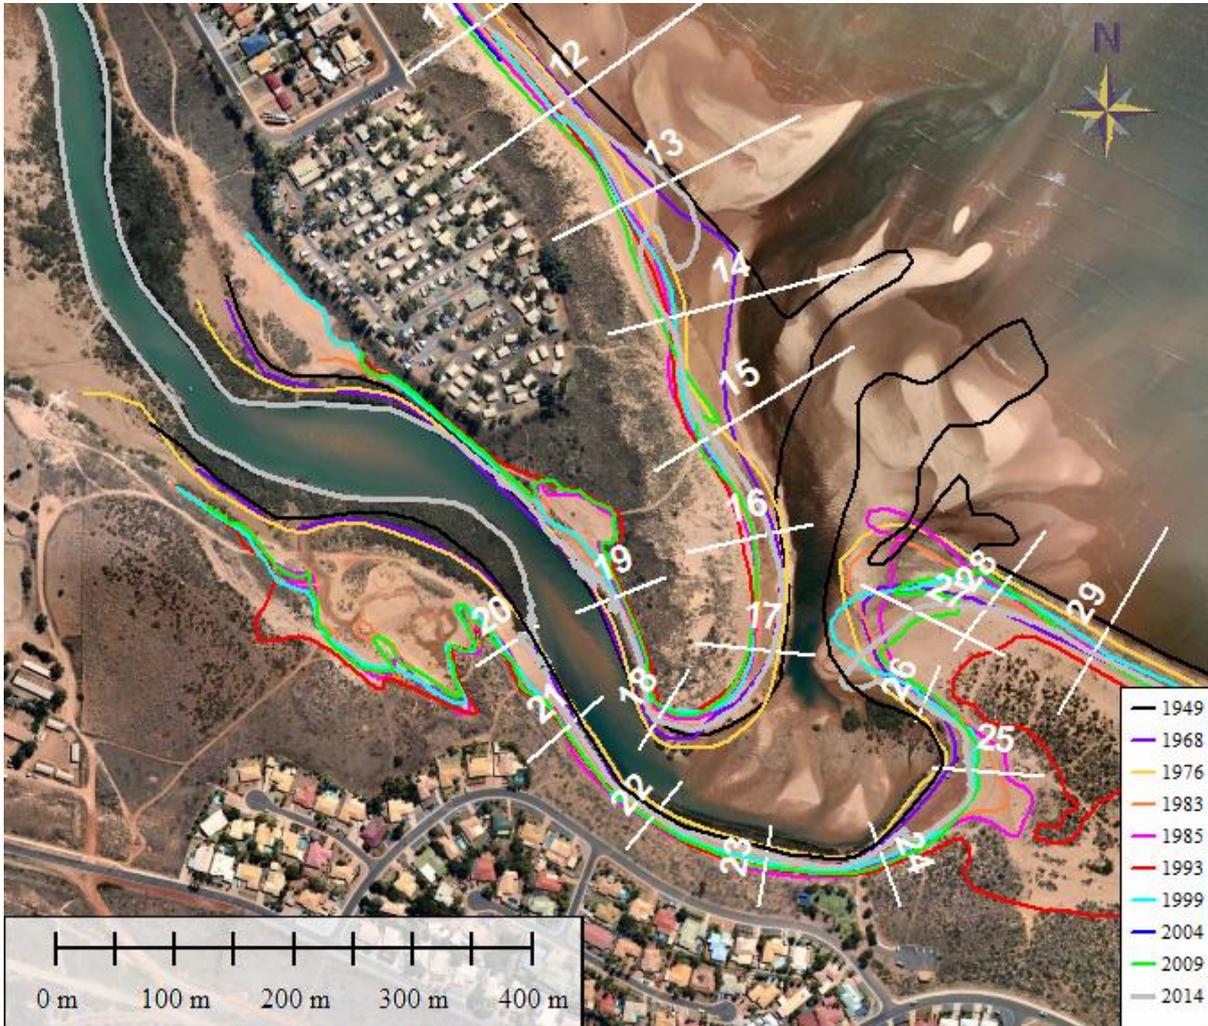
Figure 5-5 Transects 12 to 29, cast at 100 m intervals. Coloured lines indicate the MHS contour for each aerial photograph year

Transects were cast at 100 m intervals along the shoreline. Figure 5-5 shows the position of transects along the present study area. For each of the years of photogrammetric data, the transect lines were measured to the intersection point of the MHS contour. This contour was plotted over the aerial photographs, and the movement over time assessed. For this study, the MHS contour was extracted from the LiDAR data provided by LandCorp and added to the figure. This assessment is described below in Section 5.4.2.

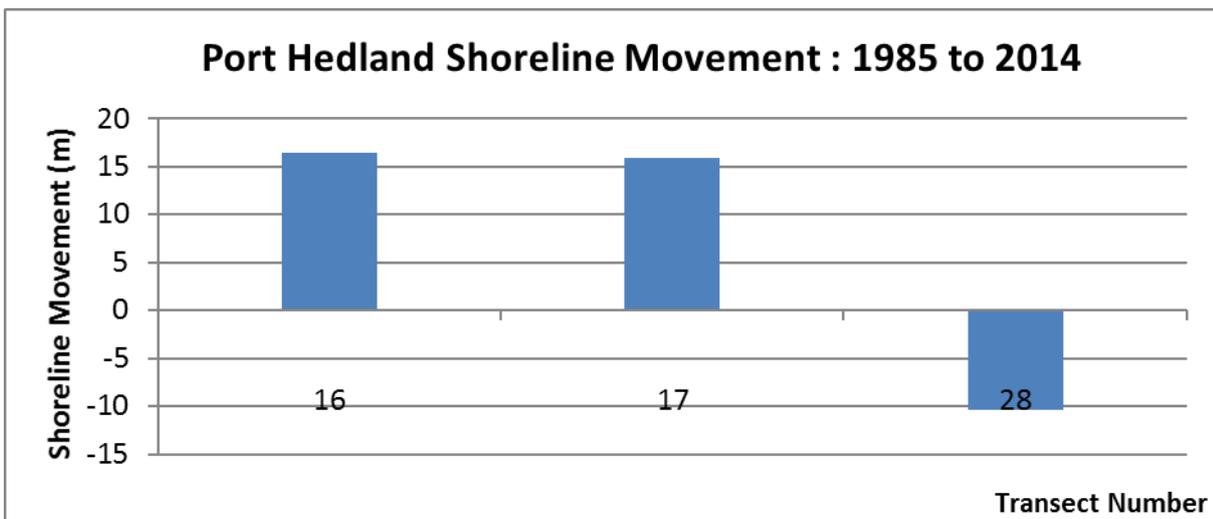
Figure 5-9 Net Shoreline Changes 1985 to 2014

To further understand the timing and causes for the shoreline position changes, a breakdown of the shoreline position change into the years 1949 to 1983 and 1985 to 2014 is shown in Figure 5-8 and Figure 5-9. From 1949 to 1983 the shoreline receded for all transects. From 1985 to 2014, transects 16 and 17, accreted on average by 23 m.

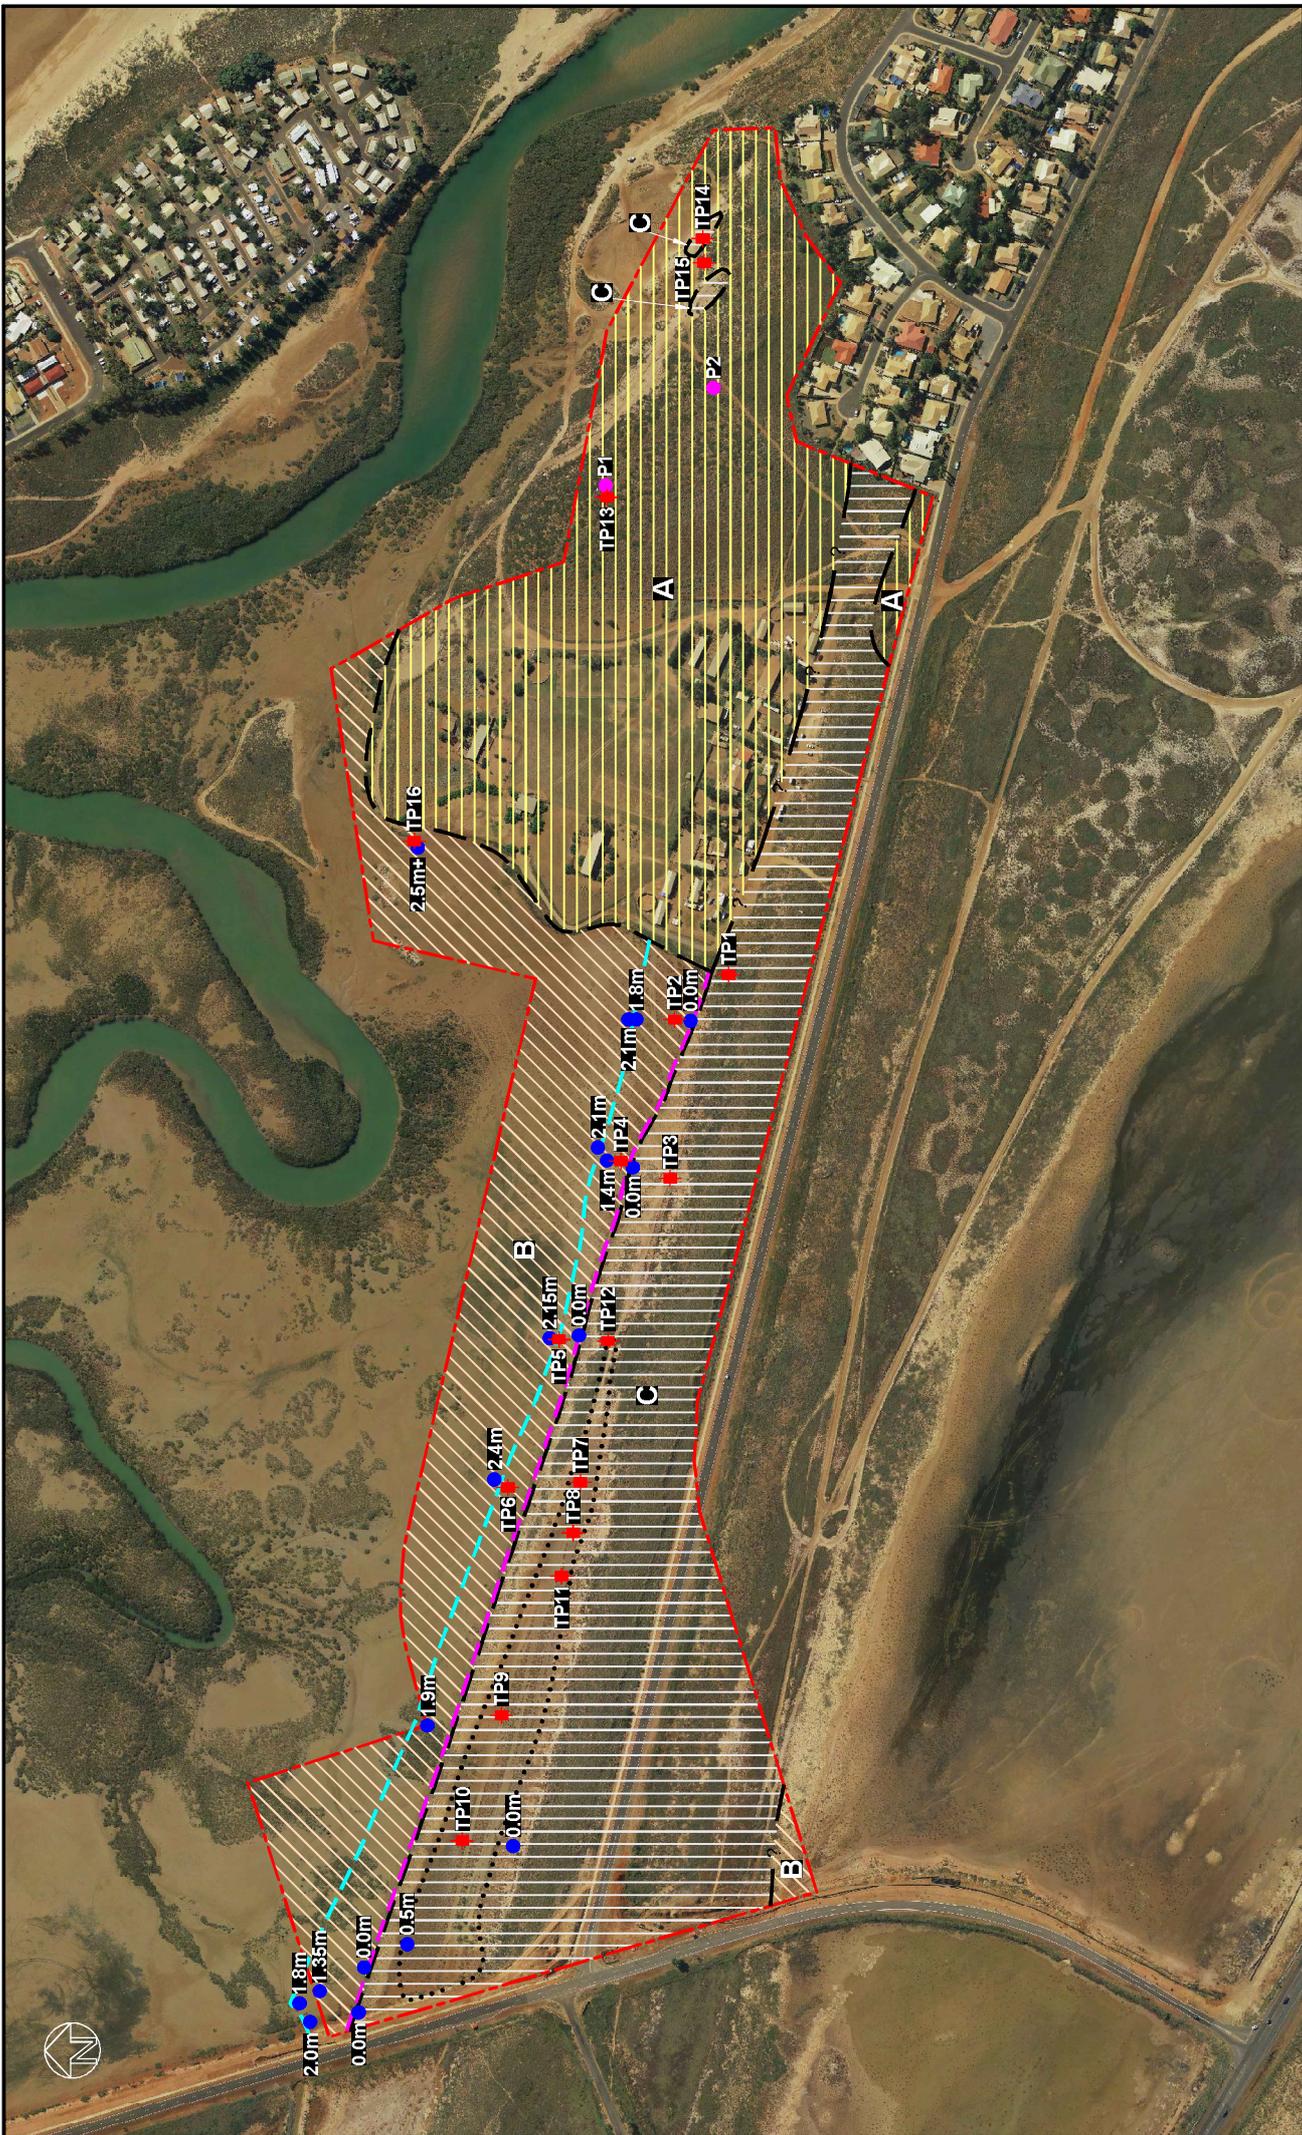
client:	JDSI CONSULTING ENGINEERS
project:	STAGE 3 - THE STABLES EAST PORT HEDLAND, WA
title:	GEOLOGICAL AREA LOCATION PLAN
project no:	GEOTPER10160AA
fig no:	FIGURE 3
rev:
