Local Water Management Strategy

Stage 3 (The Stables)
East Port Hedland

Prepared for LandCorp
April 2015

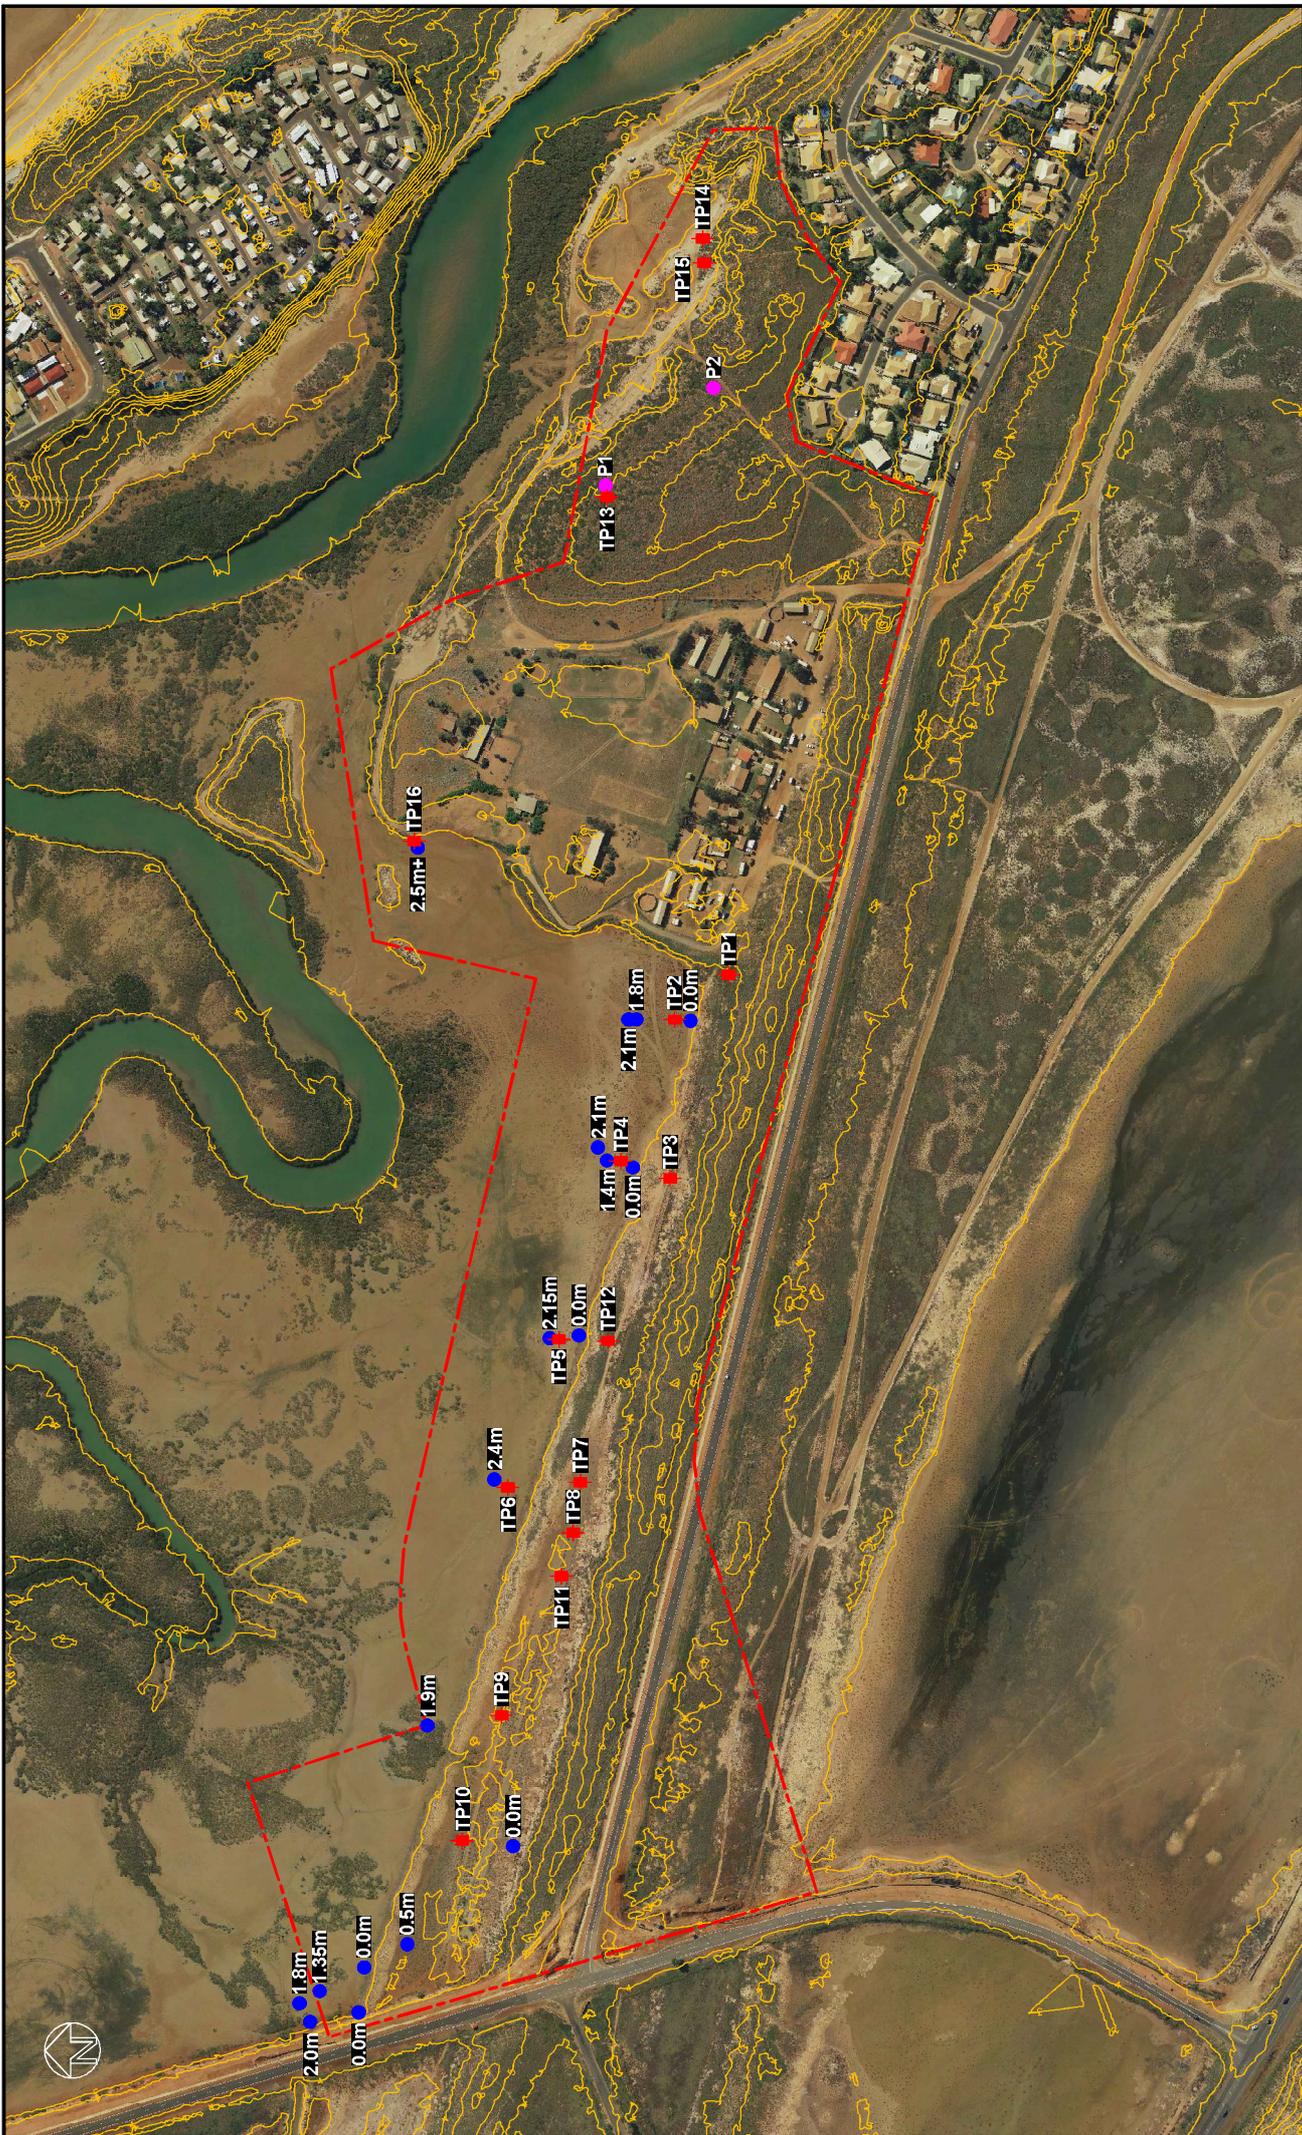
client:	JDSI CONSULTING ENGINEERS
project:	STAGE 3 - THE STABLES EAST PORT HEDLAND, WA
title:	SITE PLAN WITH TOPOGRAPHY OVERLAY PLAN
project no:	GEOTPER10160AA
fig no:	FIGURE 4
rev:

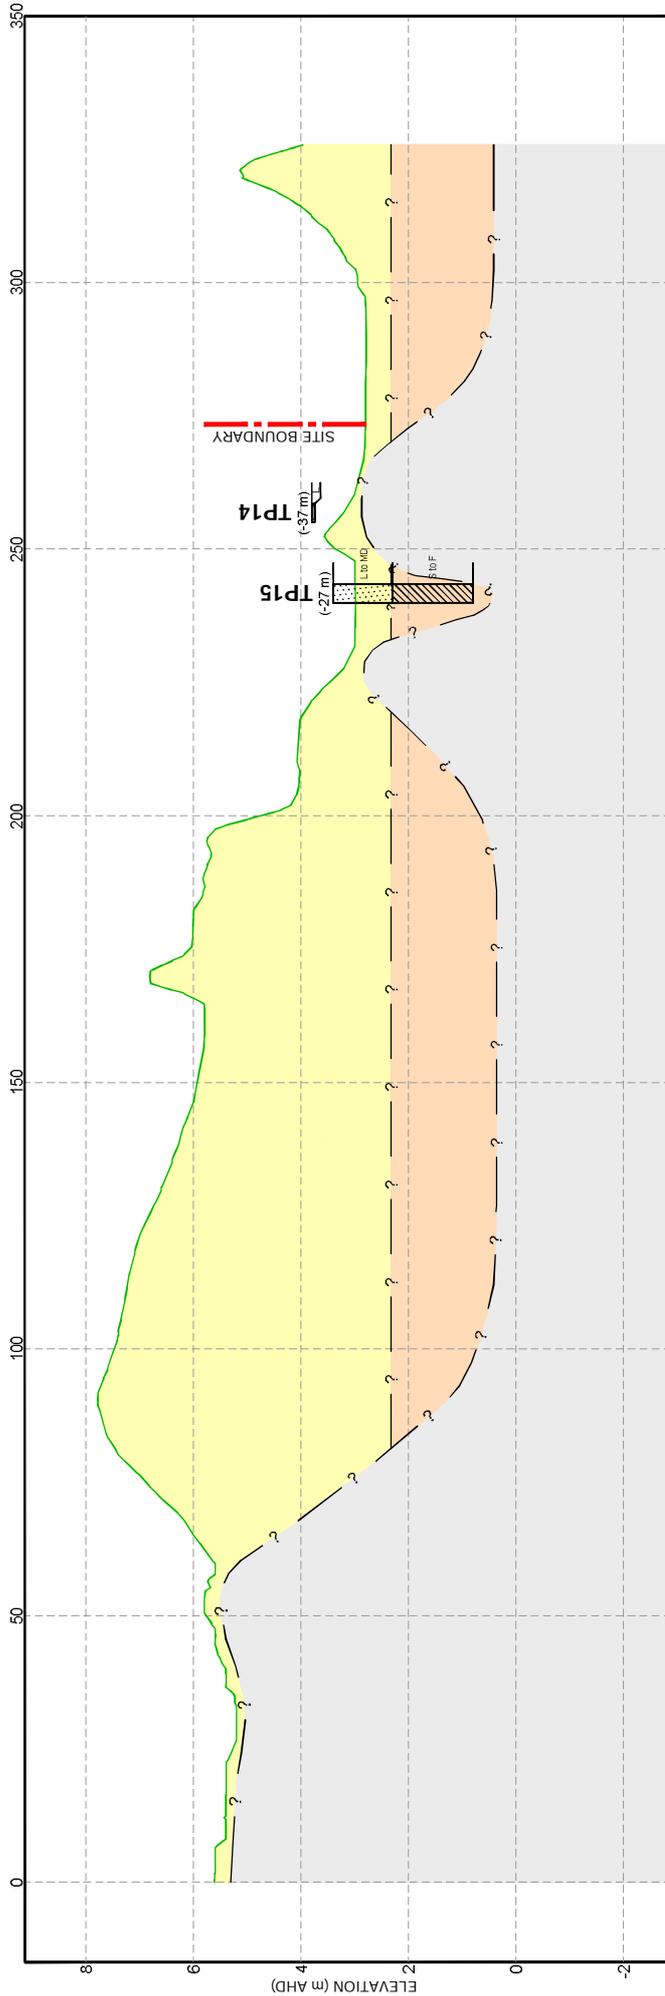
Geological boundaries are only known at the test site locations and have been inferred between the test sites. These geological boundaries have been provided to assist with the geological interpretation and should not be considered to represent actual boundaries that may vary from these lines.

- MATERIAL GRAPHIC**
- SAND
 - CLAY
- LEGEND**
- DUNE SAND
 - ESTUARINE DEPOSIT
 - LIMESTONE
 - INFERRED BOUNDARY
 - NATURAL SURFACE

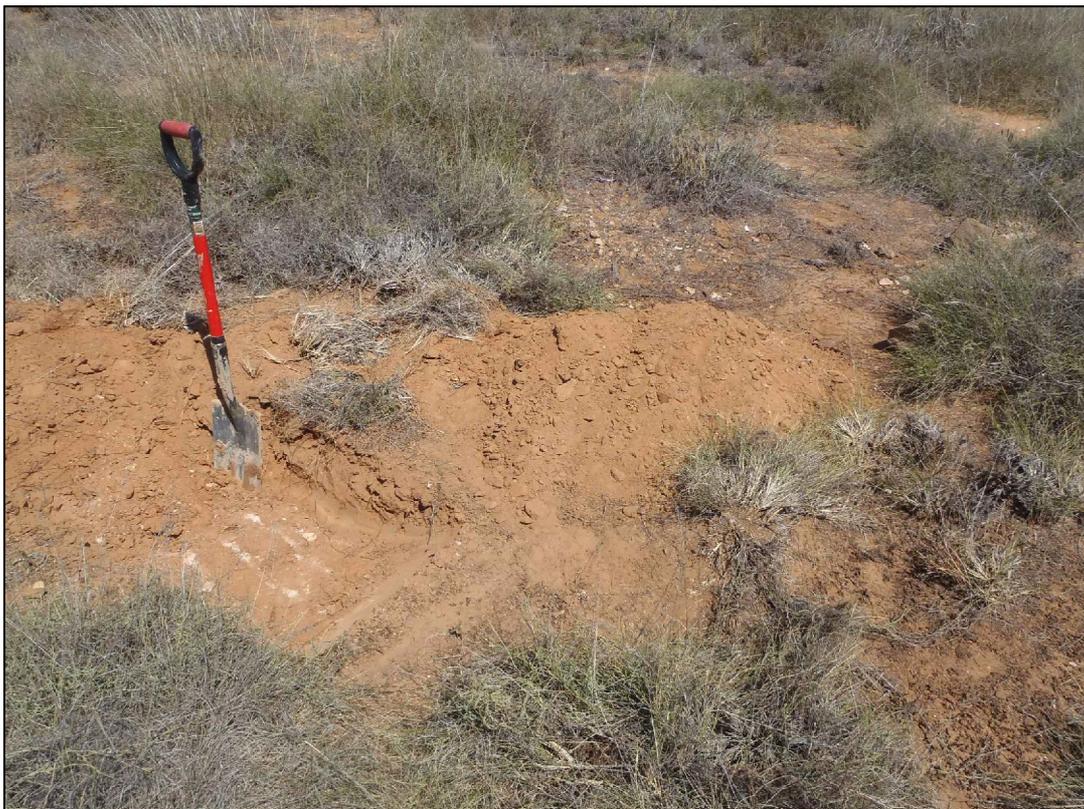
SPOIL EXCAVATED FROM TP1

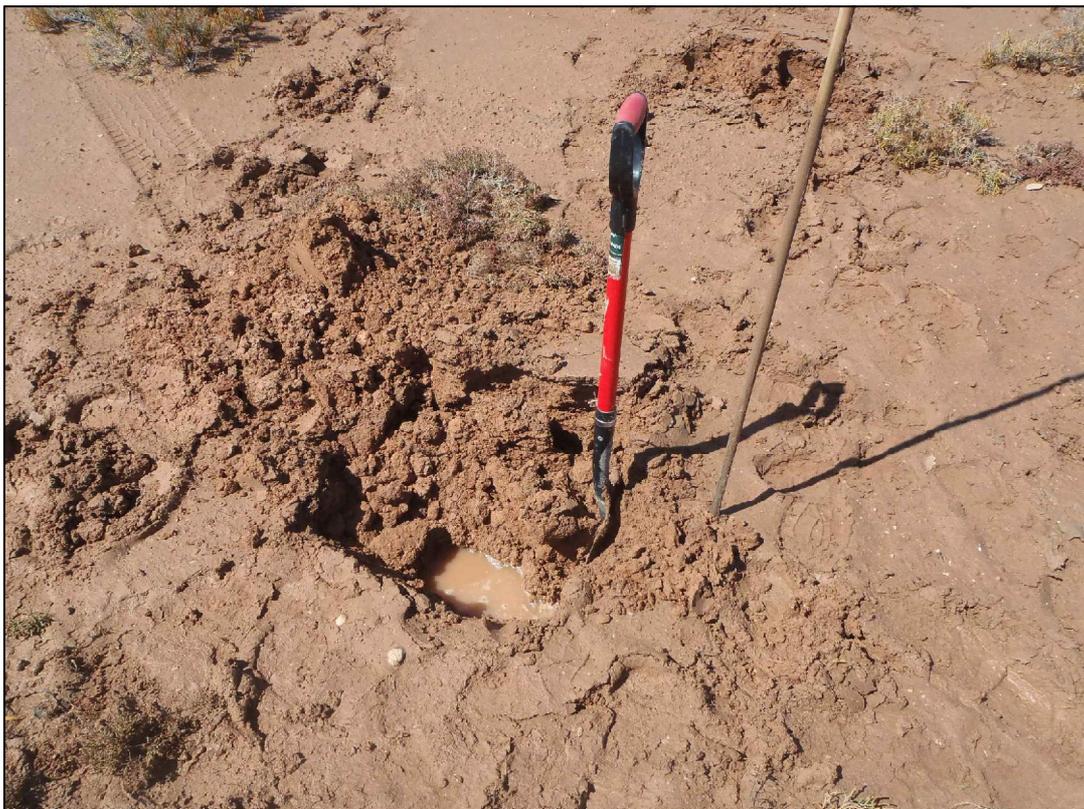
SPOIL EXCAVATED FROM TP2

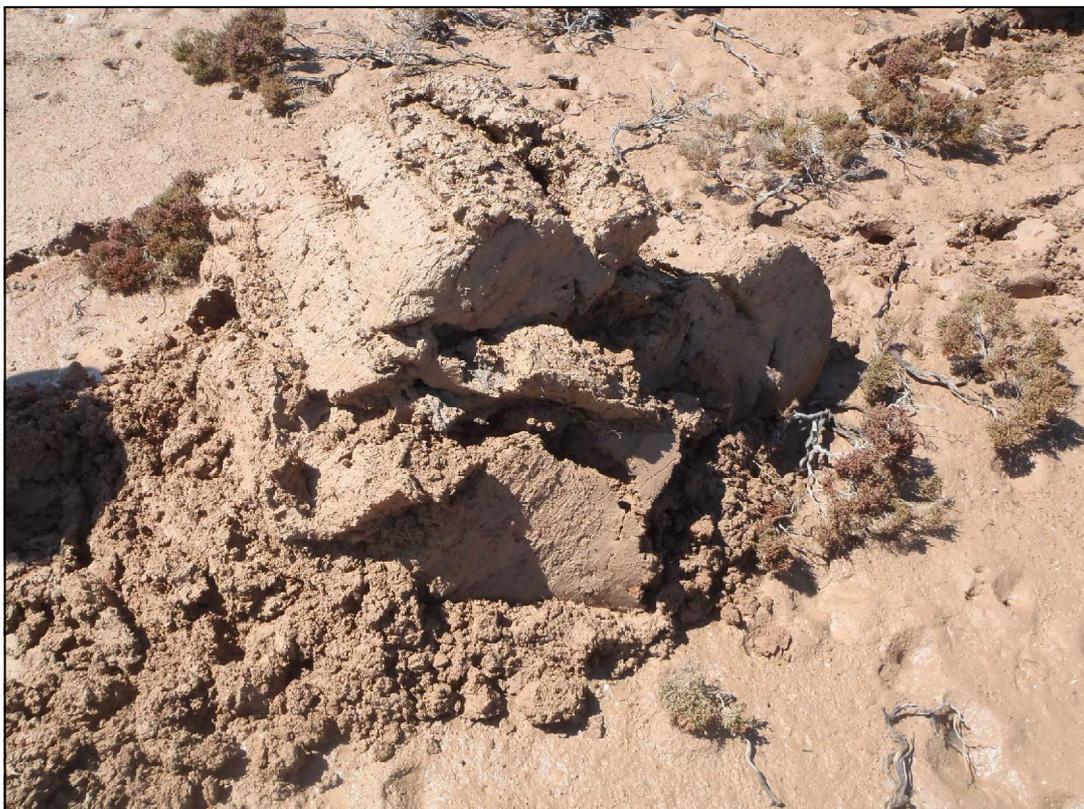
SPOIL EXCAVATED FROM TP4

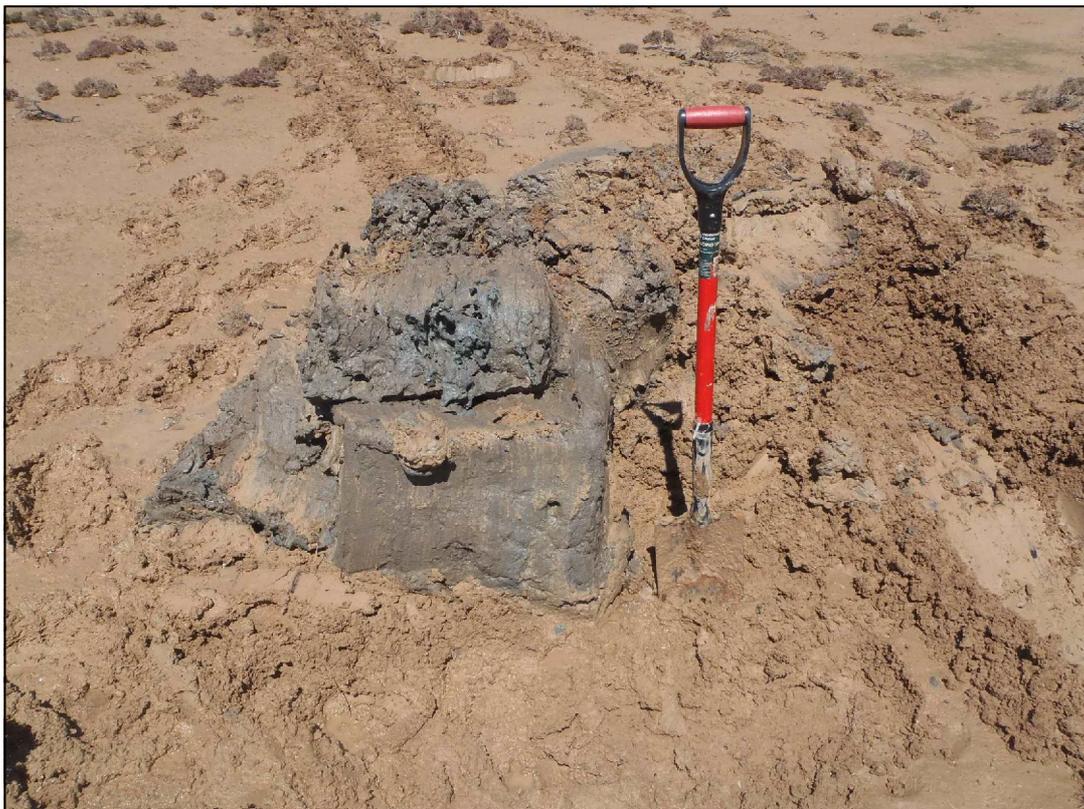
TEST PIT 5

excavation information				material substance			
method	penetration	ground water	samples & field tests	depth (m)	material description	moisture condition	consistency / relative density
VE	VI	VH	Support	RL (m)	SOIL TYPE, Plasticity or Particle Characteristic, Colour, Secondary and Minor Components		100 200 300 400
E				0.0	CLAY, low to medium plasticity, brown; trace of , shell fragments throughout	M	VS
				2.5			
				0.5			
				2.0			
				1.0	...becoming grey at 1.0m		
				1.5			
				1.5	Testpit terminated on Limestone EXCAVATION TP5 TERMINATED AT 1.50 m	W	
				1.0			
				2.0			
				0.5			
				2.5			
				0.0

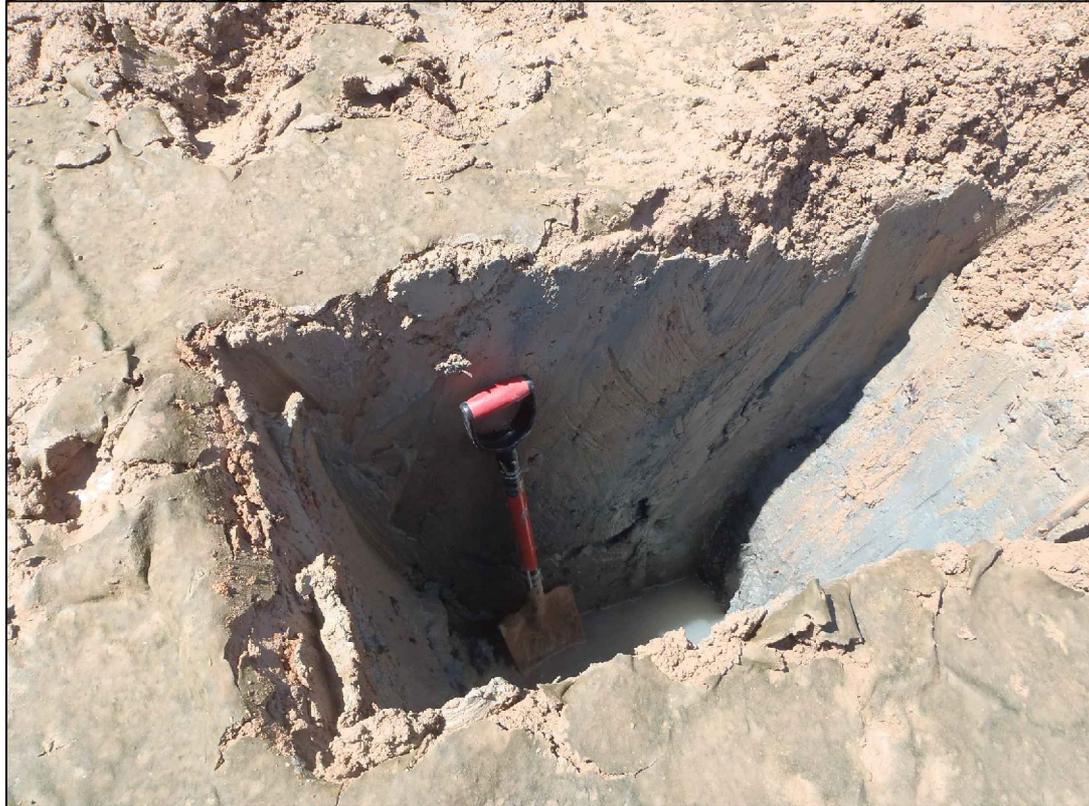
TEST PIT 6

excavation information				material substance			
method	penetration	ground water	samples & field tests	depth (m)	material description	moisture condition	consistency / relative density
VE	VI	VH	Support	RL (m)	SOIL TYPE, Plasticity or Particle Characteristic, Colour, Secondary and Minor Components		100 200 300 400
E				0.0	CLAY, low to medium plasticity, brown; trace of , shell fragments; trace of , roots (mangrove roots)	M	VS

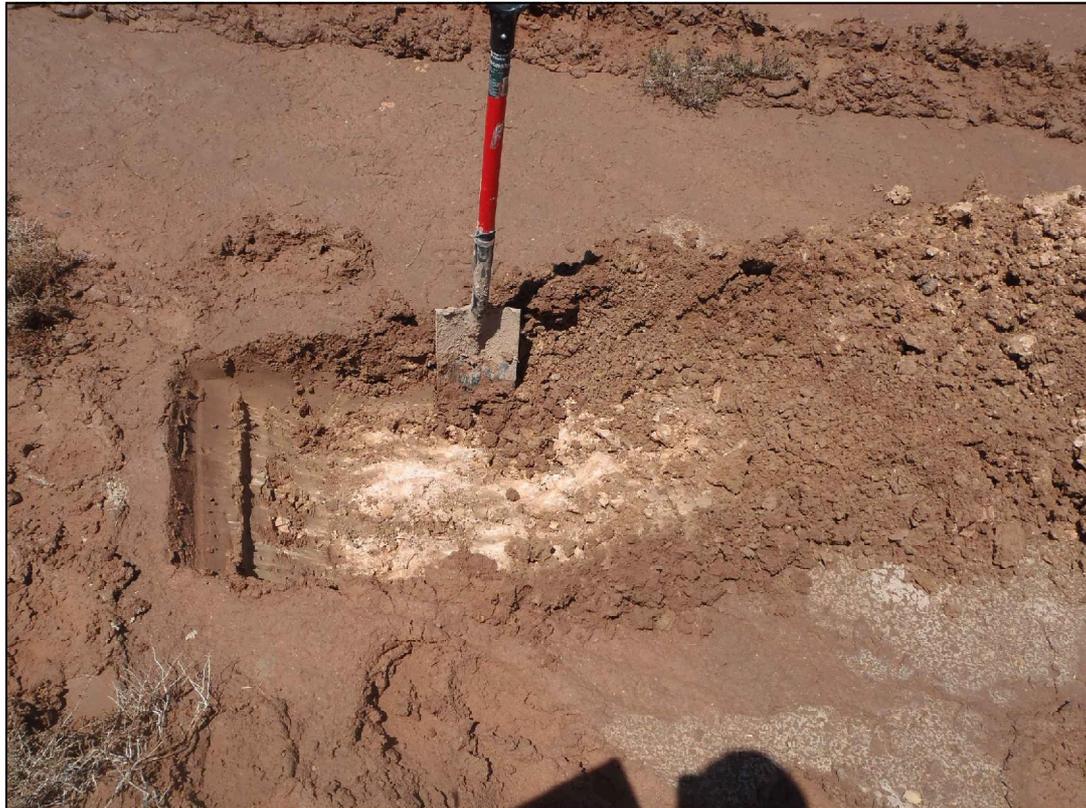
TEST PIT 7

excavation information				material substance								
method	penetration	support	ground water	samples & field tests	RL (m)	depth (m)	material description	moisture condition	consistency / relative density	hand penetrometer	Blows/150mm	structure and other observations
VE VI VII VIII IX X BH B R E	HP HP	N	Not Observed	HP = 20kPa HP = 25kPa	0.0 3.0	0.0 3.0	SANDY CLAY, medium to high plasticity, brown; sand, fine to medium grained	M	H	XX		
						0.5 2.5 1.0 2.0 1.5 2.0 1.0 2.5 0.5	Testpit terminated on Limestone EXCAVATION TP7 TERMINATED AT 0.28 m

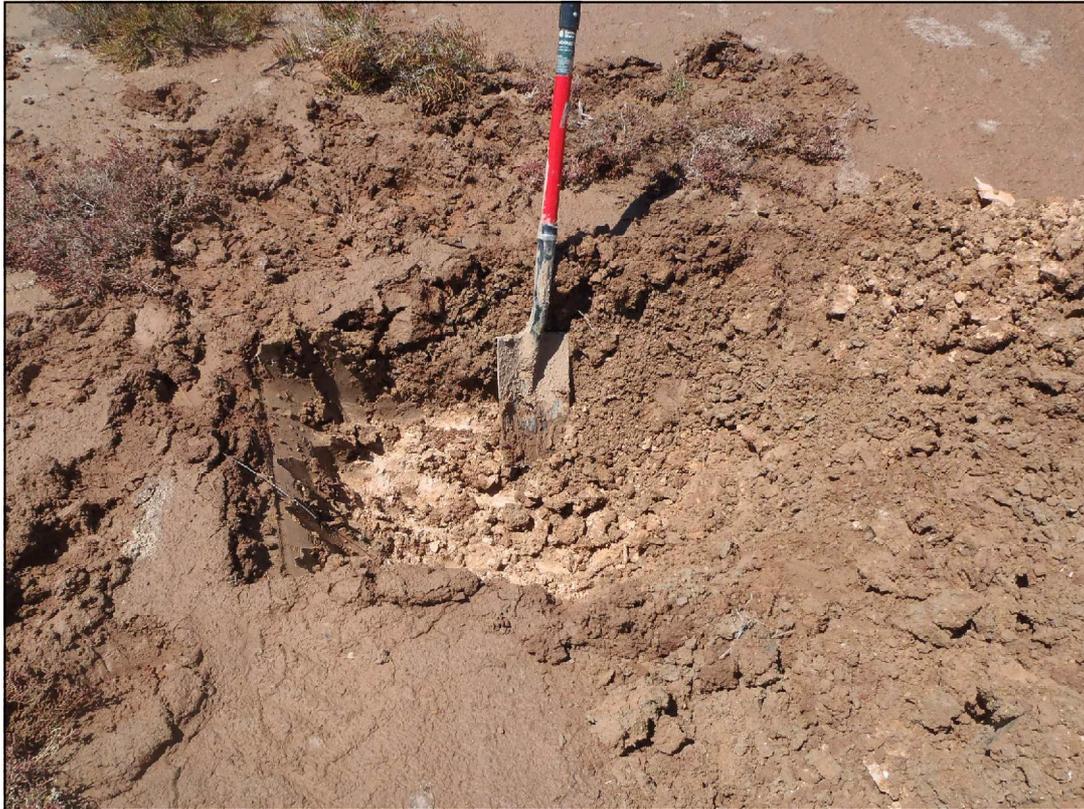
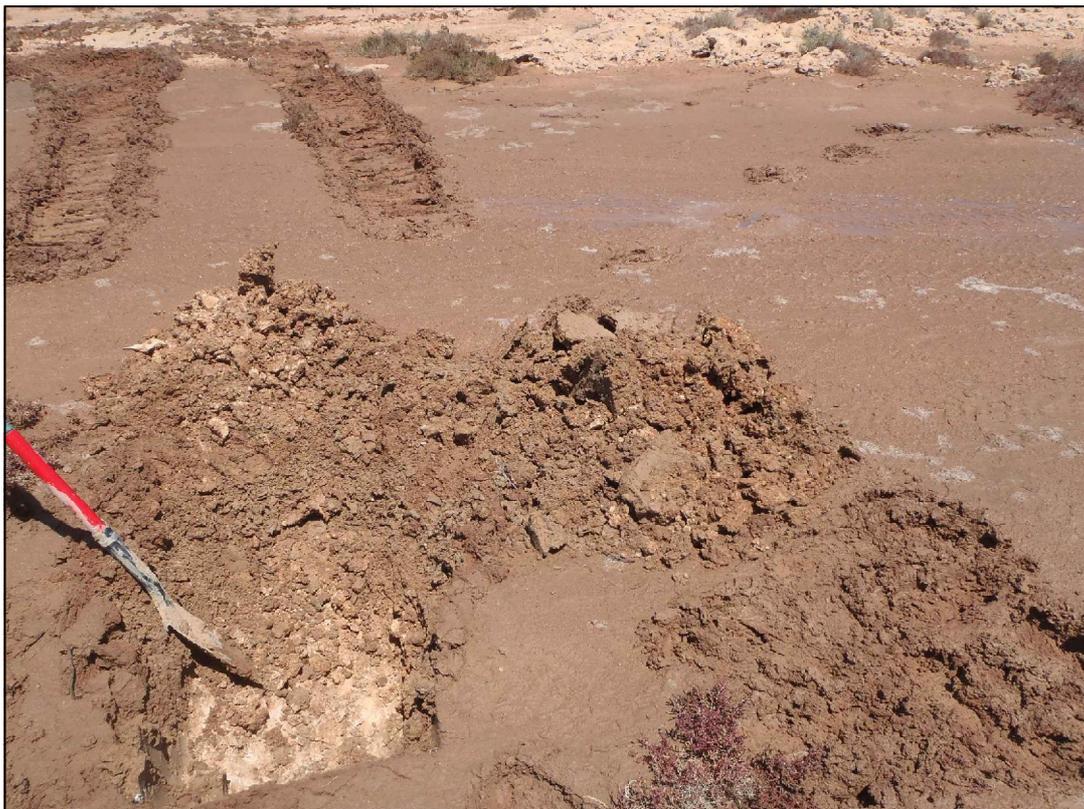
TEST PIT 8

excavation information				material substance			
method	penetration	ground water	samples & field tests	depth (m)	material description	moisture condition	consistency / relative density
VE UL LH VH			RL (m)	depth (m)	SOIL TYPE, Plasticity or Particle Characteristic, Colour, Secondary and Minor Components		hand penetrometer
							Blows/150mm
		Not Observed	HP = 250kPa HP = 300kPa	0.0 - 3.0	CLAY, medium to high plasticity, brown	M	H
				0.5	Testpit terminated on Limestone EXCAVATION TP8 TERMINATED AT 0.50 m		
				2.5			
				1.0			
				2.0			
				1.5			
				1.5			
				2.0			
				2.5			
				0.5

SPOIL EXCAVATED FROM TP8

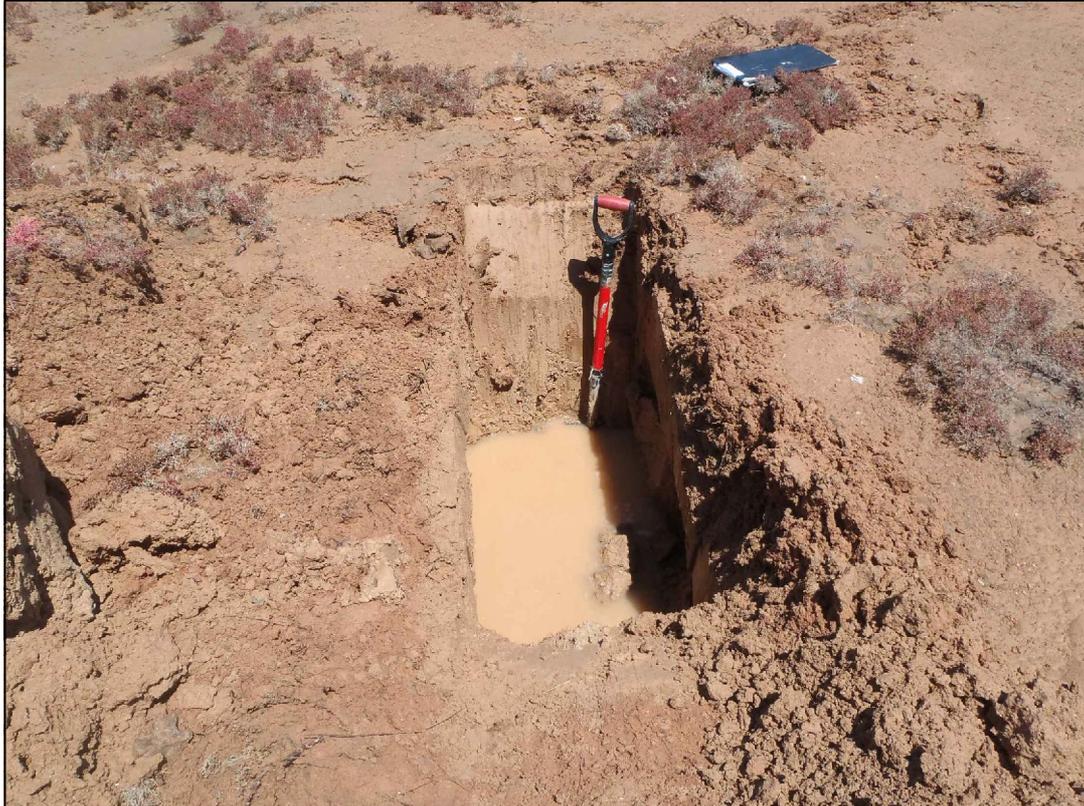
TEST PIT 9

excavation information				material substance								
method	penetration	ground water	samples & field tests	depth (m)	graphic log	classification symbol	material description	moisture condition	consistency / relative density	hand penetrometer	Blows/150mm	structure and other observations
E				0.0			SANDY CLAY, low to medium plasticity, brown; sand, fine to medium grained	M	VS			
				0.5								
				1.0								
				1.10			Testpit terminated on Limestone EXCAVATION TP9 TERMINATED AT 1.10 m					
				1.5								
				2.0								
				2.5								
				3.0

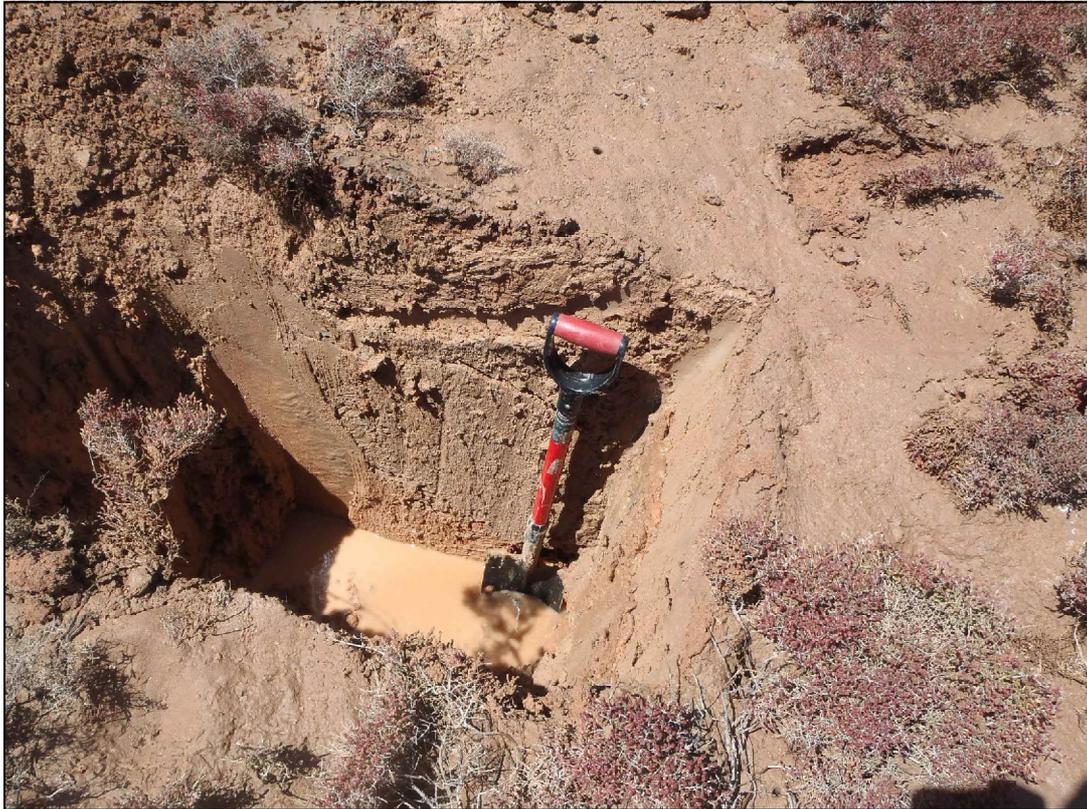
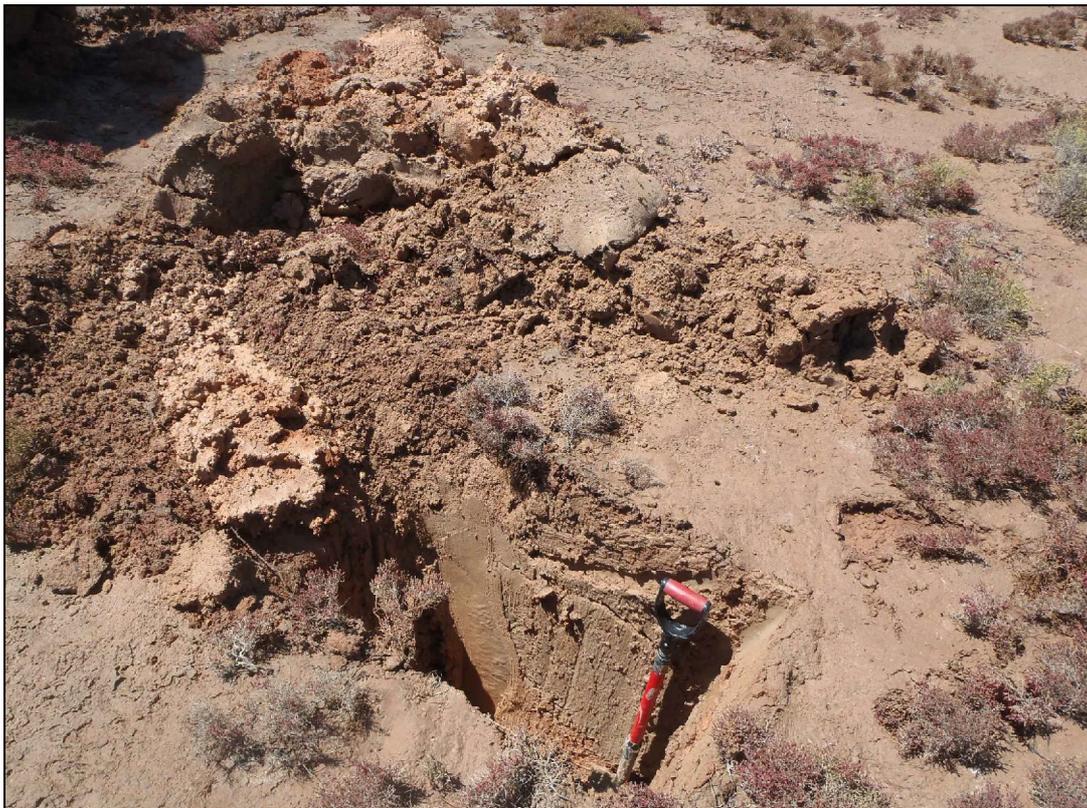
TEST PIT 10

excavation information				material substance			
method	penetration	samples & field tests	depth (m)	material description	moisture condition	consistency / relative density	structure and other observations
N Natural Exposure X Existing Excavation BH Backhoe Bucket B Bulldozer Blade R Ripper E Excavator		U50 - Undisturbed Sample 50mm diameter U63 - Undisturbed Sample 63mm diameter D - Disturbed Sample B - Bulk Disturbed Sample E - Environmental Sample MC - Moisture Content HP - Hand Penetrometer (UCS kPa) VS - Vane Shear; P-Peak, R-Remoulded (uncorrected kPa) PBT - Plate Bearing Test	3.0 2.5 2.0 1.5 1.0 0.5	SANDY CLAY, low to medium plasticity, brown; sand, fine to medium grained	M	S	
			1.5	Testpit terminated on Limestone EXCAVATION TP10 TERMINATED AT 1.20 m

SPOIL EXCAVATED FROM TP10

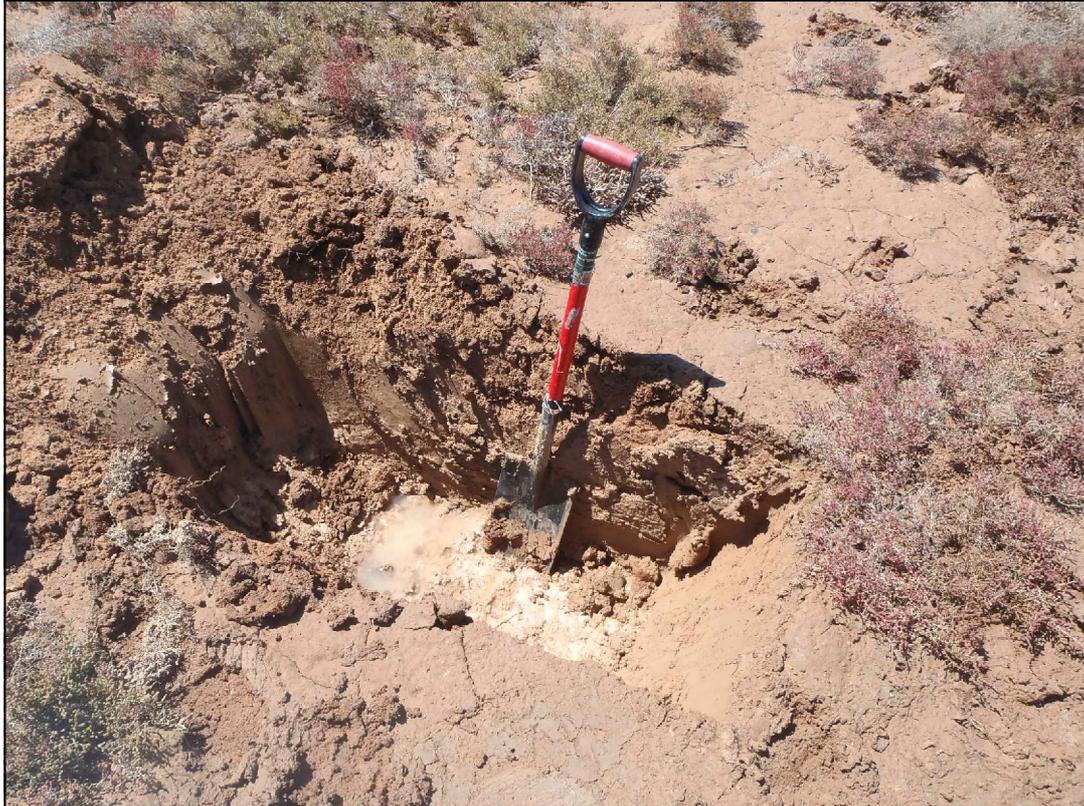
TEST PIT 11

excavation information				material substance								
method	penetration	ground water	samples & field tests	depth (m)	graphic log	classification symbol	material description	moisture condition	consistency / relative density	hand penetrometer	Blows/150mm	structure and other observations
N	VE			0.0			SANDY CLAY , medium to high plasticity, brown; sand, fine to medium grained	M	VSt			
			HP = 150kPa	0.5								
				2.5								
				1.0			Testpit terminated on Limestone EXCAVATION TP11 TERMINATED AT 0.70 m					
				2.0								
				1.5								
				1.0								
				2.0								
				2.5								
				0.5

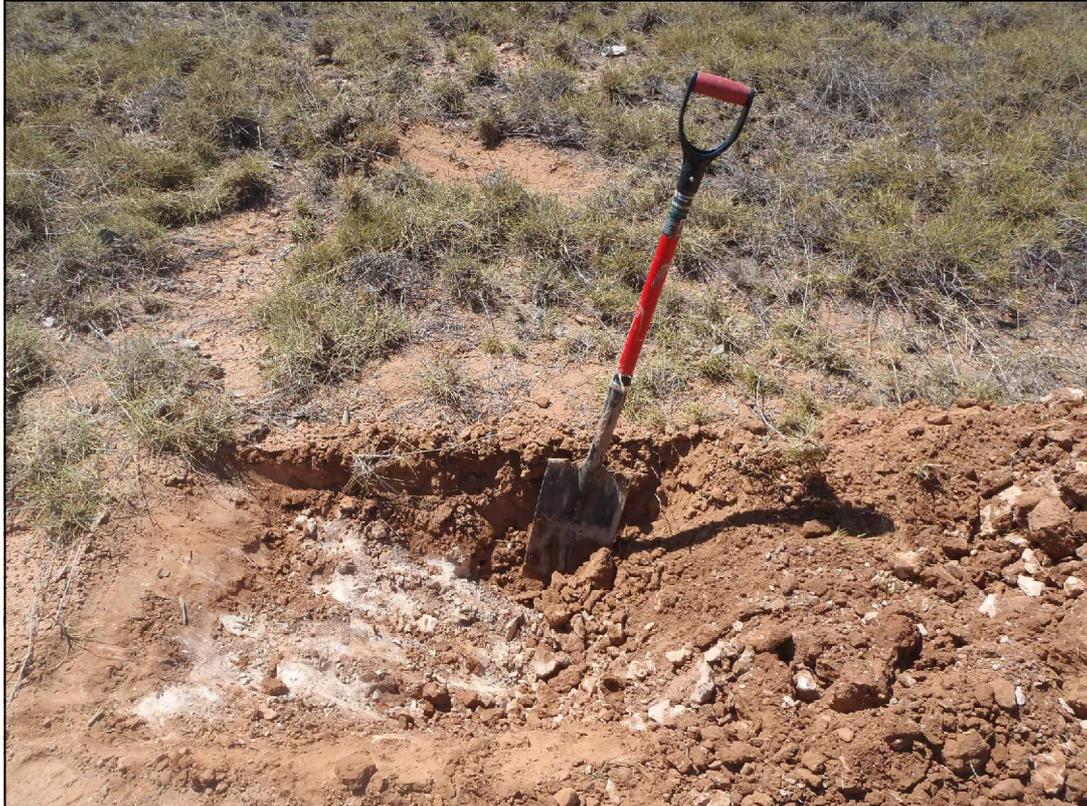
TEST PIT 12

excavation information						material substance								
method	penetration	support	ground water	samples & field tests	RL (m)	depth (m)	graphic log	classification symbol	material description	moisture condition	consistency / relative density	hand penetrometer	Blows/150mm	structure and other observations
N			Not Observed	HP -350kPa	3.5	0.0			CLAY, medium to high plasticity, brown	D	H			
					3.0	0.5			Testpit terminated on Limestone EXCAVATION TP12 TERMINATED AT 0.10 m					
					2.5	1.0								
					2.0	1.5								
					1.5	2.0								
					1.0	2.5

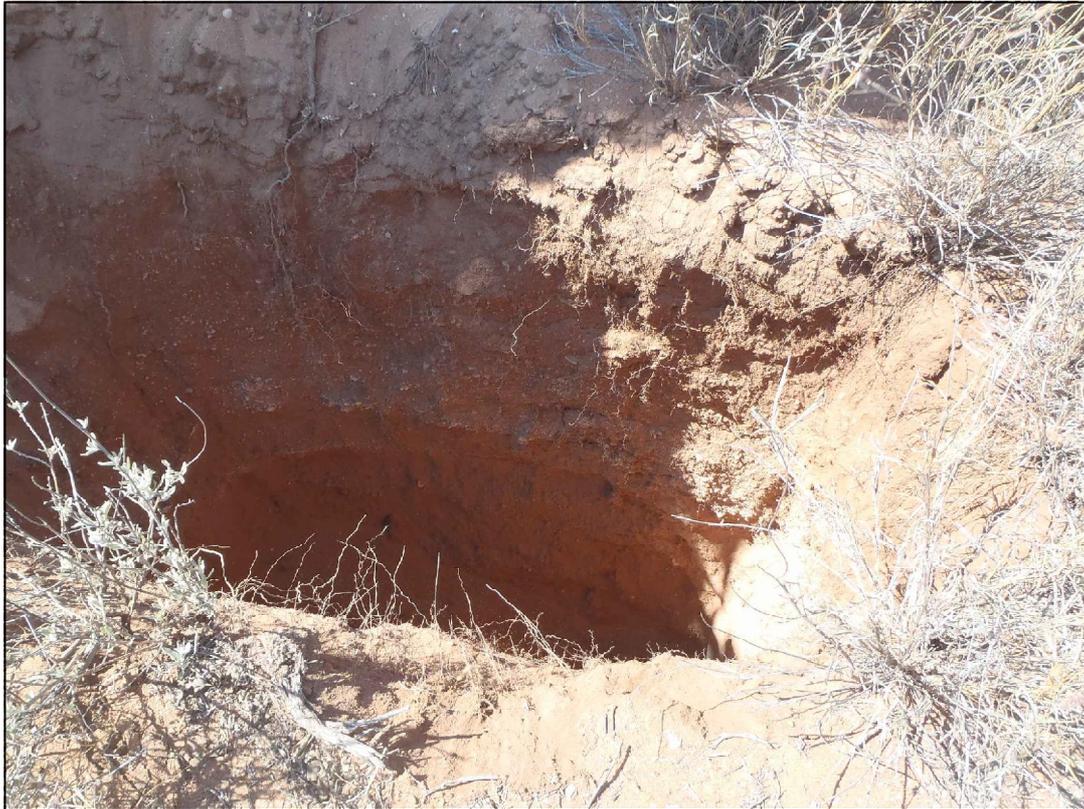
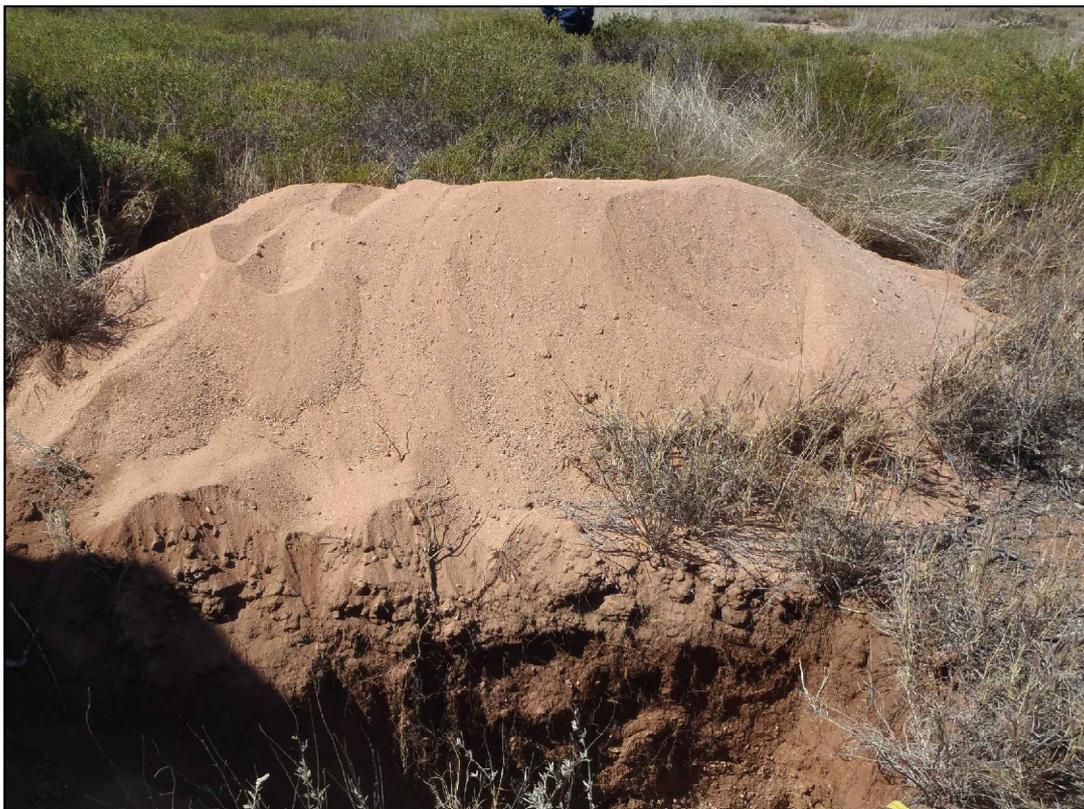
TEST PIT 13

excavation information				material substance			
method	penetration	ground water	samples & field tests	depth (m)	material description	moisture condition	consistency / relative density
VE	VI	VH	Support	RL (m)	SOIL TYPE, Plasticity or Particle Characteristic, Colour, Secondary and Minor Components		100 200 300 400 kPa
N				0.0	SAND, fine to coarse, pale brown; trace of , silt; trace of , shell and shell fragments; trace of roots to 2.0m	D	L to MD
X				6.0			
BH				0.5			
B				5.5			
R				1.0			
E				5.0			
				1.5			
				4.5			
				2.0			
				4.0			
				2.5	EXCAVATION TP13 TERMINATED AT 2.50 m		
				3.5

SPOIL EXCAVATED FROM TP13

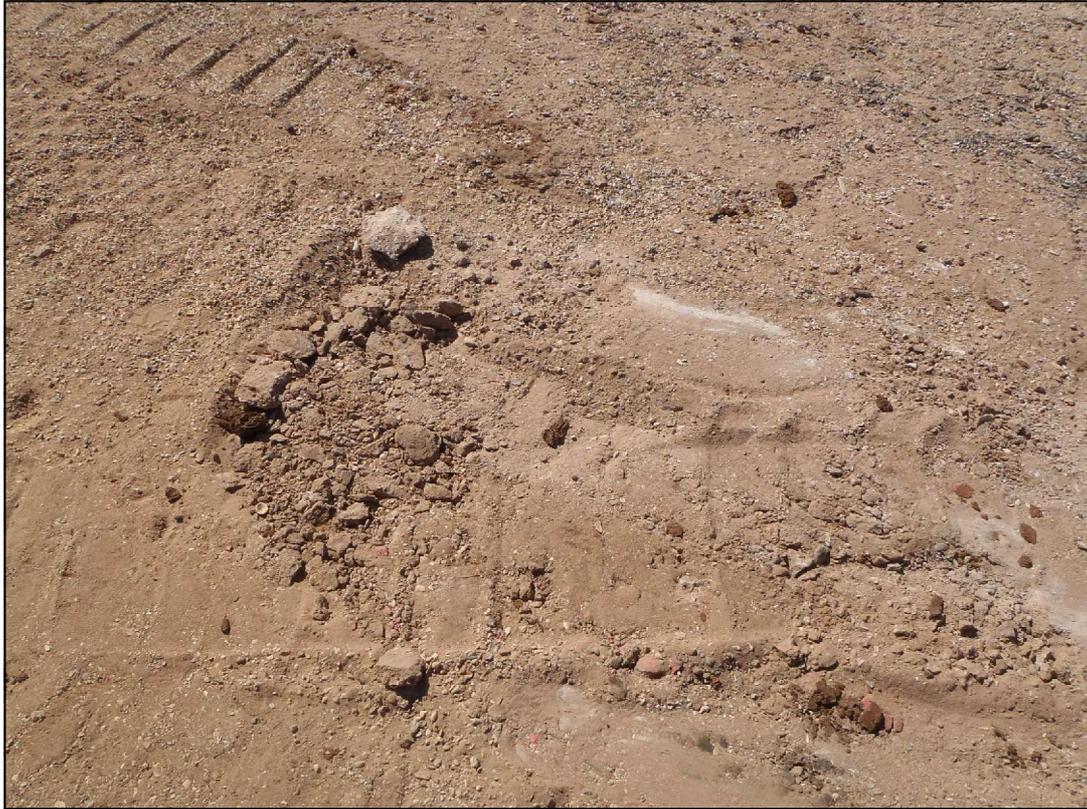
TEST PIT 14

excavation information						material substance								
method	penetration	support	ground water	samples & field tests	RL (m)	depth (m)	graphic log	classification symbol	material description	moisture condition	consistency / relative density	hand penetrometer	Blows/150mm	structure and other observations
E	VE	N	Not Observed		3.8	0.0			SAND, fine to coarse, pale brown; with some, fine to medium sub rounded to sub angular gravels	D	L			
					3.5	0.5			Testpit terminated on Limestone EXCAVATION TP14 TERMINATED AT 0.05 m					
					3.0	1.0								
					2.5	1.5								
					2.0	2.0								
					1.5	2.5								
					1.0	3.0

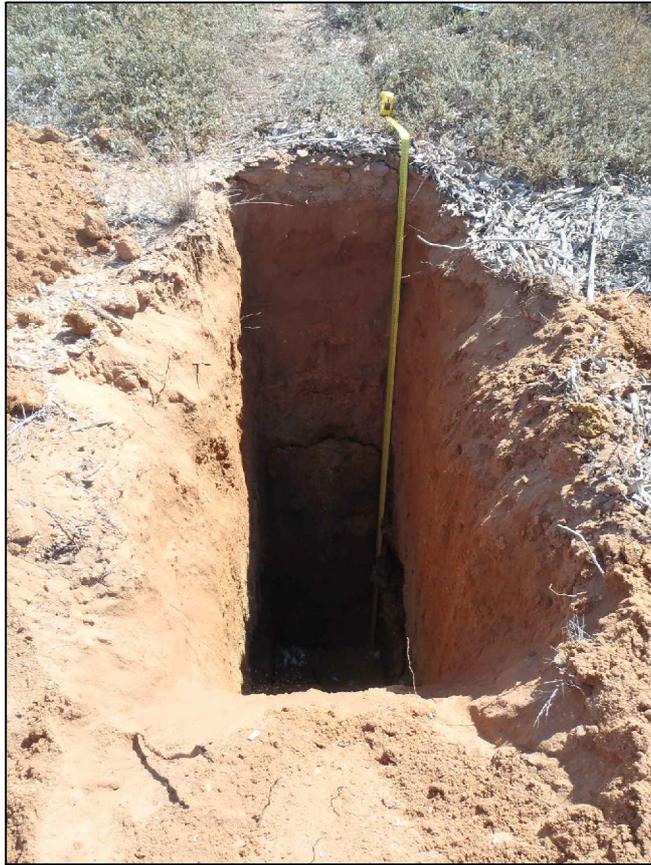
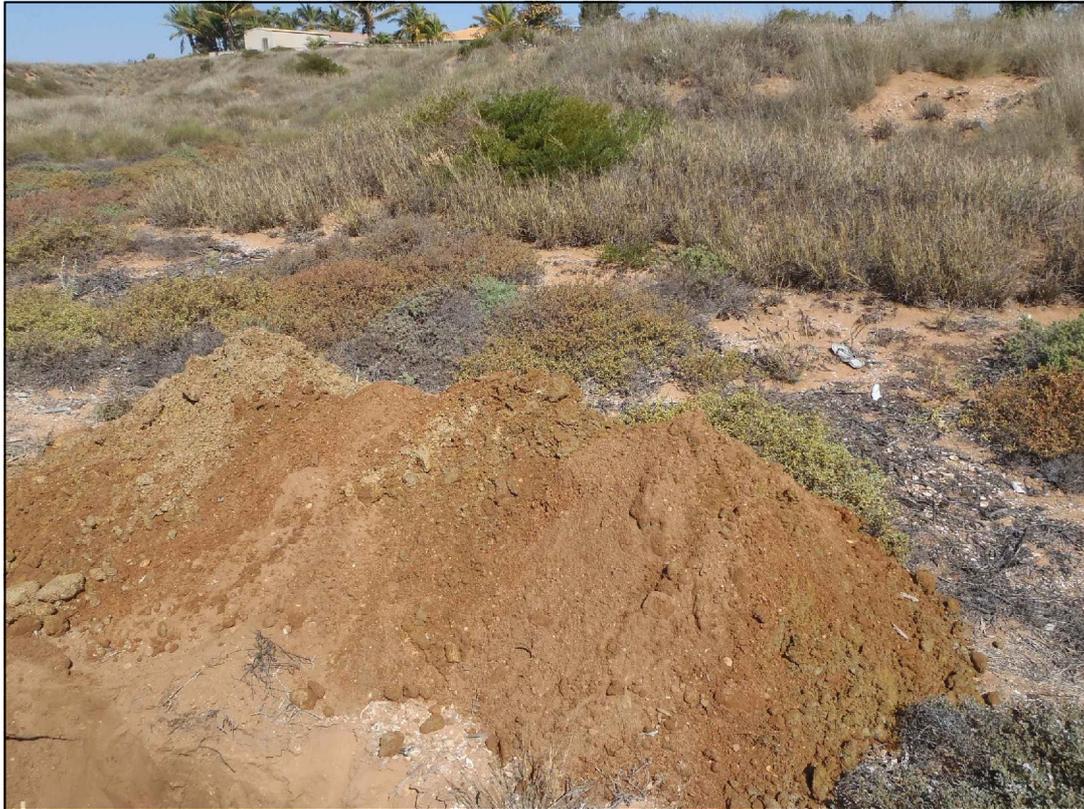
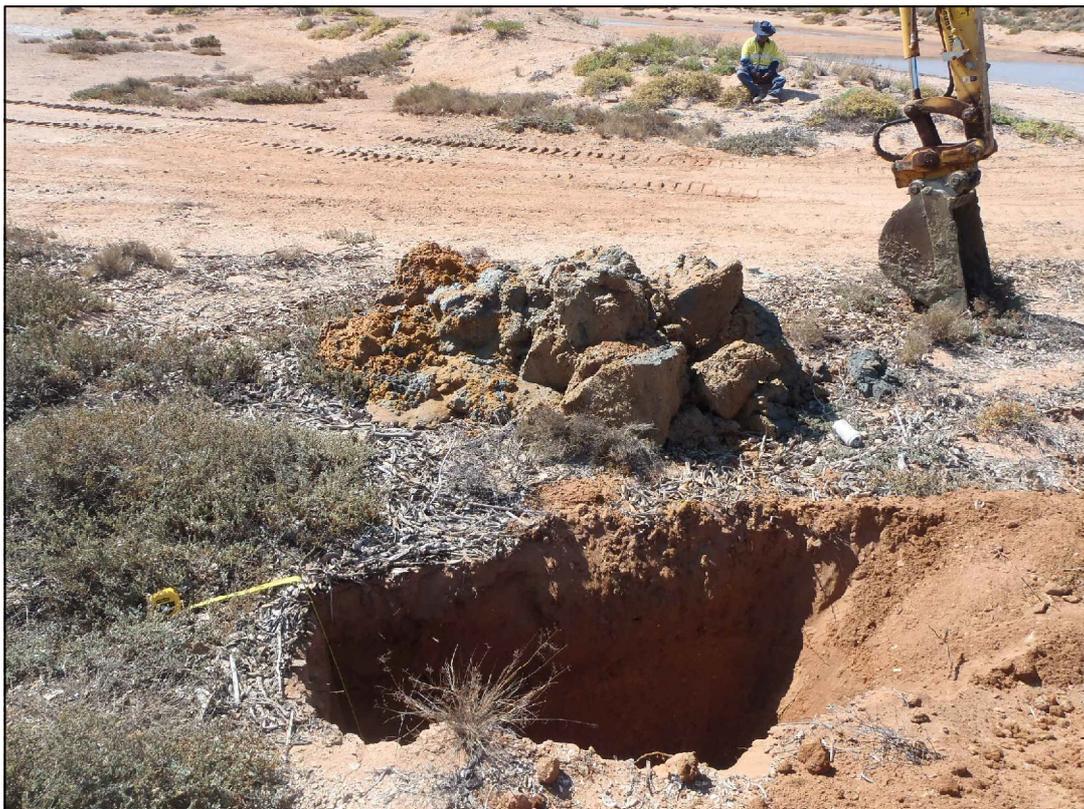
TEST PIT 15

excavation information				material substance			
method	penetration	ground water	samples & field tests	depth (m)	material description	moisture condition	consistency / relative density
VE	VI	VH	RL (m)	depth (m)	SOIL TYPE, Plasticity or Particle Characteristic, Colour, Secondary and Minor Components		100 200 300 400 kPa
N				0.0	SAND, fine to coarse, pale brown; trace of, sub rounded fine to medium gravels; trace of, shell and shell fragments	D	L to MD
X				0.5		M	
BH				1.0	SANDY CLAY, low plasticity, grey and green grey; sand, fine frained		S to F
B				1.5			
R				2.0			
E				2.5			
				2.6	EXCAVATION TP15 TERMINATED AT 2.60 m

SPOIL EXCAVATED FROM TP15
