Local Water Management Strategy

Stage 3 (The Stables)
East Port Hedland

Prepared for LandCorp
April 2015

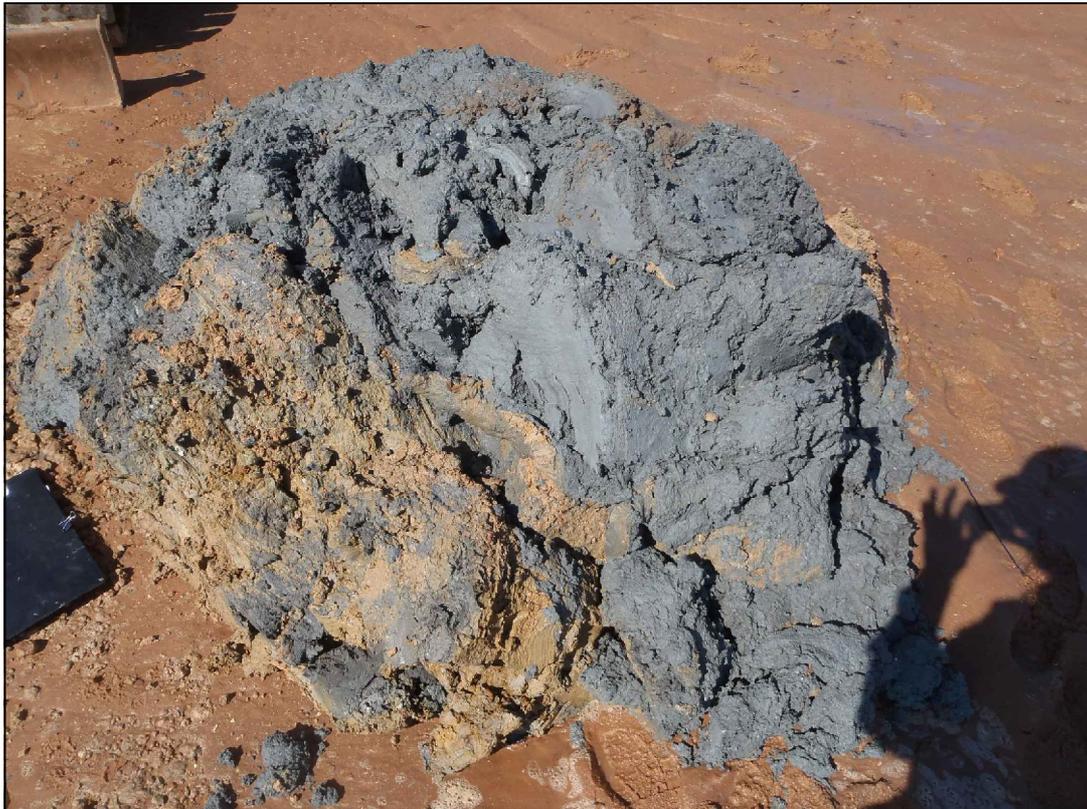
SPOIL EXCAVATED FROM TP16

excavation information				material substance						
method	penetration	ground water	samples & field tests	depth (m)	material description	moisture condition	consistency / relative density	hand penetrometer	Blows/150mm	structure and other observations
VE	VE	N		0.0	SOIL TYPE, Plasticity or Particle Characteristic, Colour, Secondary and Minor Components	M	S to F	100		
				0.0	CLAY, low to medium plasticity, brown					
				2.5						
				0.5	SANDY CLAY, low to medium plasticity, grey; sand, fine to medium grained					
				2.0						
				1.0						
				1.5						
				1.5						
				2.0						
				2.0	EXCAVATION TP16 TERMINATED AT 2.00 m	W				
				0.5						
				2.5						
				0.0

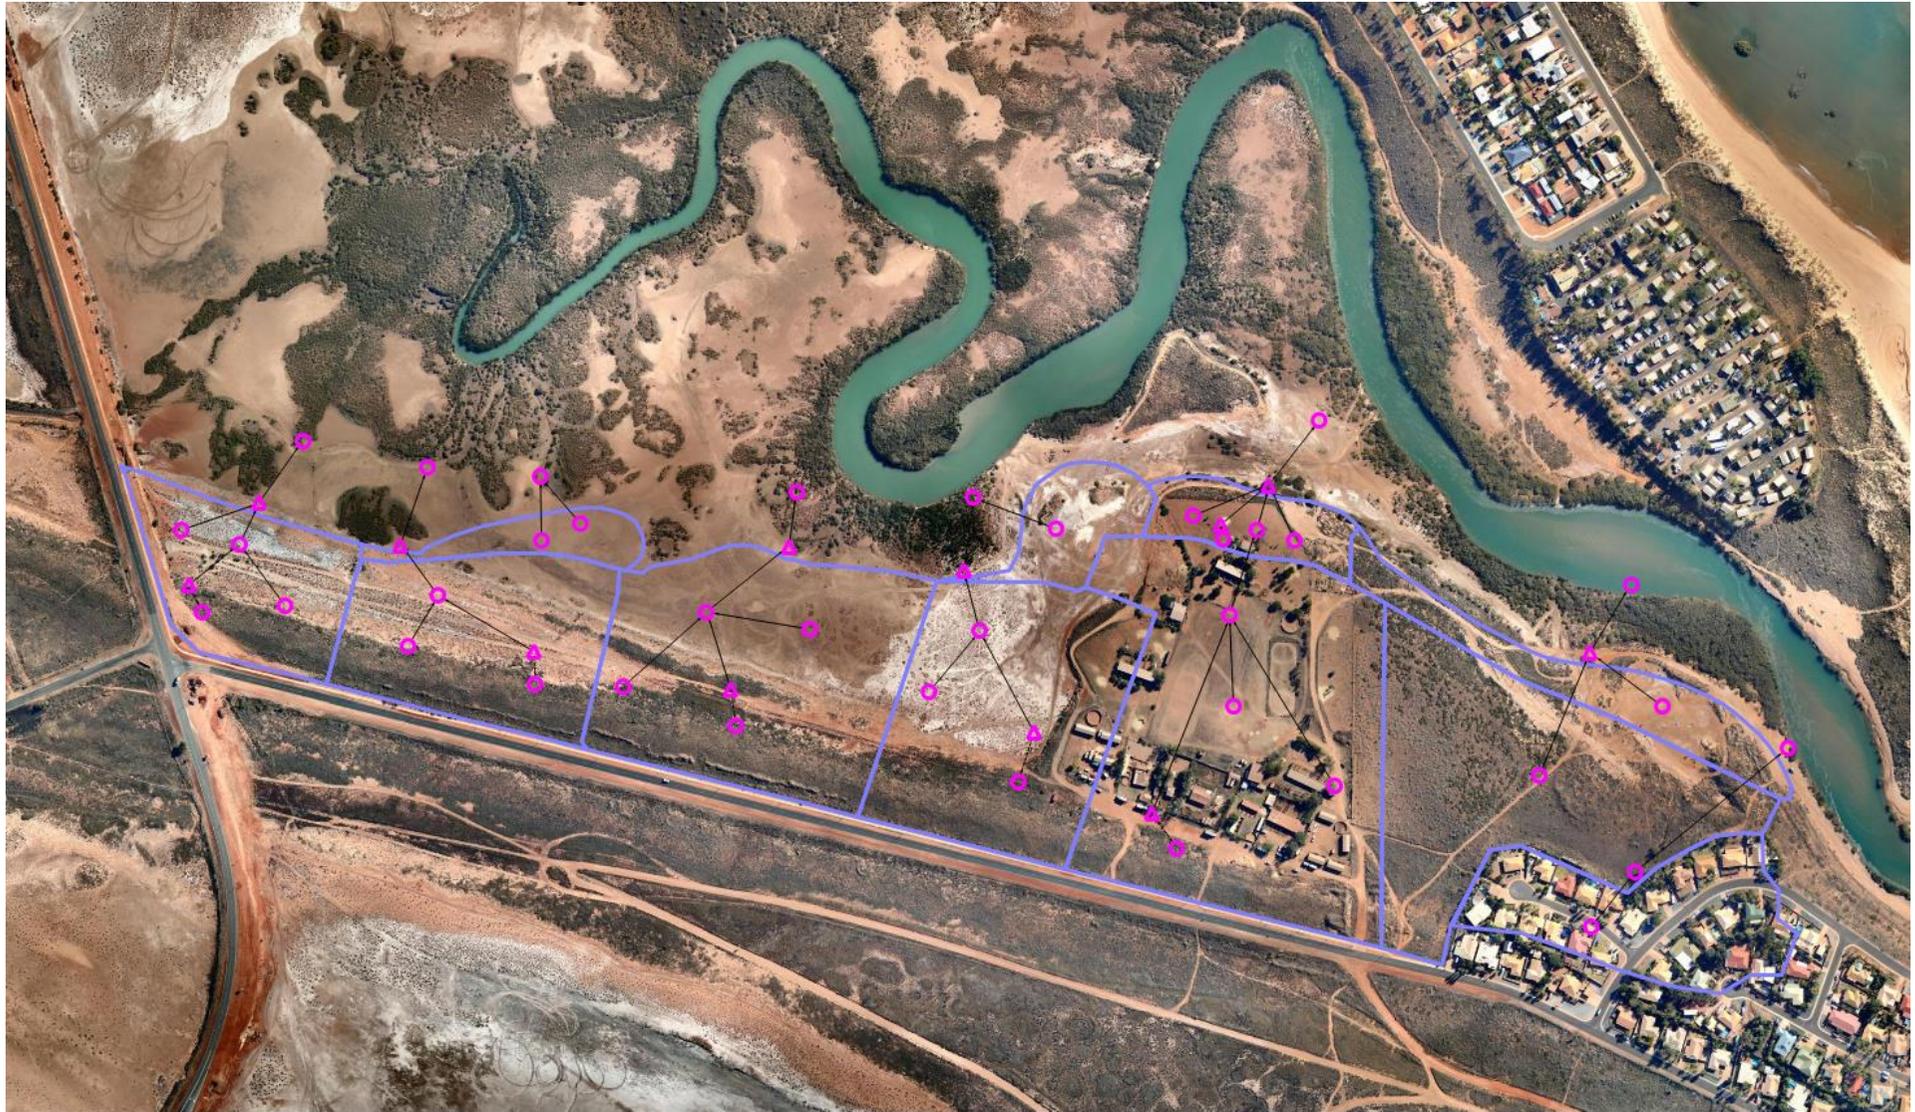
Figure C1 XPSWMM Model Nodes and Links for Conceptual Development Option 1

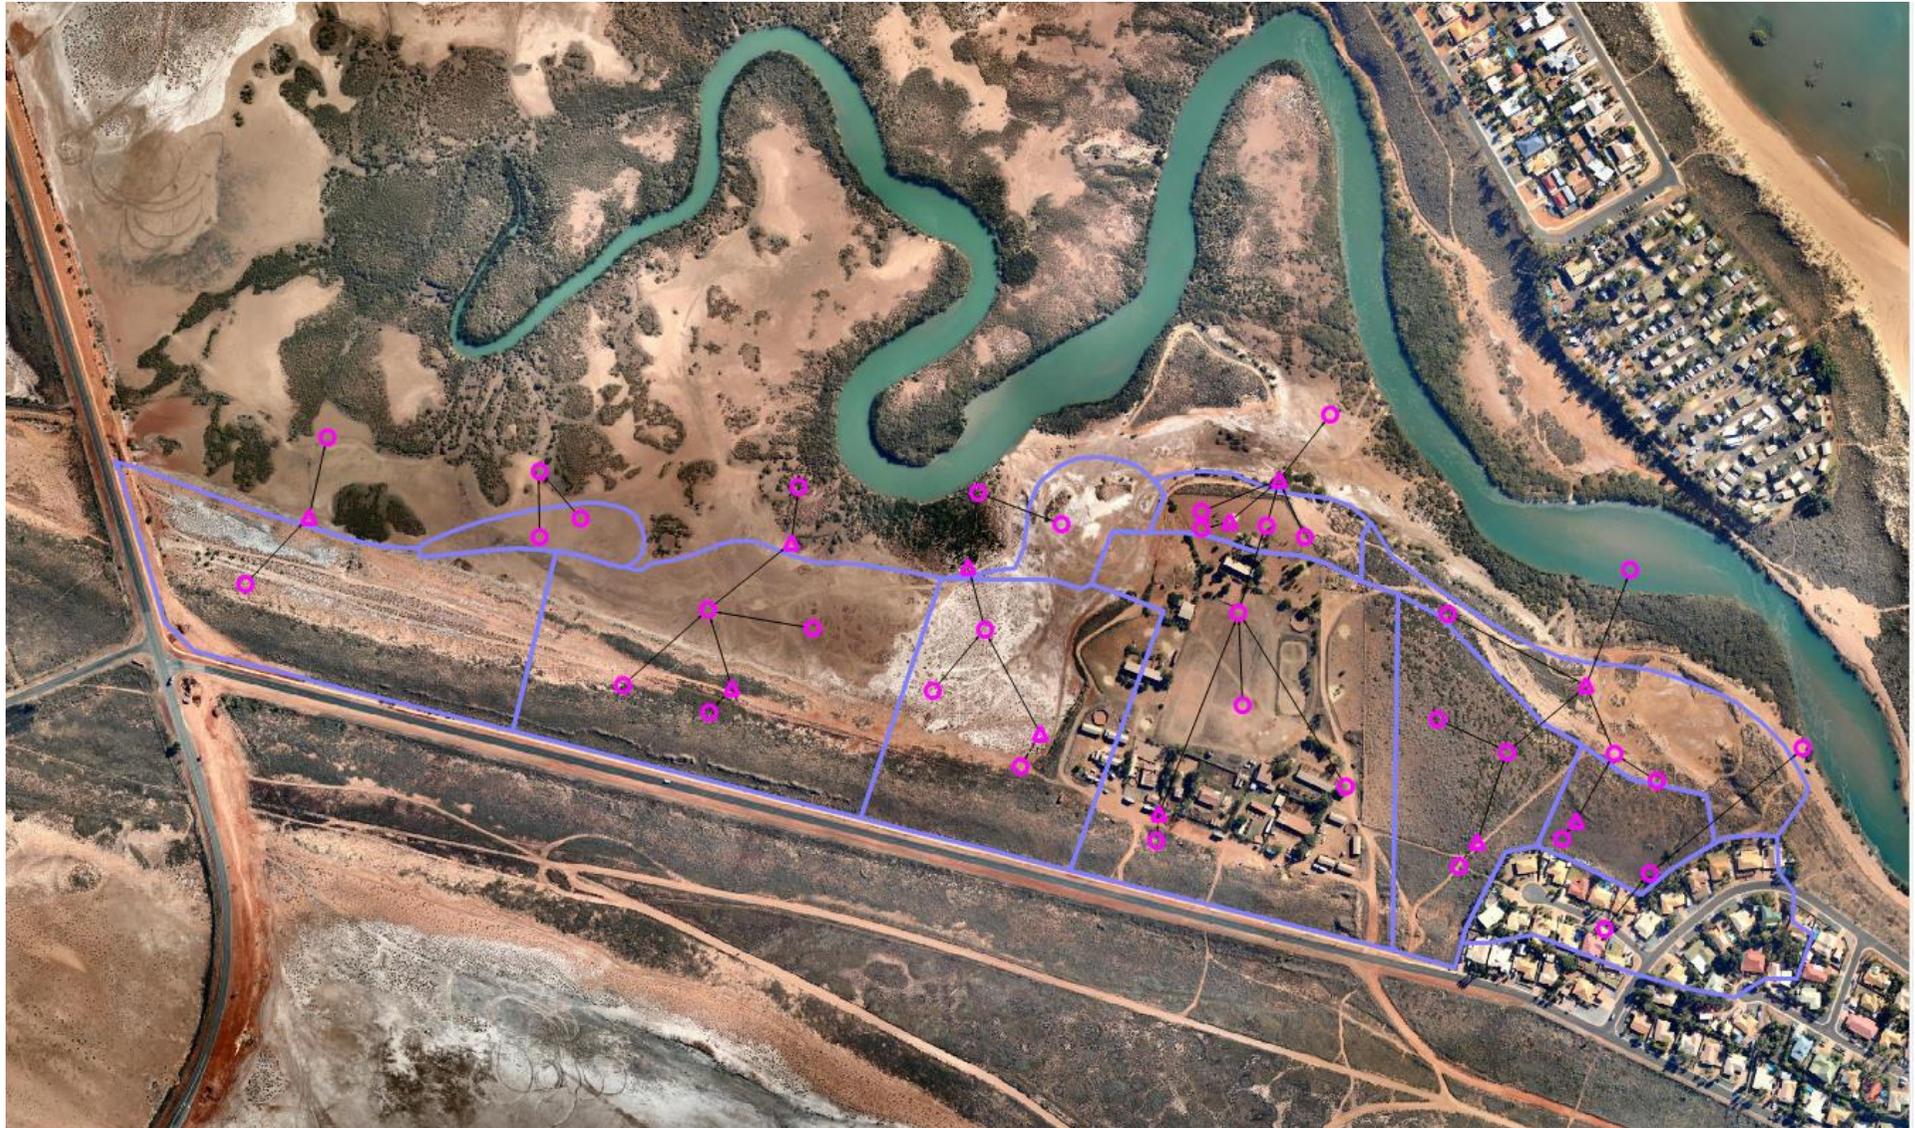
Figure C2 XPSWMM Model Nodes and Links for Conceptual Development Option 2
