Site Conditions and Constraints

LOT 555 MURDOCH DR
STRUCTURE PLAN

P14005

Prepared for
Department of Housing

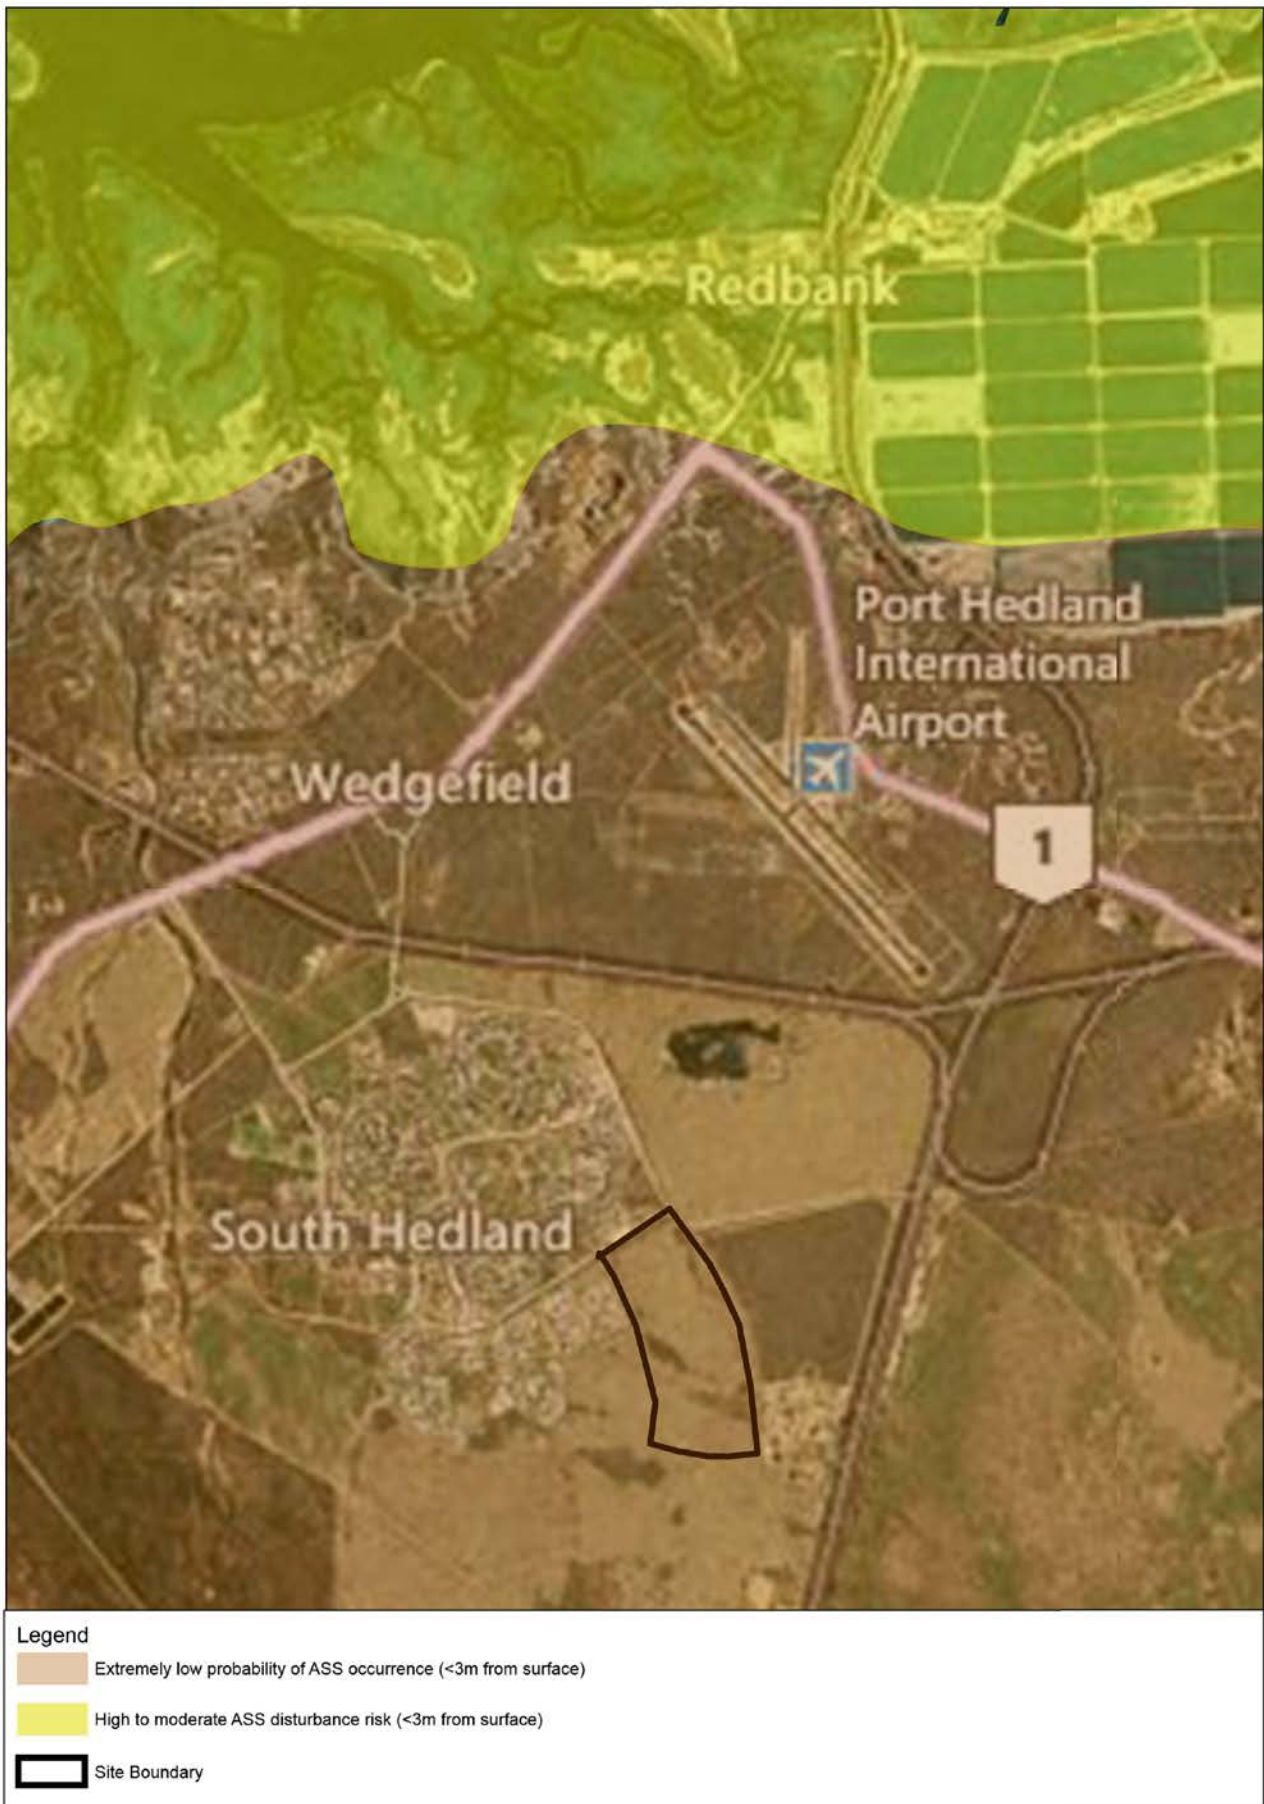
Figure 1-1 ASS Risk Map

The Landgate WA Atlas provides broad-scale risk maps for several coastal regions of WA. The ASS map showed that there is an extremely low probability of ASS occurrence has been identified. Figure 1-1 shows

the ASS mapping for the surrounding area of the site, confirming that the site is not within an area of ASS. The mapping database indicates that the nearest mapped area to the site is 5.3km to the north, and is classified '*high risk to moderate of ASS occurring within three metres of the natural soil surface*'. The regional ASS risk map is presented in Figure 1-1.

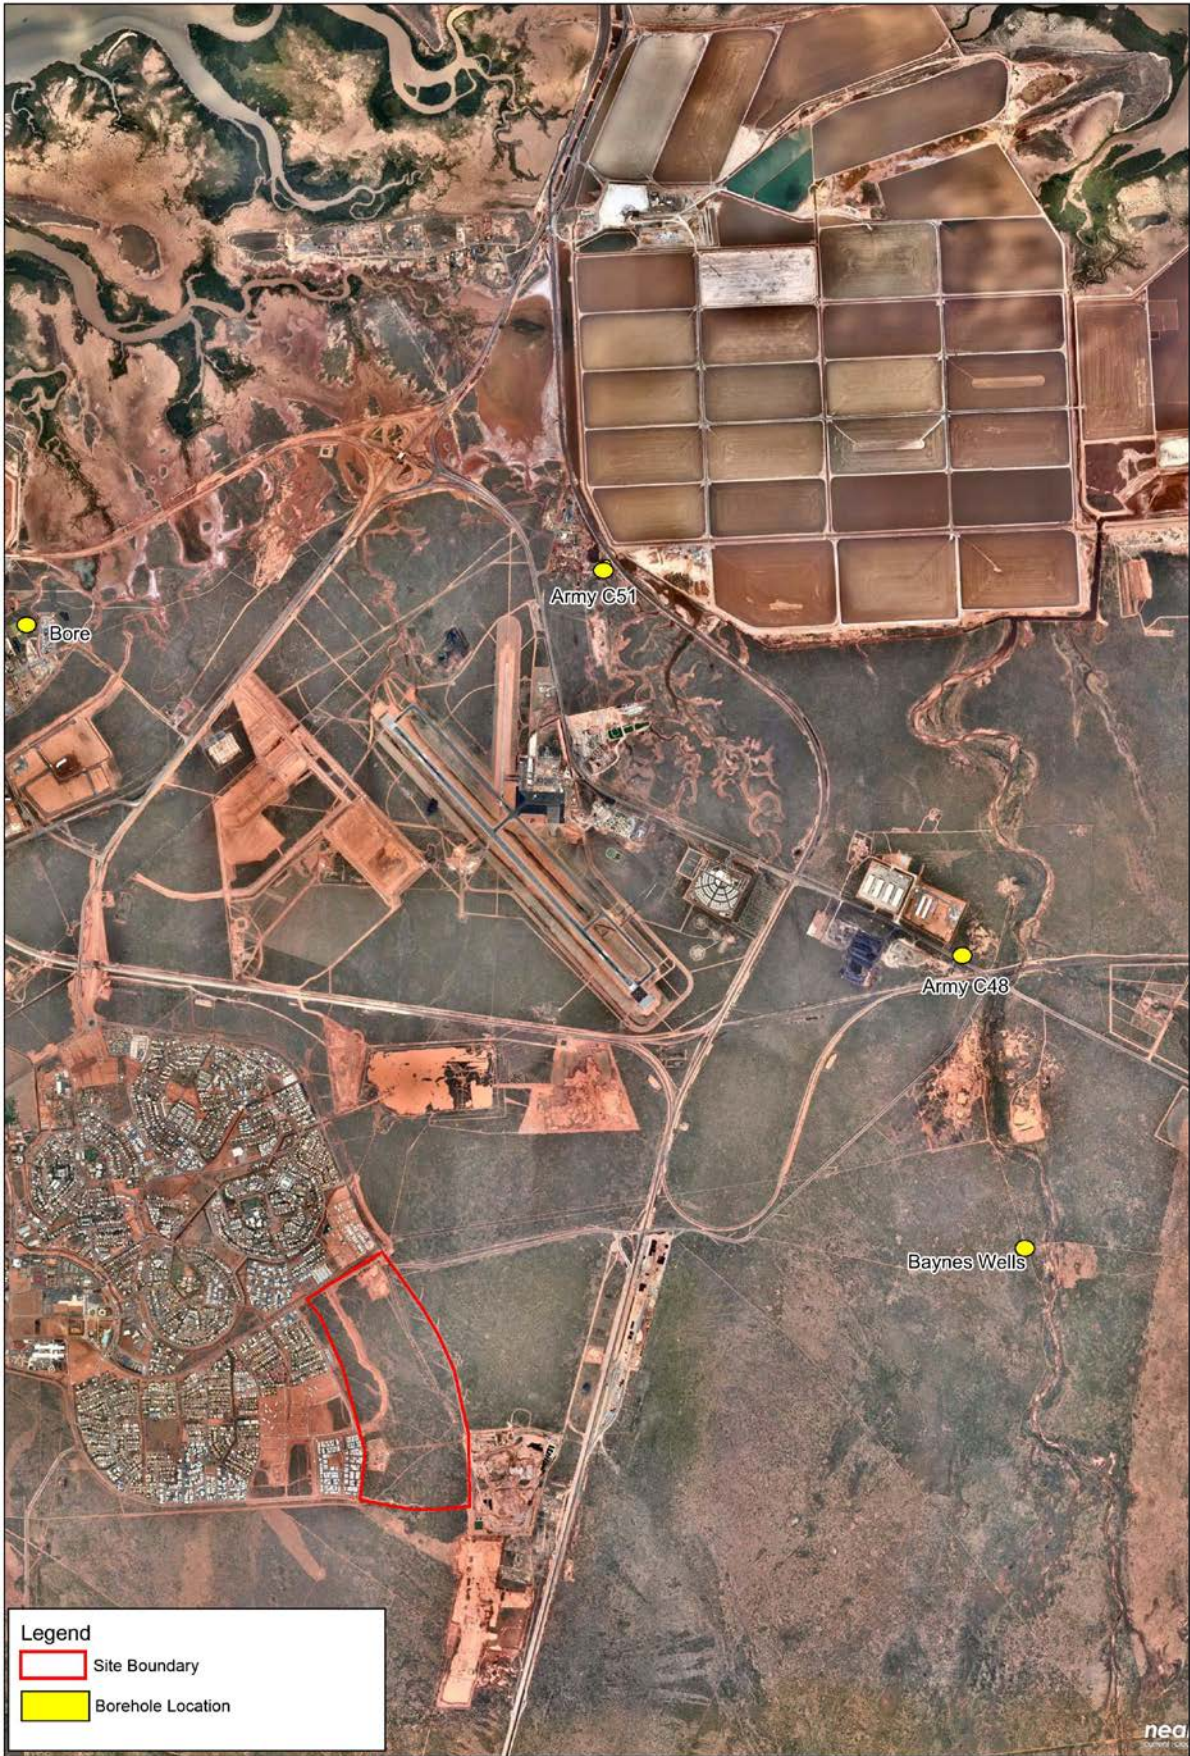
Figure 1-2 Borehole Locations

The DoW WIR database for registered boreholes indicates that there are two groundwater boreholes within a 5 km radius of the site that are used for livestock watering. Baynes Well approximately 3.6 km to the east of the site, and another bore approximately 5 km to the north west of the Site. Bore water is reportedly used for garden irrigation. The borehole locations are presented in Figure 1-2.

The Department of Water (DoW) Hydrogeological Atlas (<http://www.water.wa.gov.au/idelve/hydroatlas/>), accessed 4 March 2014, indicates that the hydrogeology beneath the site comprises superficial sediments with the Pilbara Coastal Saline deposits overlying Pilbara Alluvial deposits which are typically 'brackish'. The Atlas also indicates that the total dissolved solids (TDS) of the groundwater beneath the site is in the range between 1,000 mg/L and 3,000 mg/L, which corresponds to between 'fresh' and 'brackish'. However, these values are based on the Generalised State Salinity mapping which is broad scale and may not be accurate at a local scale. A search of DoW boreholes indicated that the groundwater within boreholes ARMY C51 (5 km north) and ARMY C48 (4.5 km south-east) had TDS levels of 5,720 mg/L and 4,468 mg/L respectively, corresponding to 'saline' and 'brackish'. The borehole locations are presented in Figure 1-2.

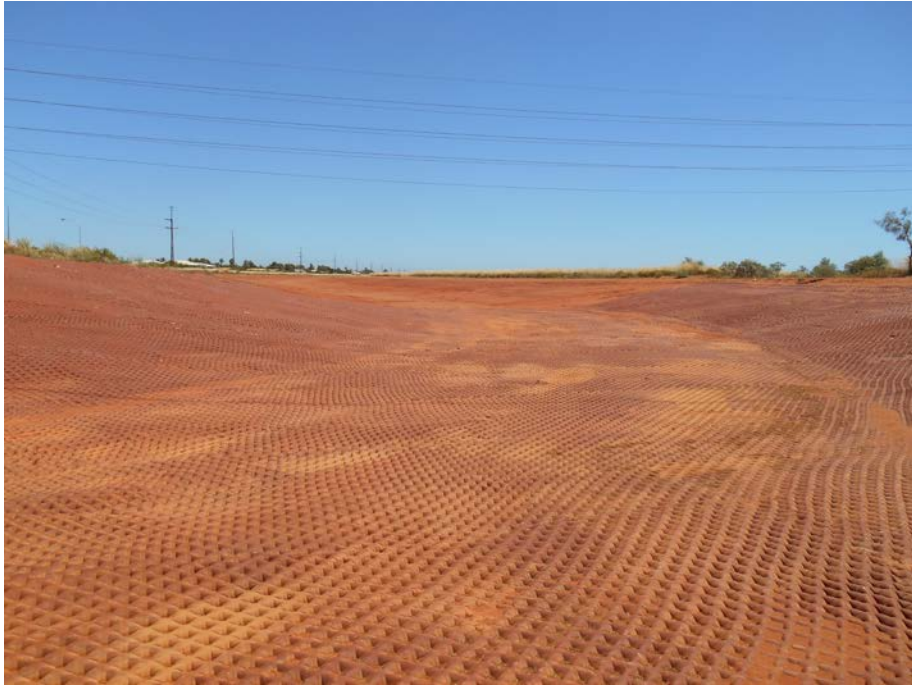
Plate 1 Constructed Drainage Channel

A review of aerial photography and a site visit (6th March 2014) was used to identify surface water bodies within and surrounding the site. A man-made drainage channel (Plate 1) traversing the site has recently been constructed. This channel connects with existing drainage channels along the North Circular Road and flows north. A drainage assessment (Parsons Brinckerhoff, 2012) was completed for the Ospreys housing development located to the west of the site. The drainage assessment uses the site to transfer runoff through the man-made constructed drainage channel. This assessment also proposed a number of drainage channels and Public Open Space's (Figure 1-3) to convey flows. The report recommends that the site utilises POS areas for flood storage in the 100yr Average Recurrence Interval storm event to provide flood protection for the new developments. Until a completed drainage assessment of the proposed development has been undertaken it is unclear whether these channels and POS areas for flood attenuation are needed.

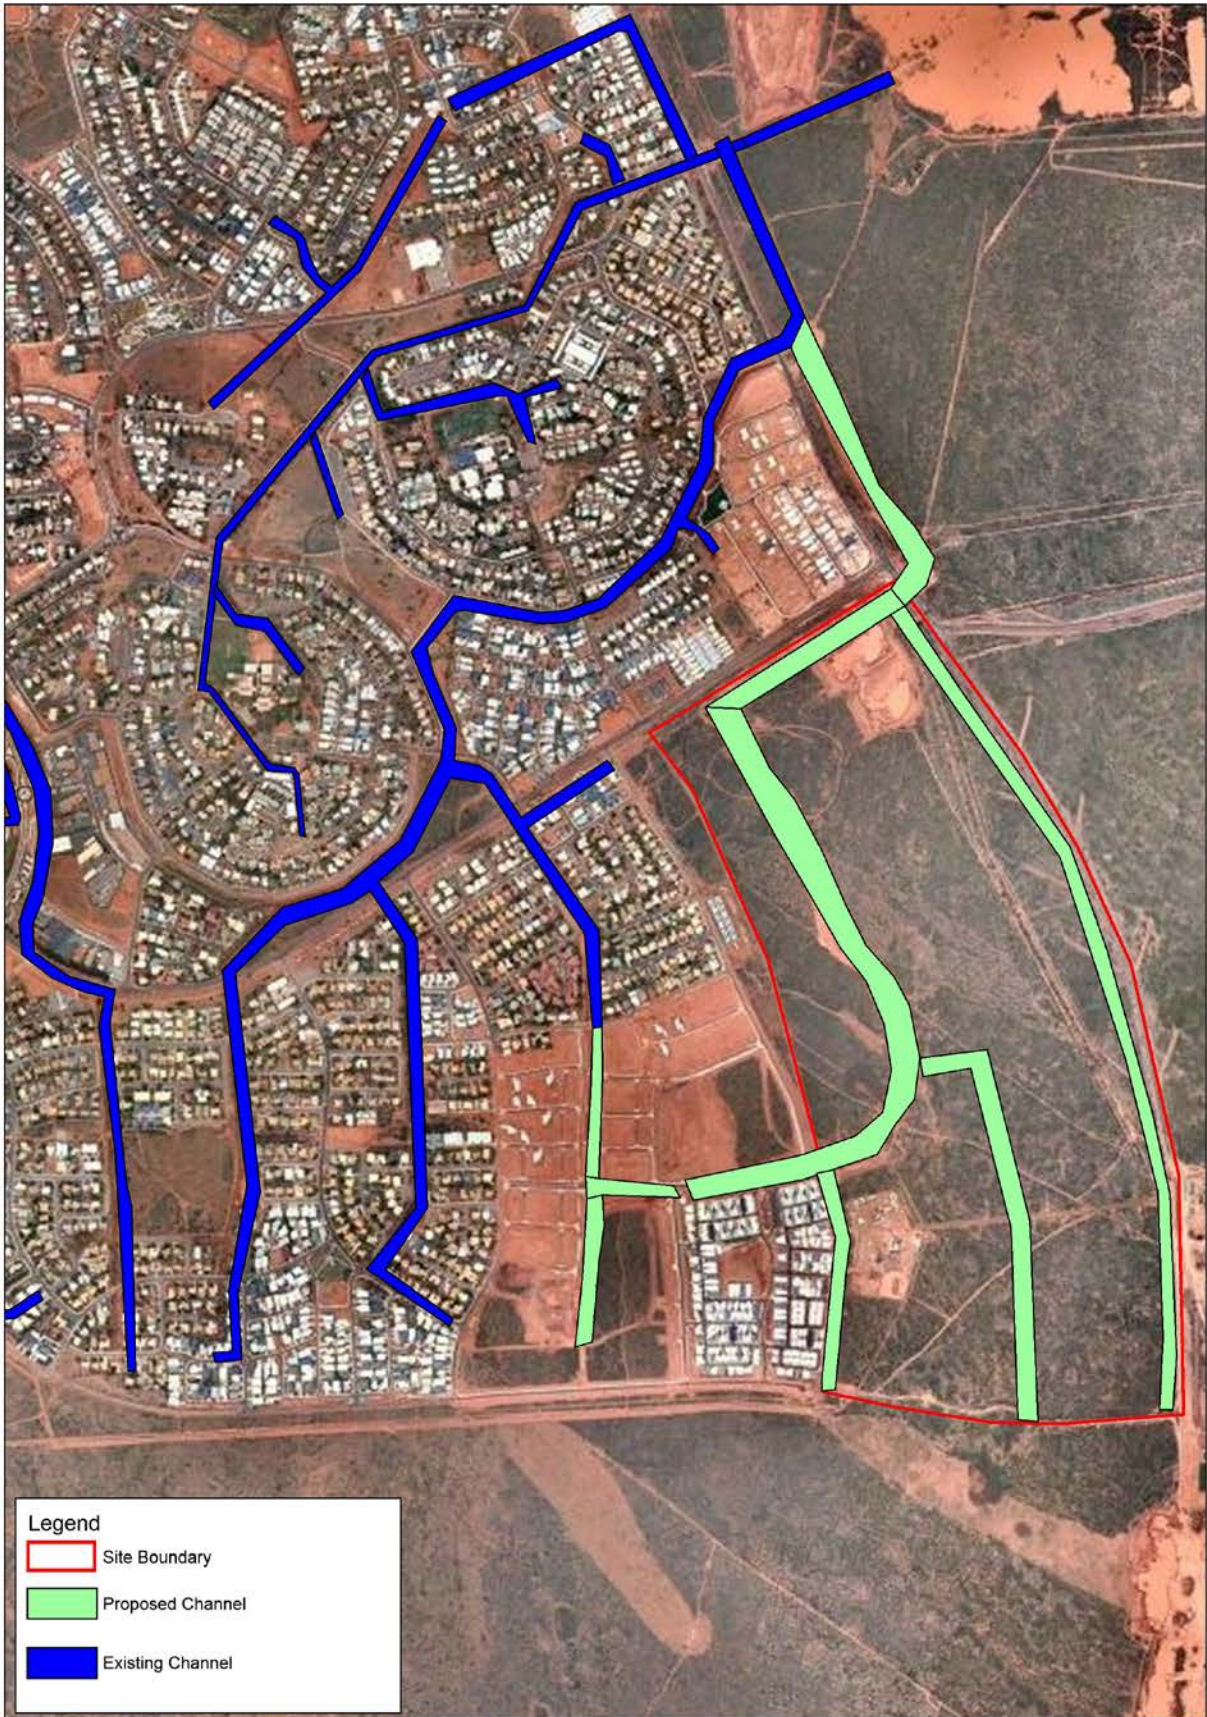
Figure 1-3 Drainage Channels

There are many existing interlinking drainage channels throughout South Hedland. As South Hedland is generally flat with a gentle slope toward the north west and north east divided by a low ridge running north south through the centre of the town. The ridge is an extension of naturally higher land south of the town and varying between 13 m and 16 mAHD. Throughout most parts of the town, lots drain overland to adjacent road reserves and roads are graded to direct stormwater to a network of open channels. The open drainage channels convey stormwater through culverts and small bridges to the natural drainage line immediately west of the South Hedland and to a large infiltration/evaporation basin east of North Circular Road. A recent flood study (GHD, 2011) for the town of South Hedland produced flood maps of the area. The flood extent shows that the current drainage system for the town (as of 2010) does not inundate the site.
