Town of Port Hedland

Structural Review of Observation Tower, Wedge Street, Port Hedland

RSA 15-0440-150727-R TOPH 139515 July 2015

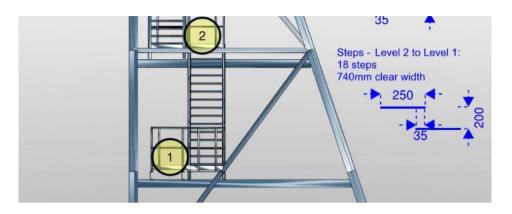
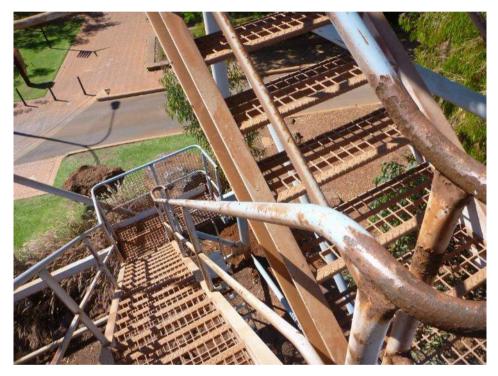
3.2.1 Level 1 to 2

Number	$2 \le N_{steps} = 18 \le 18$	OK
Riser	$130mm \le R = 200mm \le 225mm$	OK
Going	$215mm \le G = 215mm \le 355mm$	OK
Combination	$540mm \le (2R+G) = 615mm \le 700mm$	ОК

The stairway steps comply with the requirements of AS 1657 for a stairway.

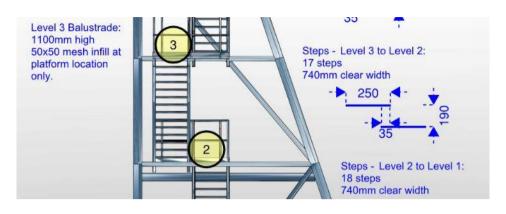
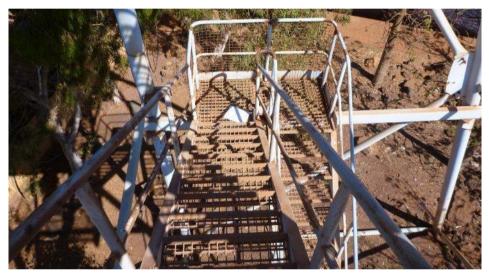
3.2.2 Level 2 to 3

Number	$2 \le N_{steps} = 17 \le 18$	ОК
Riser	$130mm \le R = 190mm \le 225mm$	OK
Going	$215mm \le G = 215mm \le 355mm$	OK
Combination	$540mm \le (2R+G) = 595mm \le 700mm$	ОК

The stairway steps comply with the requirements of AS 1657 for a stairway.

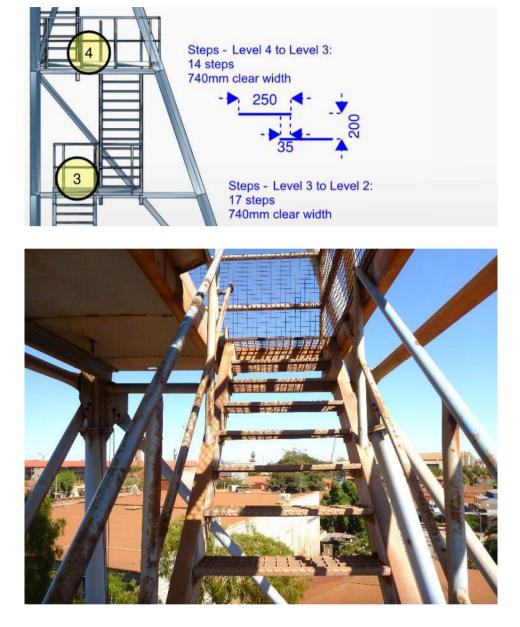
3.2.3 Level 3 to 4

Number	$2 \le N_{steps} = 14 \le 18$	ОК
Riser	$130mm \le R = 200mm \le 225mm$	ОК
Going	$215mm \le G = 215mm \le 355mm$	OK
Combination	$540mm \le (2R+G) = 615mm \le 700mm$	ОК

The stairway steps comply with the requirements of AS 1657 for a stairway.

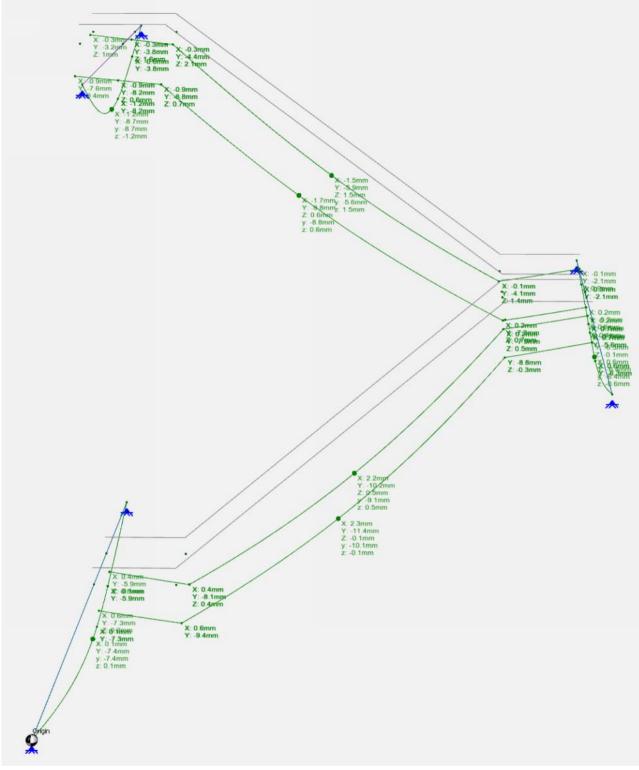
Figure 15: Deformation for Load Combination G+0.7Q

The maximum vertical deflection of approximately 11.4mm occurs for the lower stairway stringers which span nominally 6,000mm between supporting beams.

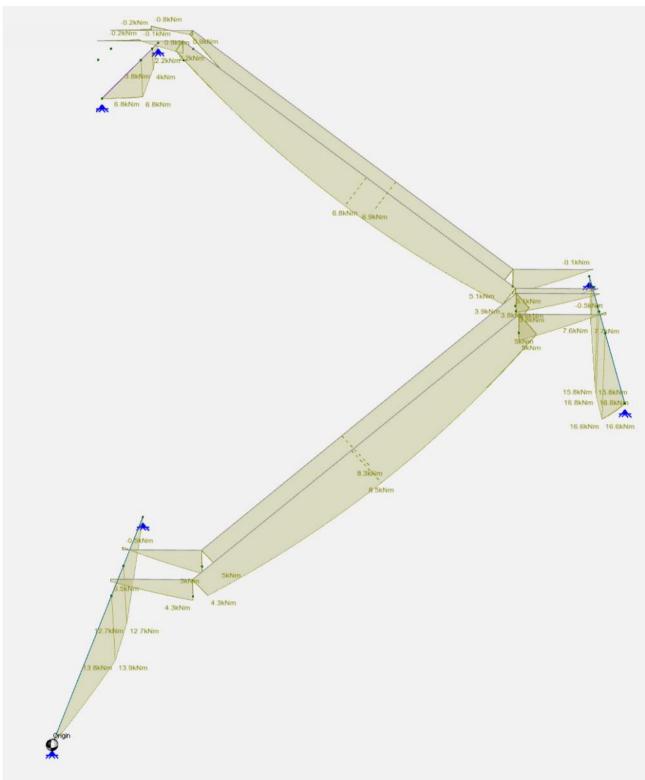
Figure 16: Bending Moment Diagram for Load Combination 1.2G + 1.5Q

The maximum bending moment in the stair stringer is approximately 8.5kNm. The maximum bending moment in the top supporting CHS is approximately 6.8kNm. The maximum bending moment in the support RHS sections is approximately 16.8kNm.

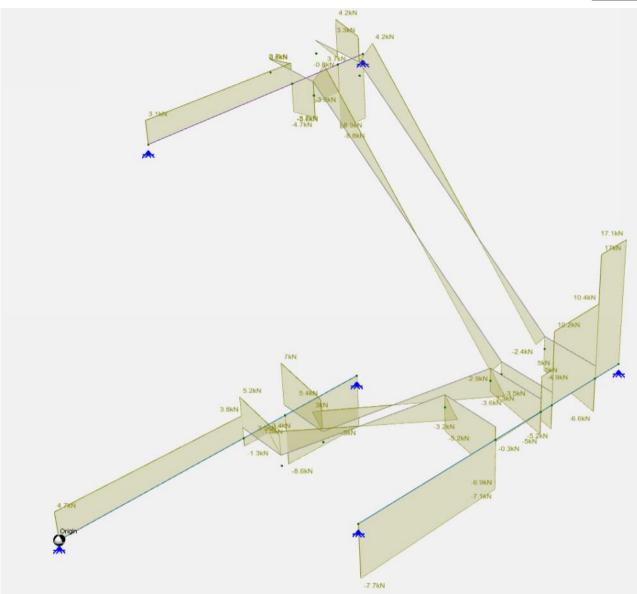
Figure 17: Shear Force Diagram for Load Combination 1.2G+1.5Q

The maximum shear force in the stair stringers is approximately 7kN. The maximum shear force in the top supporting CHS is approximately 8.9kN. The maximum shear force in the supporting RHS sections is approximately 17.1kN.

The calculated design actions are less than the factored section capacity. No structural deficiencies are identified.

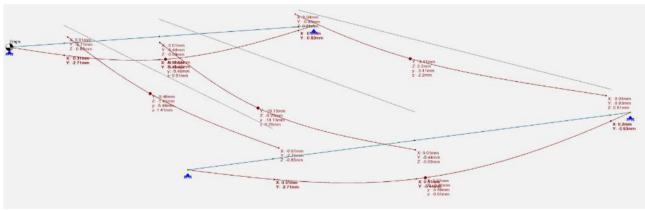
Figure 19: Deformation for Load Combination G+0.7Q

The maximum vertical deflection of a 150PFC is approximately 10.1mm (for a span of approximately 4.3m). The maximum vertical deflection of a supporting CHS is approximately 5.5mm for a span of approximately 2.7m.

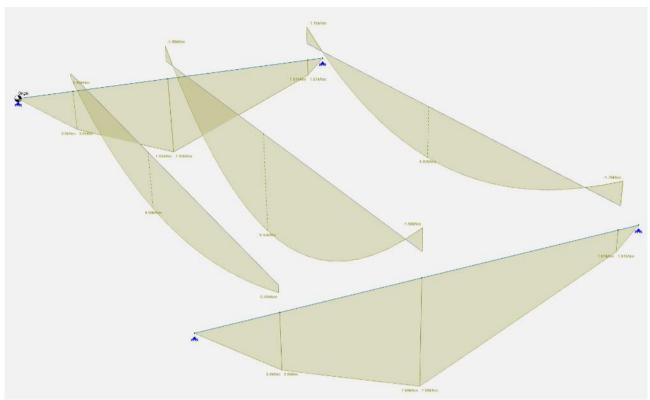
Figure 20: Bending Moment Diagram for Load Combination 1.2G + 1.5Q

The maximum bending moment in a 150PFC is approximately 8.4kNm. This assumes that a bending moment of approximately 1.6kNm can be transferred at the welded connection between the 150PFC and the supporting 114CHS section.

The maximum bending moment in the supporting CHS is approximately 7.7kNm.

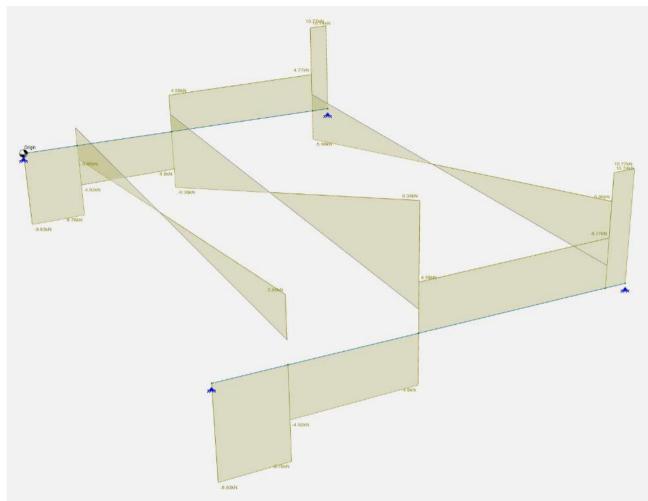
Figure 21: Shear Force Diagram for Load Combination 1.2G+1.5Q

The maximum shear force in a 150PFC is approximately 9.4kN. The maximum shear force in a supporting CHS section is approximately 11kN.

The calculated design actions are less than the factored section capacity. No structural deficiencies are identified.

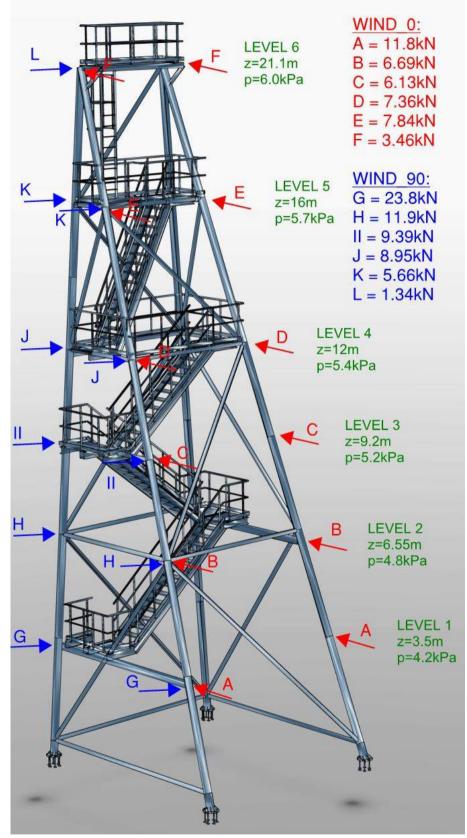
Figure 23: Wind Load Applied in SAP Computer Model

Wind loads were applied as illustrated on the following page. Key results are presented in Appendix C. No structural deficiency was identified.

Under wind loading the maximum calculated uplift is approximately 65kN. As noted previously, the top of one of the concrete footings was exposed to verify the size as given on the "Tower Relocation Note" included in Appendix A. This is illustrated on SK03 included in Appendix C. The footing size is therefore nominally 2.5x2.5x1.3m with a factored mass of 0.9G=175.5kN based on a concrete unit weight of 24kN/m^3. On this basis the existing footing is considered adequate to resist the applied uplift.

The largest axial compression force in the lower level braces is approximately 75kN. In comparison the factored axial compression capacity of these members is approximately 105kN, based on C250 steel and effective length of 6m. This is reduced to 92kN noting that the yield strength is considered to be 221MPa rather than 250MPa. On this basis we can tolerate a reduction in steel material of approximately 20% before the remaining material is no longer sufficient to carry the calculated design action.

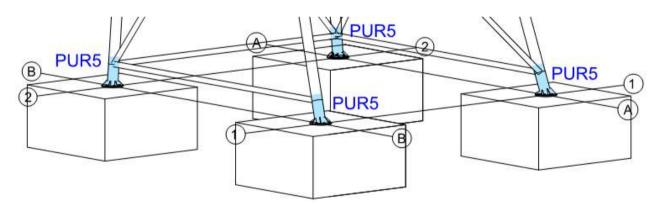
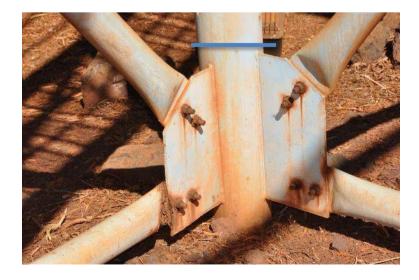
A more durable protective coating is specified for column bases. Site inspection suggests that this zone is more prone to corrosion, as evidenced by greater corrosion in this area.

At column bases provide additional thickness of the mid coating, extending up to the top of the lower strut and brace connection as illustrated and outlined below:
